Dynamic seat control is not functioning correctly and/or air cushions do not inflate fully

Topic number	LI91.10-P-059386
Version	1
Design group	91.10 Front seats
Date	07-12-2014
Validity	Model series 211, model series 219 with SA code 433 and 434
Reason for change	Damage code list updated; FC entered in reference list and text updated
Reason for block

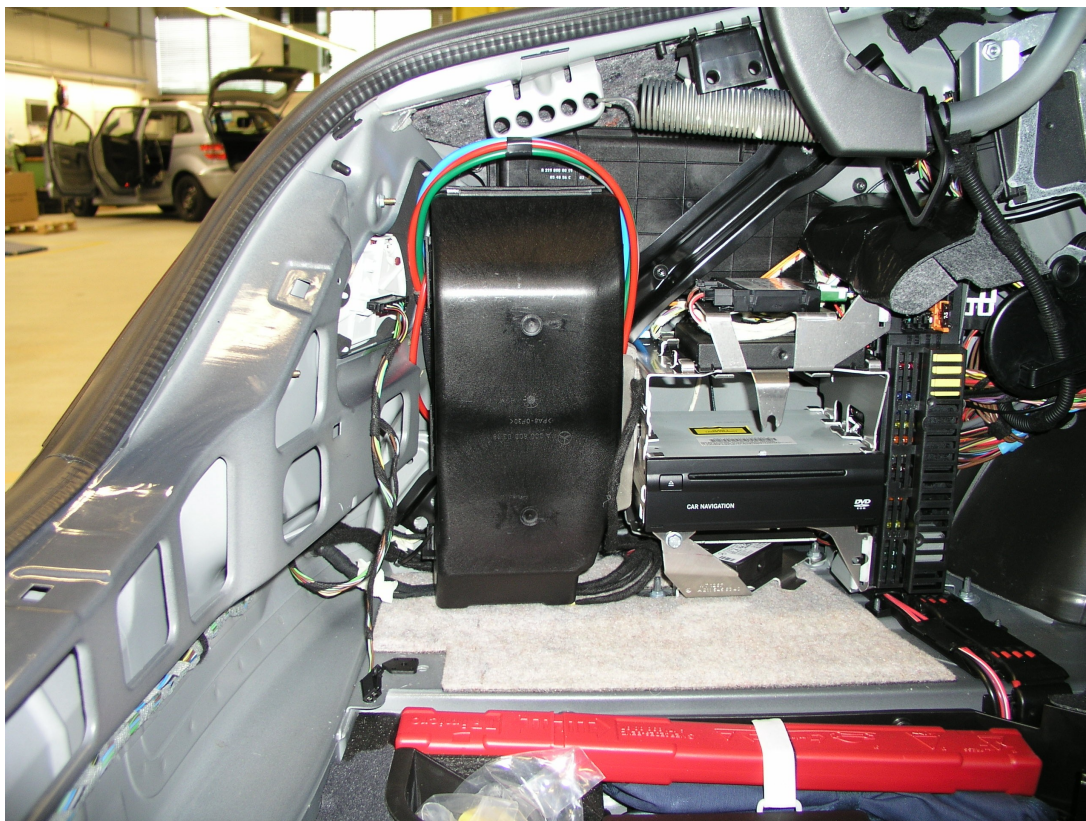
Reparaturkit im eingebauten Zustand.JPG:

Attachments	
File	Description
Reparaturkit im eingebauten Zustand.JPG	Repair kit
Zange.jpg	Special tool

- Note: When the pneumatic pump is replaced on vehicles up to 31.08.2006, the pneumatic pump with the four-color pneumatic line set used in vehicles as of 1.09.2006 must be installed.
- Disconnect pressure line from pressure reservoir.
- Disconnect vent line from pressure reservoir.
- Connect green pneumatic line in place of the pressure line.
- Connect blue pneumatic line in place of the vent line.
- Connect red pneumatic line to the pneumatic line on the vehicle.
- After installing the pneumatic pump, fasten the pneumatic line harness to the pneumatic pump using a cable tie.
- Info: Route the pneumatic wiring harness so that it cannot chafe and does not kink.

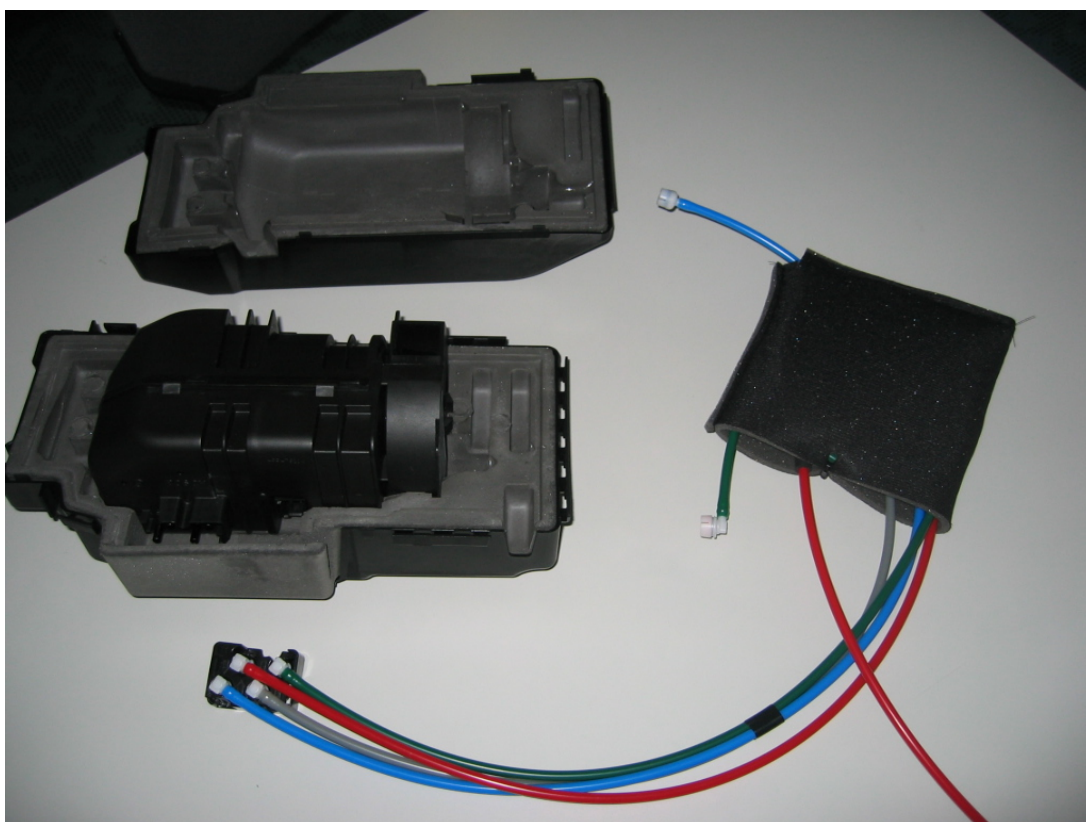
Teile des Reparaturkits. JPG:

Attachments	
File	Description
Teile des Reparturkits.JPG	Parts listing

Part number	ES1	ES2	Designation	Quantity	Note	EPC	Other ma- ke part
A 000 800 03 18			Protective cap holder	1	Component of the repair kit. Is supplied automatically.	X	
A 000 800 42 48			Optimized pump	1	Component of the repair kit. Is supplied automatically.	X	
A 000 800 35 15			Replacement hose line/pres- sure supply	1	Component of the repair kit. Is supplied automatically.	X	
W000 589 04 37 00			Pliers for pneumatic lines	1	Order via GLC		X
