## Multicontour/dynamic seat, malfunctions

Topic number	LI91.25-P-059392
Version	1
Design group	91.25 Multicontour seat (MCS)
Date	07-12-2014
Validity	Model series W/V 221 with SA code 406 or 409 or 432 as of VIN 221...106647 up to VIN 221...134746 Model series 216 with SA code 409 or 432 as of VIN 216...002723 up to VIN 216...006715
Reason for change	Update
Reason for block

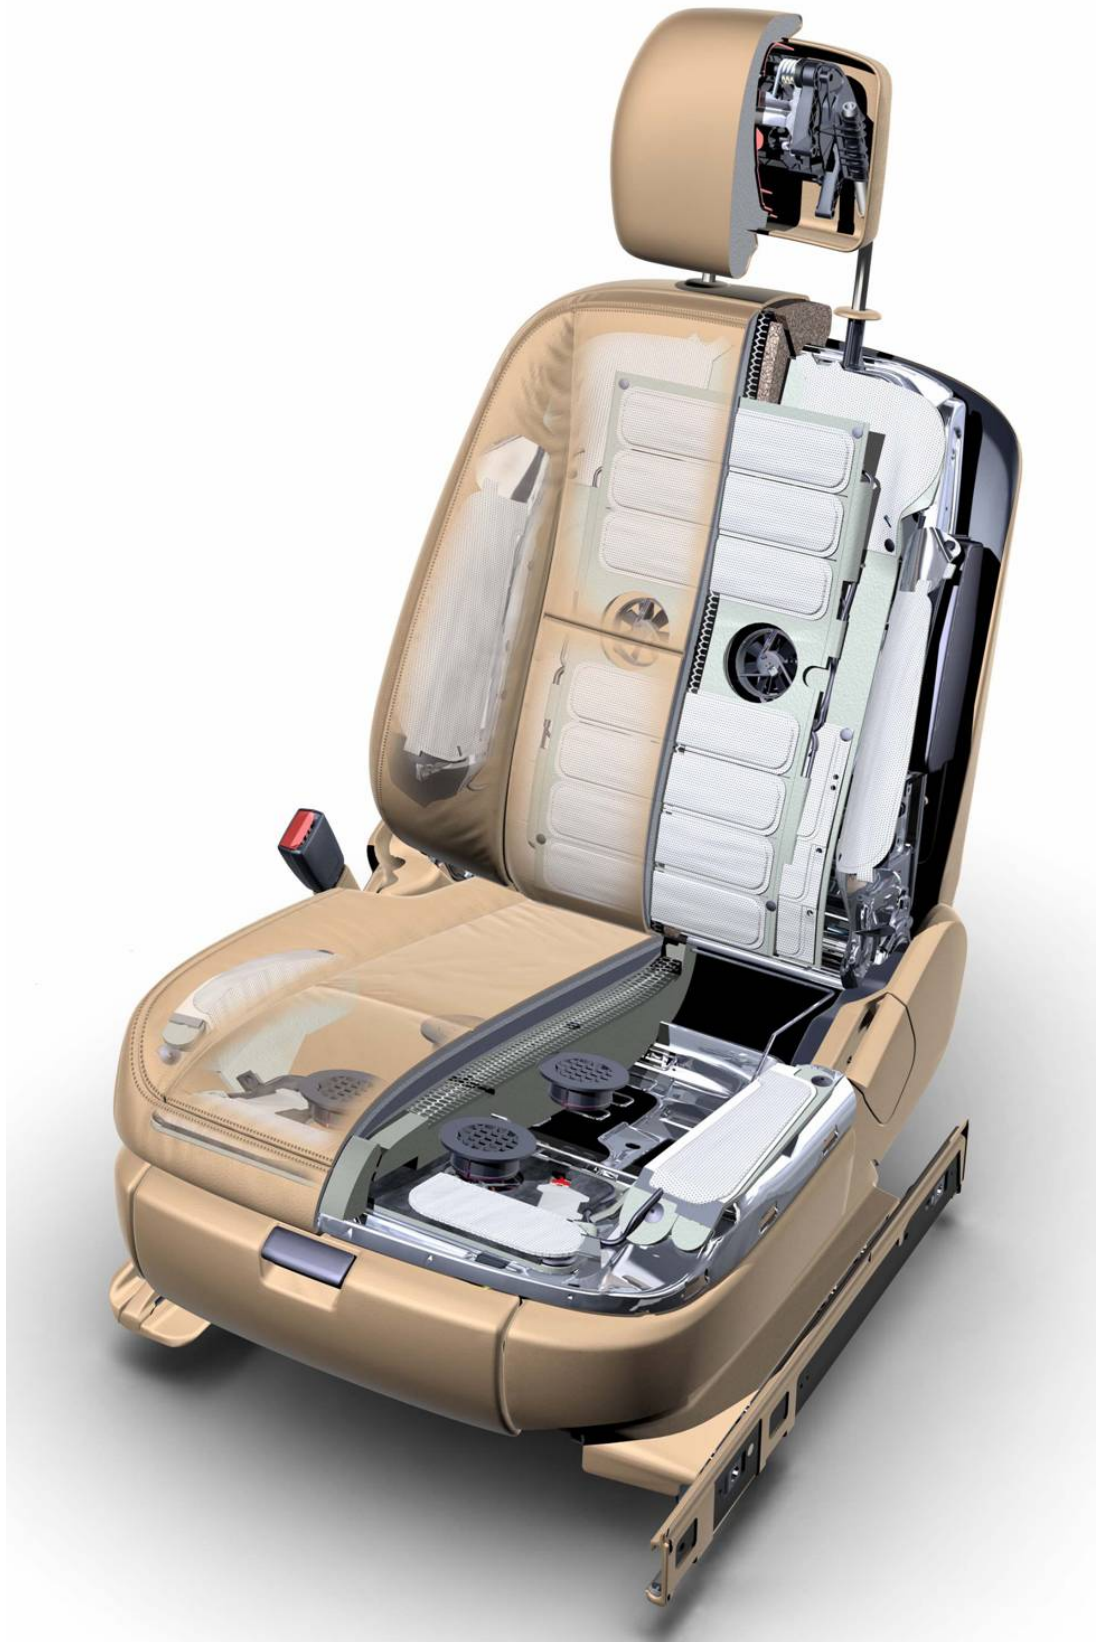
Schnittbild\_221\_Sitz\_vorn.jpg:

Attachments	
File	Description
Schnittbild_221_Sitz_vorn.jpg	(1) 221 Sitz vorn Schnittbild - 221 Front seat cutaway view
Schnittbild_221_Sitz_Fond.jpg	(2) 221 Sitz Fond Schnittbild - 221 Rear seat cutaway view

Please note: The massage pad in the front seats is permanently integrated in the backrest pad, so the entire backrest pad must be replaced (cf. picture 1 and 3). As mentioned above, the same applies for the massage pads in the rear seats (cf. picture 2).

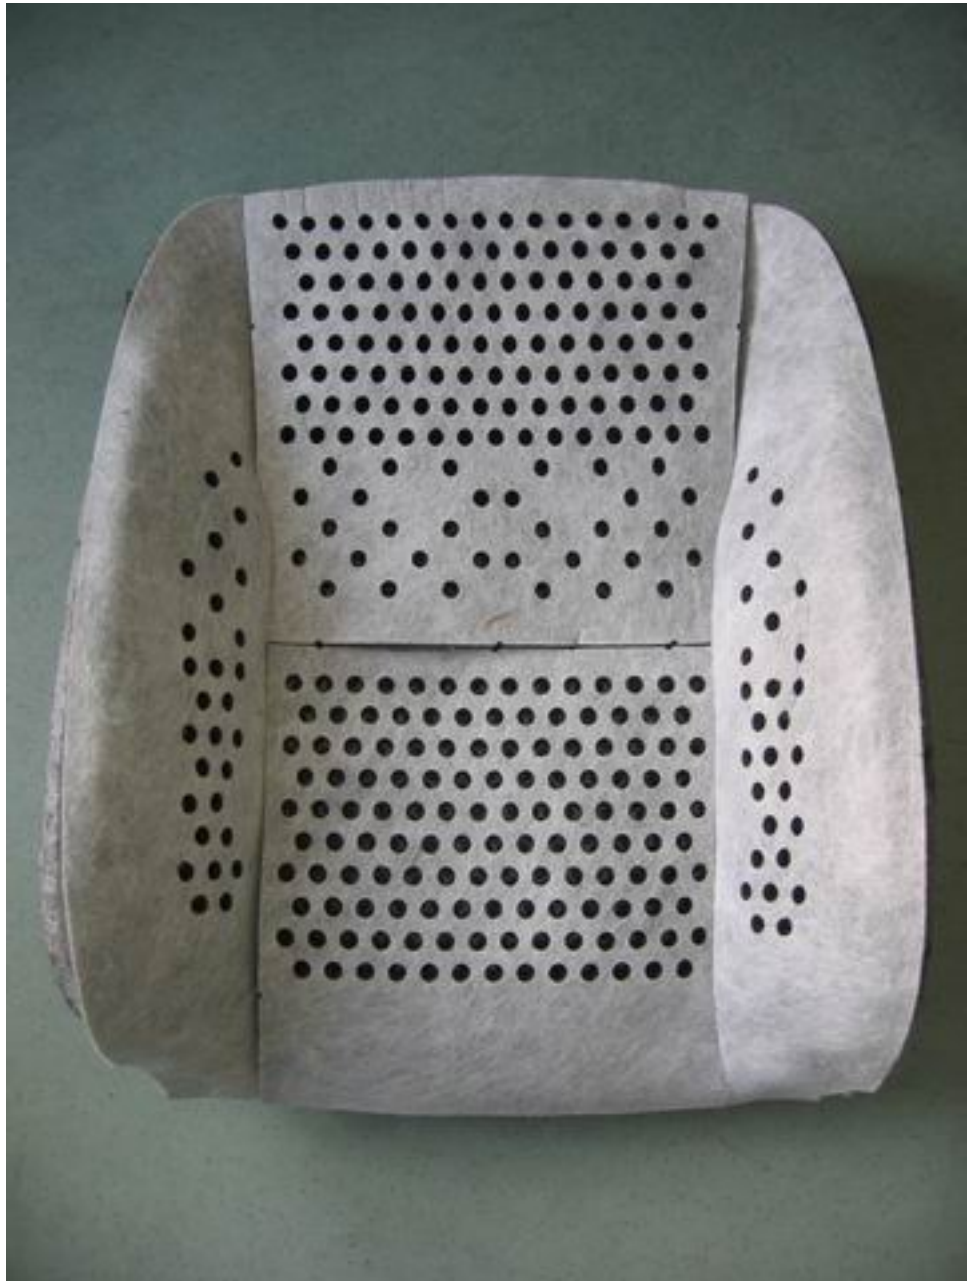
Lehnenauflage\_Massa-  
geeinlage\_221.JPG:

Lehnenauflage_Massageeinlage_221.JPG	(3) 221 Lehnenauflage mit optionaler Massageeinlage vorn - 221 Backrest padding with optional massage layer, front
MKS_FDS_Einlage_Lehne_221.JPG	(4) 221 Multikontur-/ Fahrdynamik-Einlage (-Modulträger) Lehne vorn - 221 Backrest multicontour / dynamic seat pad (module carrier), front
MKS_FDS-Einlage_Kissen_221.JPG	(5) 221 Multikontur-/ Fahrdynamik-Einlage (-Modulträger) Kissen vorn - 221 Seat cushion multicontour / dynamic seat pad (module carrier), front
Lehnenauflage_Massageeinlage_216.JPG	(6) 216 Lehnenauflage mit optionaler Massageeinlage vorn - 216 Backrest padding with optional massage layer, front
MKS_FDS_Einlage_Lehne_216.JPG	(7) 216 Multikontur-/ Fahrdynamik-Einlage (-Modulträger) Lehne vorn - 216 Backrest multicontour / dynamic seat pad (module carrier), front
MKS_FDS-Einlage_Kissen.JPG	(8) 216 Multikontur-/ Fahrdynamik-Einlage (-Modulträger) Kissen vorn - 216 Seat cushion multicontour / dynamic seat pad (module carrier), front

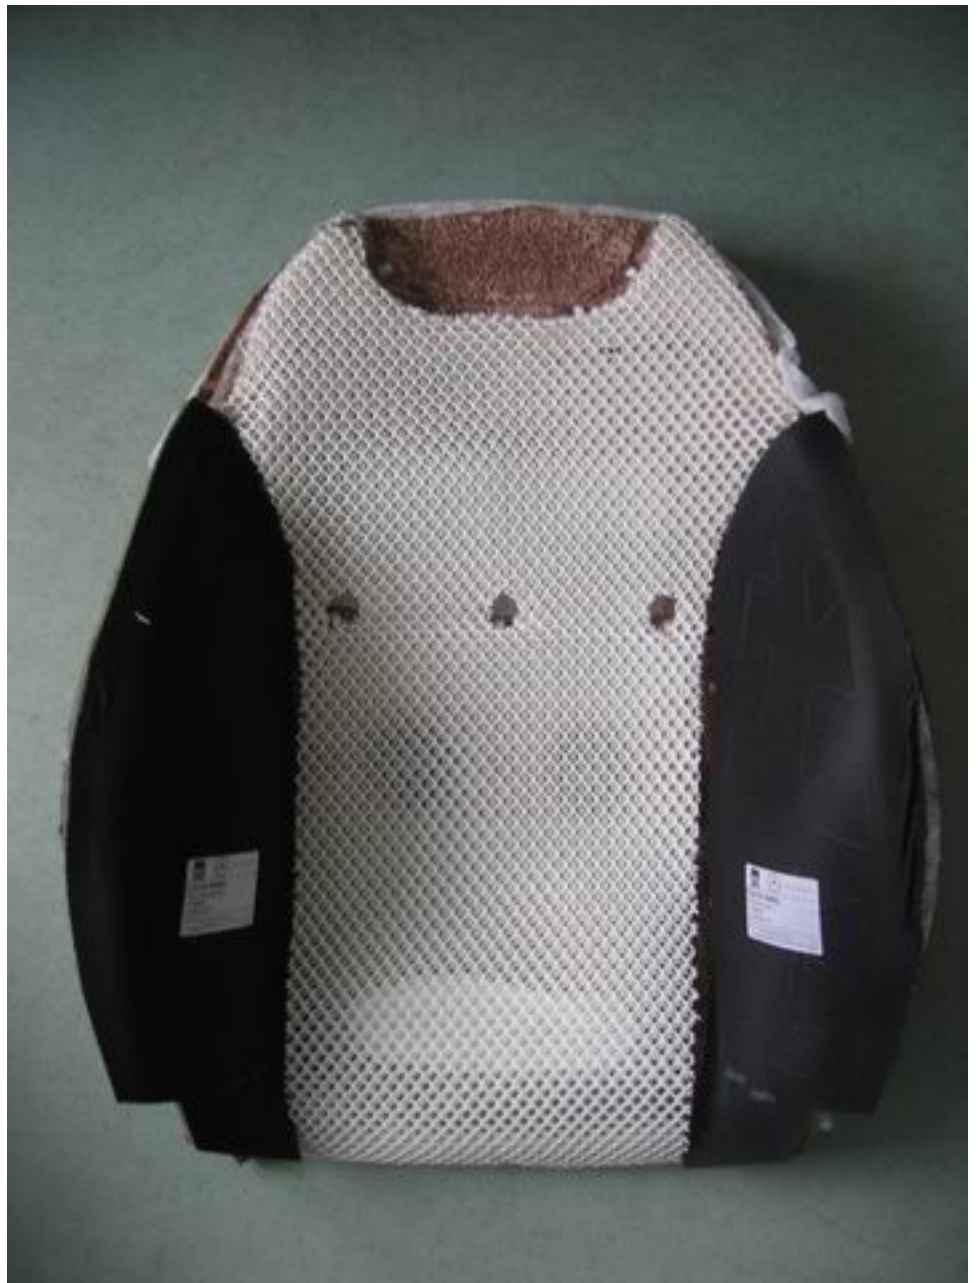
Lehnenauflage\_Massageeinlage\_216.JPG:

For the massage pads at the front (only with SA code 432, Figures 3 and 6) and at the rear (only with SA code 406, Figure 2):

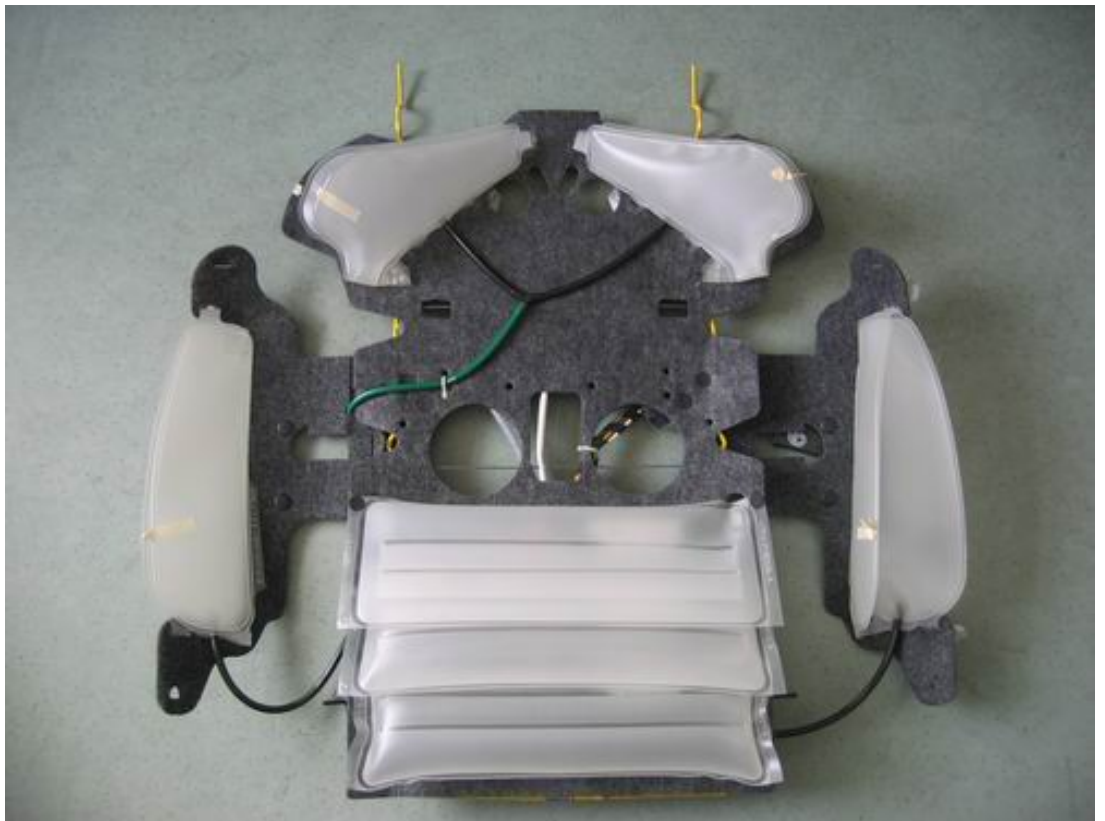
MKS\_FDS\_Einlage\_Leh-  
ne\_216.JPG:

For the front multicontour/dynamic seat pads in the backrest (Figures 4 and 7) and cushions (Figures 5 and 8) and for the multicontour pads in the rear (Figure 2):

Please note: On the front seats, the pads (module carriers) in the backrest (pictures 4 and 7) and cushion (pictures 5 and 8) for the multicontour/dynamic seat function can be replaced separately. On the rear seat, however, the entire backrest pad (Figure 2) must be replaced because in this case the corresponding modules are permanently integrated.

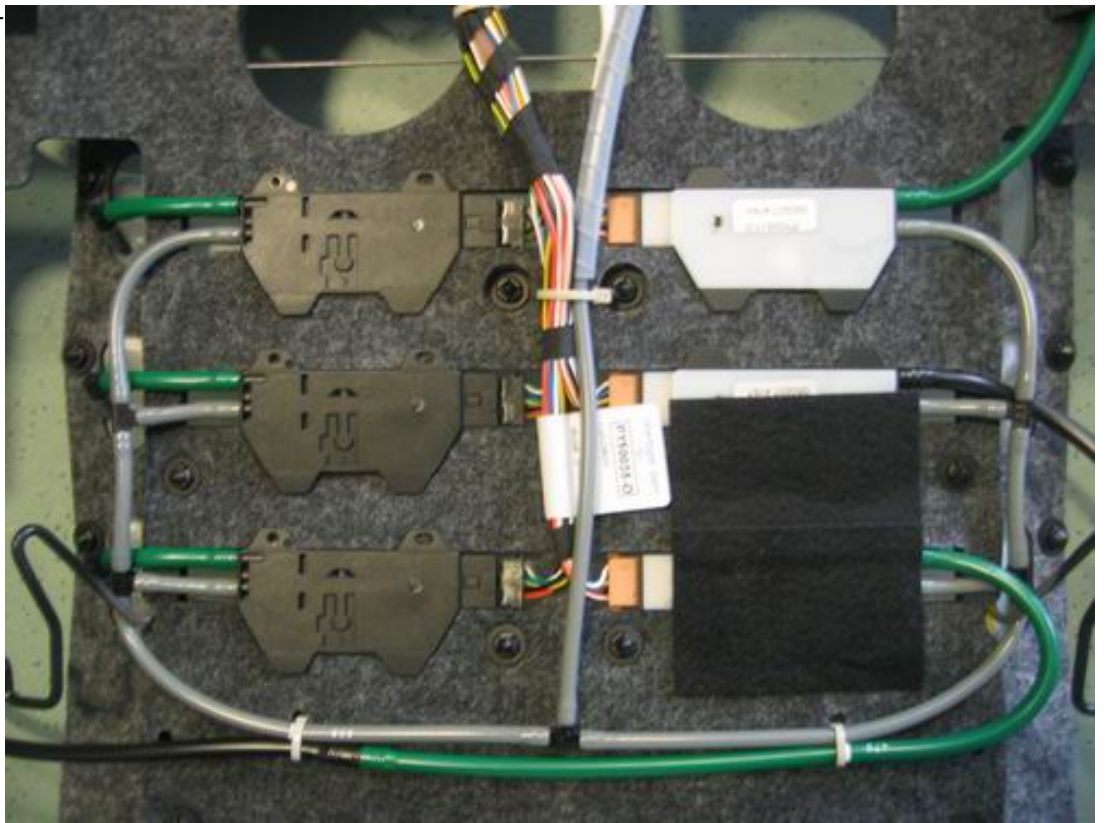
Ventile\_MKS\_FDS\_Einla-  
ge.JPG:

Due to faulty transistors in the valve electronics, valves (Figure 9) in the cushion/backrest pads can operate by themselves.

Depending on the switch position of the valve, this can result in either non-inflation or over-inflation of air cushions without any action by the driver.

Attachments	
File	Description
Ventile_MKS_FDS_Einlage.JPG	(9) Ventile der Multikontur/ Fahrdynamik-Einlagen - Valves of multicontour / dynamic seat pads

If these fault codes are found, the corresponding multicontour/dynamic seat pads (module carriers) in the relevant seats must be replaced.
