JTB00514NAS5 TECHNICAL BULLETIN 09 SEP 2019

415-00

Disc Does Not Eject From The Digital Disc Player

Incorrect specification Universal Serial Bus (USB) cables, from both the USB HUB and IMC, were used causing issues with the digital disc player functionality.

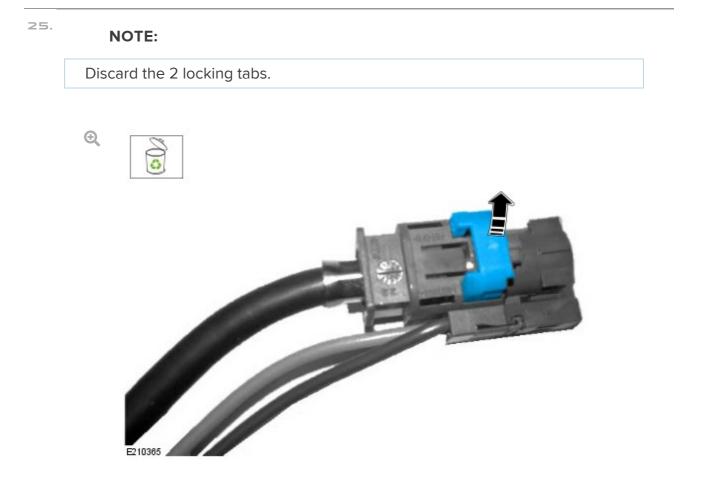
Use a suitable tool to remove the locking tab from the electrical connector at each end of the original USB link lead.

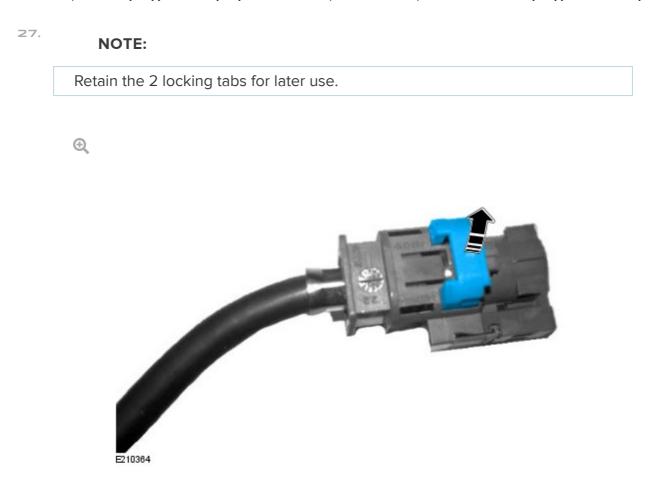
Use a suitable tool to remove the locking tab from the electrical connector at each end of the new USB link lead.

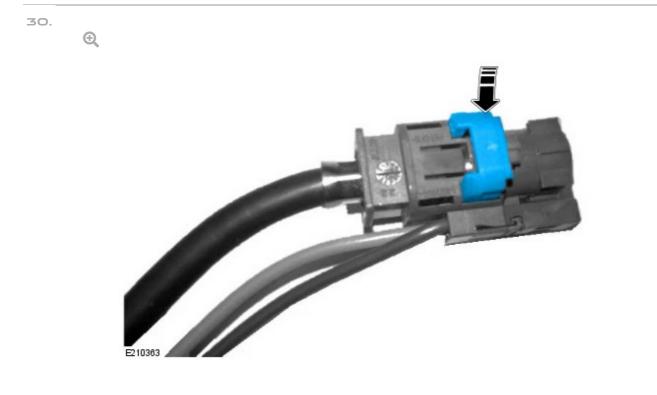
Install the locking tabs into the electrical connector at each end of the new USB link lead.
