Technical product information

Topic	Vibration / humming at idle - engine mount leak
Market area	Bentley: worldwide (2WBE),Hongkong-Macau (5HK)
Brand	Bentley
Transaction No.	2051340/2
Level	EH
Status	Approval
Release date

Vehicle vibration / humming noise at idle

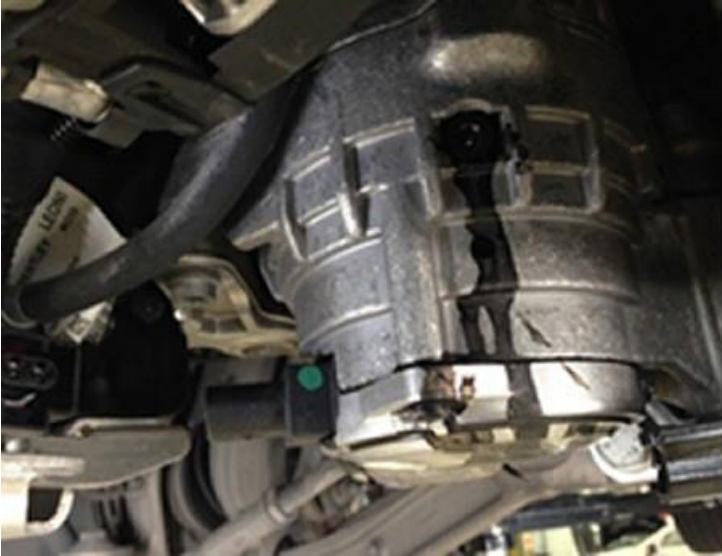
Right hand Active Engine Mount (AEM) failed, oil may also be leaking from AEM. This failure mode is only seen on W12 engine installations and is only apparent at idle.

Figure 1 Active engine mount leaking oil

In the event of a failure/complaint as detailed then replace both AEM with service parts 4M0 199 255 BH and 4M0 199 256 BH

Follow the workshop manual procedure, Rep.Gr.10 Engine mounts – To remove and fit

Additionally changes must be made to the active engine mount control module, apply the instructions in TPI 2055760.
