Technical Service Bulletin

70 Noises from headliner/sunroof area

70 19 68 2038029/7 October 31, 2019. Supersedes Technical Service Bulletin Group 70 number 18-66 dated March 16, 2018 for reasons listed below.

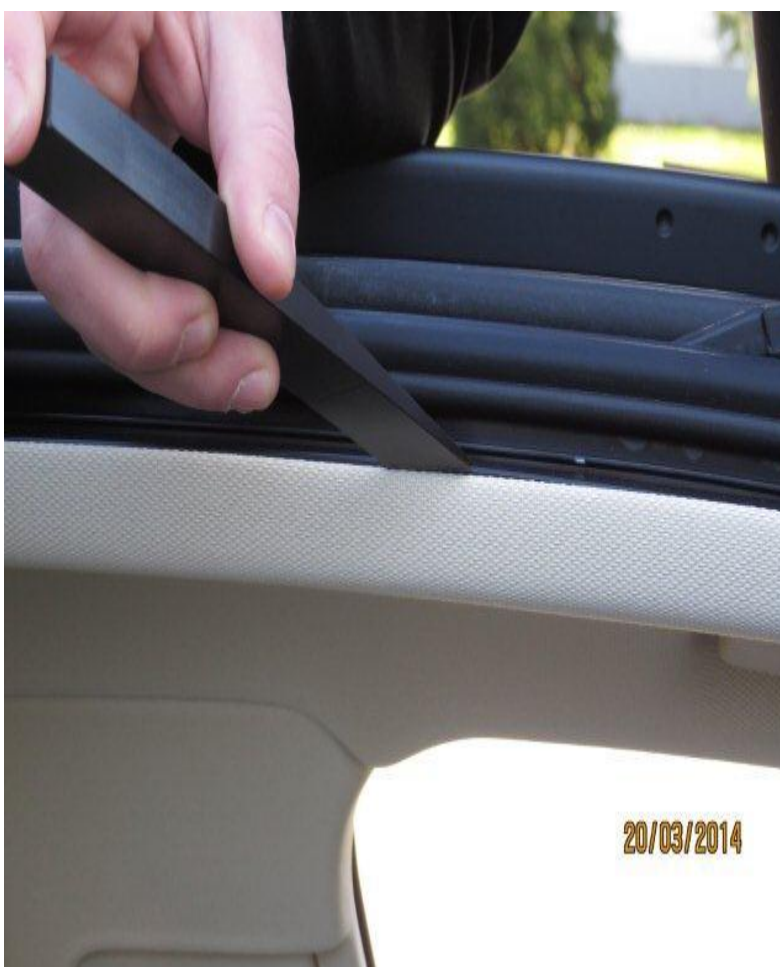
Figure 1. Unclipping the sunroof cover trim frame.

1. Carefully unclip the sunroof cover trim frame and lower the headliner (Figure 1). The headliner does not need to be removed.

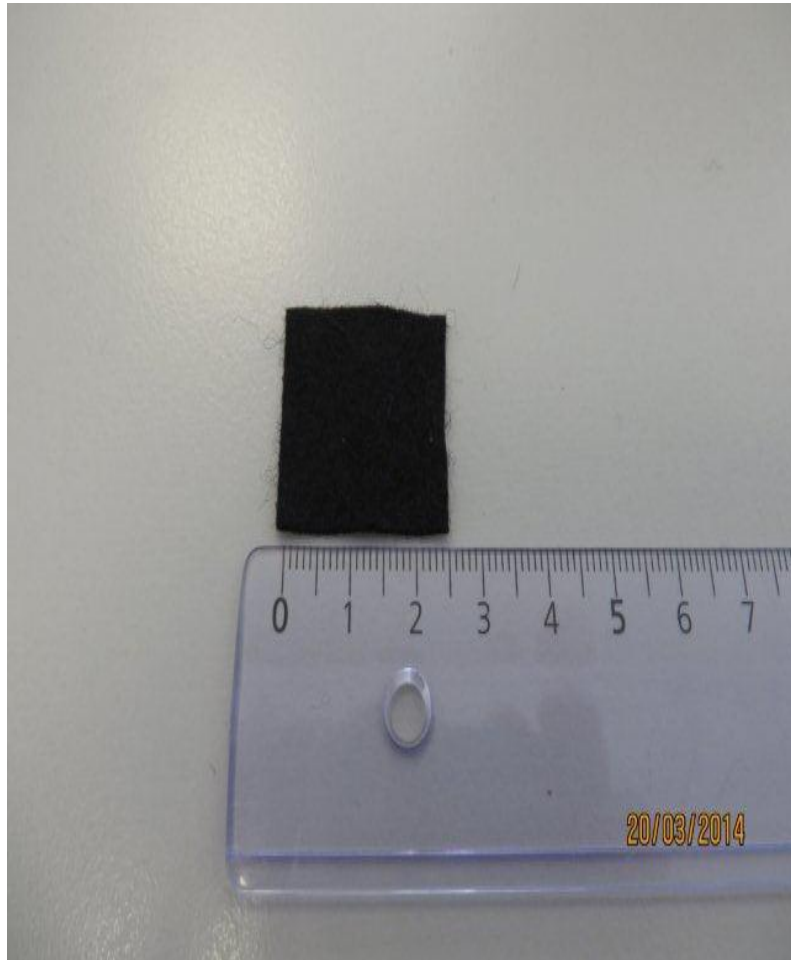
Figure 2. A 25mm section of fleece adhesive tape D 004350A2.

2. The number of retaining clips will vary by model. A piece of dampening tape (webbing adhesive tape D 004350A2) will be applied to each clipping point. Cut pieces of the tape 25mm long (Figure 2).

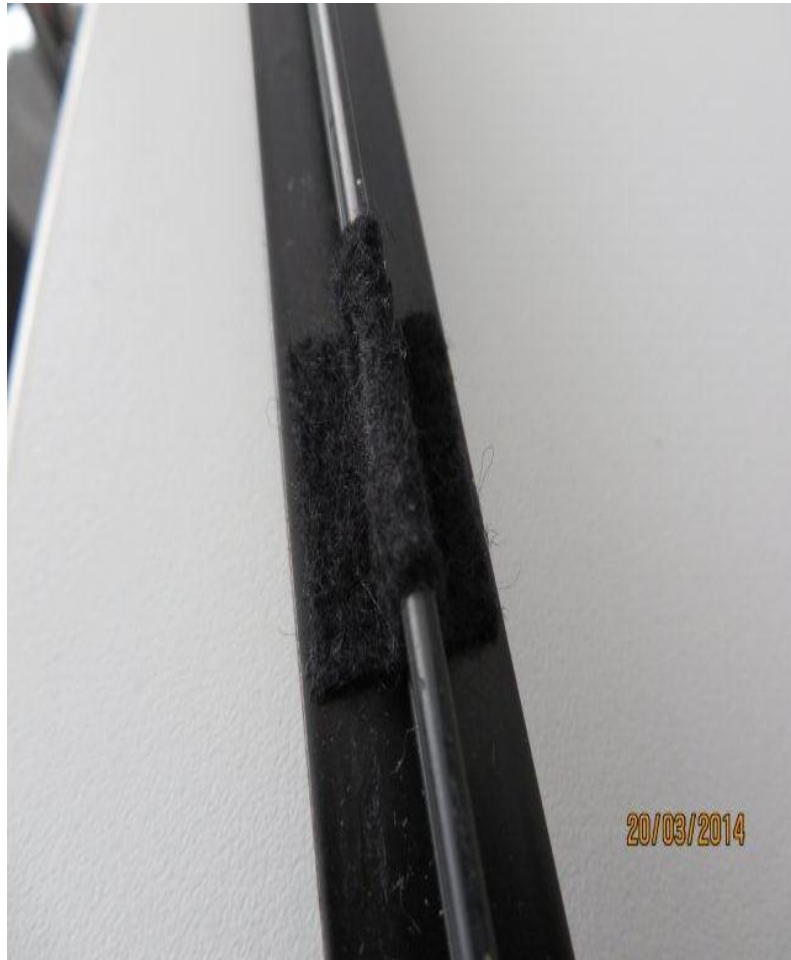
Figure 3. Fleece adhesive tape section applied.

3. Apply the sections of webbing adhesive tape to the sunroof cover trim frame to each clipping point as shown (Figure 3 and Figure 4).

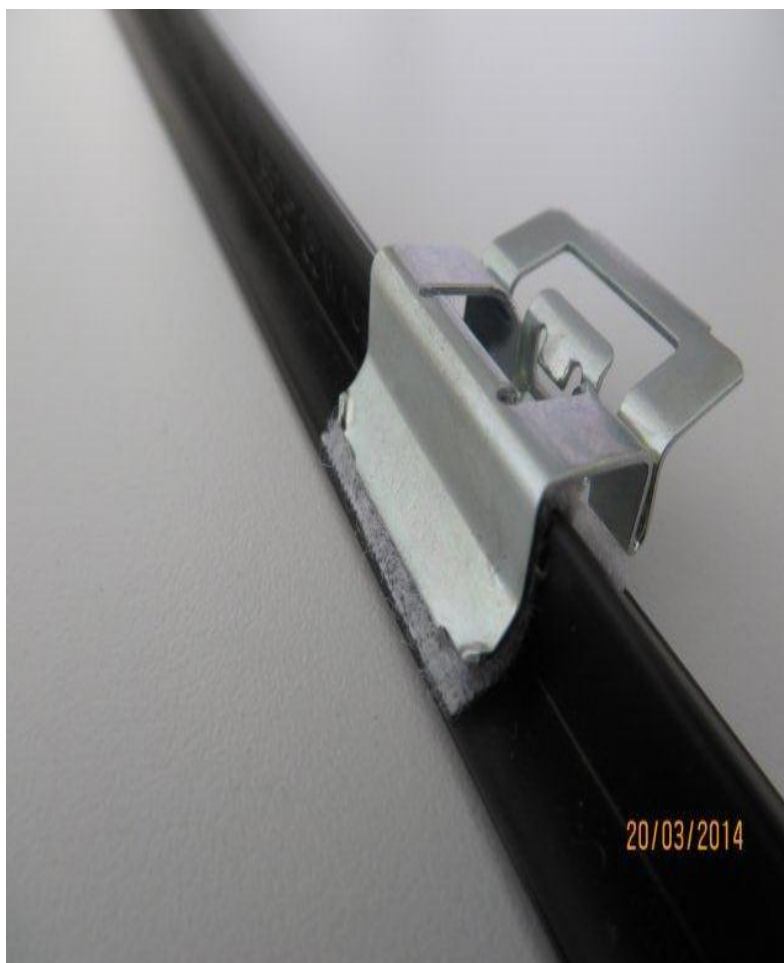
Figure 4. Retaining clip isolated with the fleece adhesive tape.
