AT15-007h

2013 JX35 AND 2014 – 2018 QX60; CVT JUDDER AND DTC P17F0 OR P17F1 STORED

APPLIED VEHICLES: 2013 JX35 (L50)
2014-2018 QX60 (L50) **V6 engine only**

APPLIED TRANSMISSION: CVT

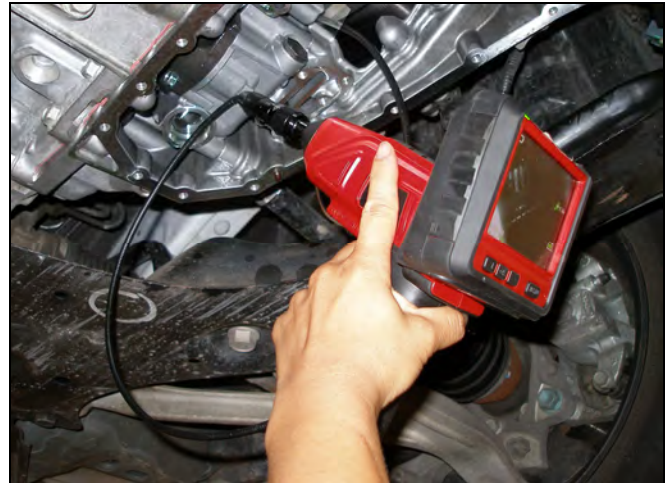
Figure 11

- Holding the borescope with one hand allows for turning the tire with the other hand (see Figure 11).

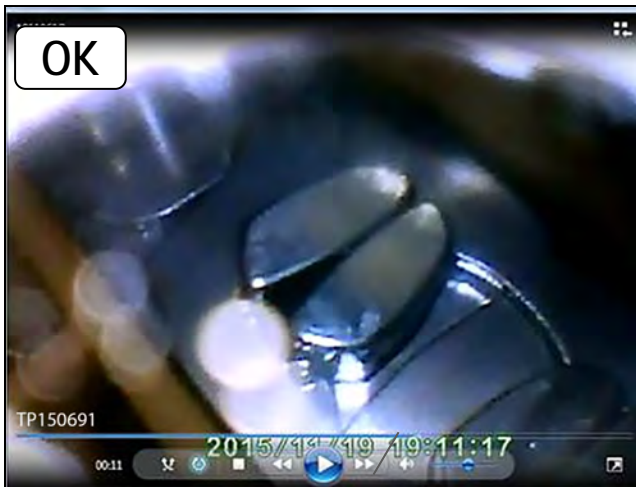
Pictures in Figure 16 and 17 were taken with borescope J-51951.

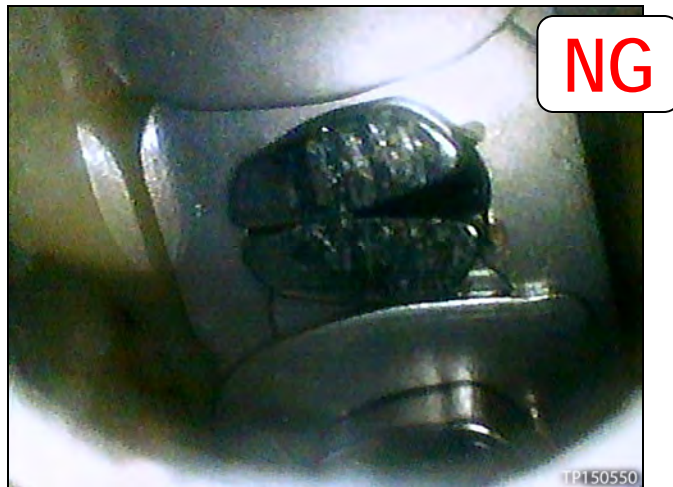
Pictures in Figure 20-21 were taken with borescope J-51951.

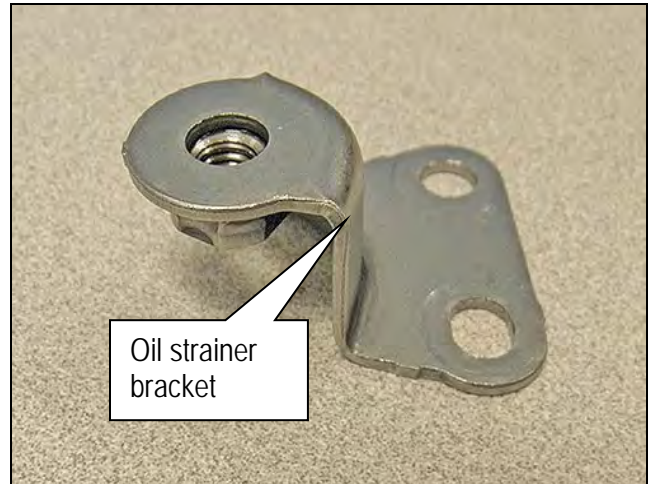
Figure 25

1. Discard the oil strainer bracket (Figure 25).
