# SERVICE BULLETIN

Classification:	Reference:	Date:
EC19-010a	NTB19-052a	October 8, 2019

## 2016-2018 MAXIMA; LOW POWER / STOP LAMPS STAY ON

**APPLIED VEHICLES:** 2016-2018 Maxima (A36)

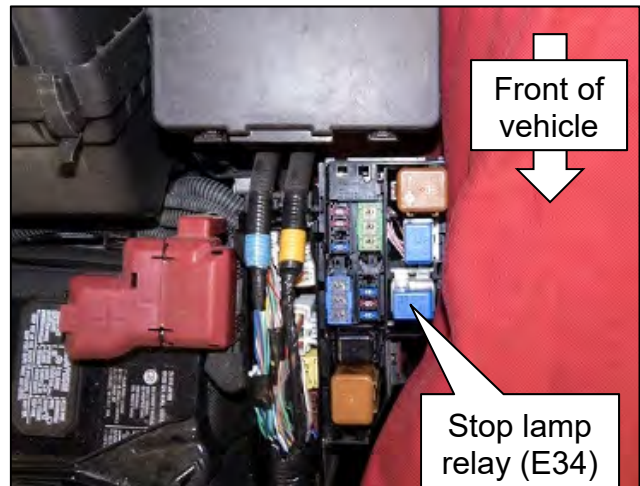
Figure 1

4. Remove the stop lamp relay (E34).

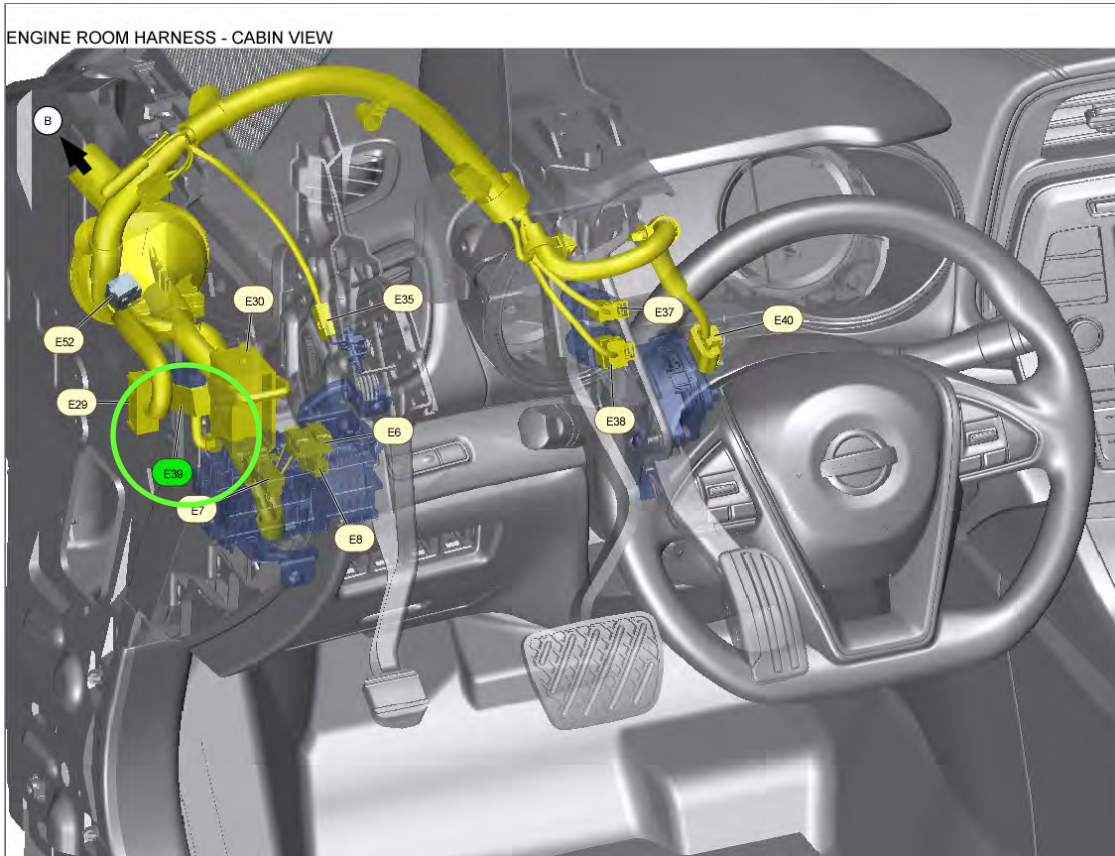
Figure 2

5. Locate Joint Connector-E08 (shown as E39 in Figure 2).

**NOTE:** Joint Connector-E08 is taped to the engine room harness behind the E7 Fuse Block (J/B).

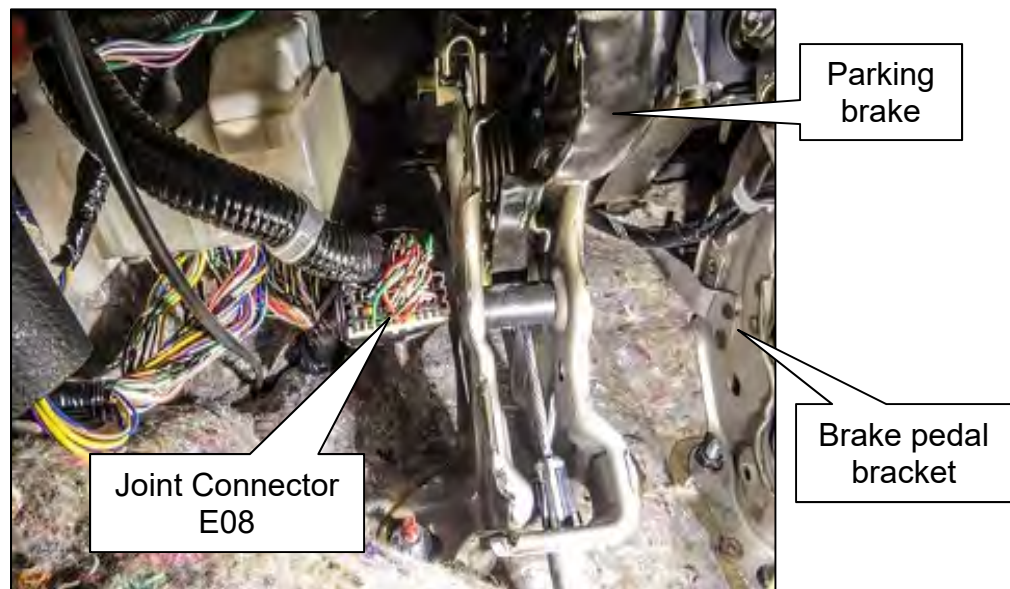
Figure 3

6. Untape Joint Connector-E08 from the engine room harness.

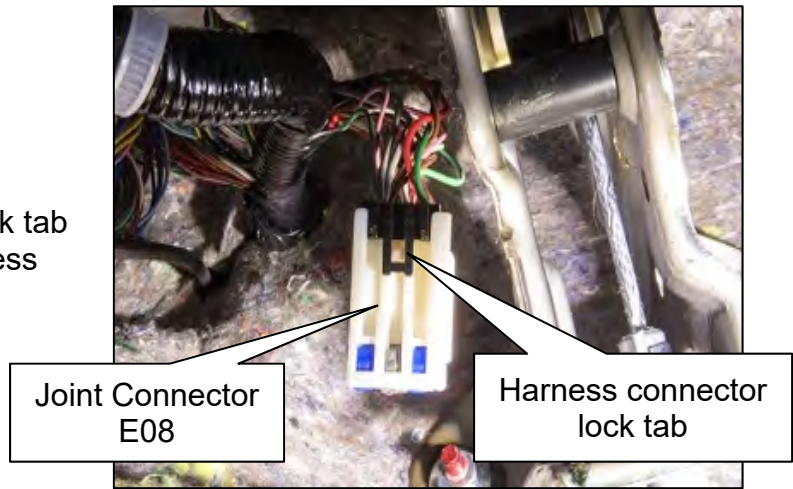
Figure 4

7. Release the harness connector lock tab (Figure 4), and then slide the harness connector lock out (Figure 5) and remove from Joint Connector-E08.

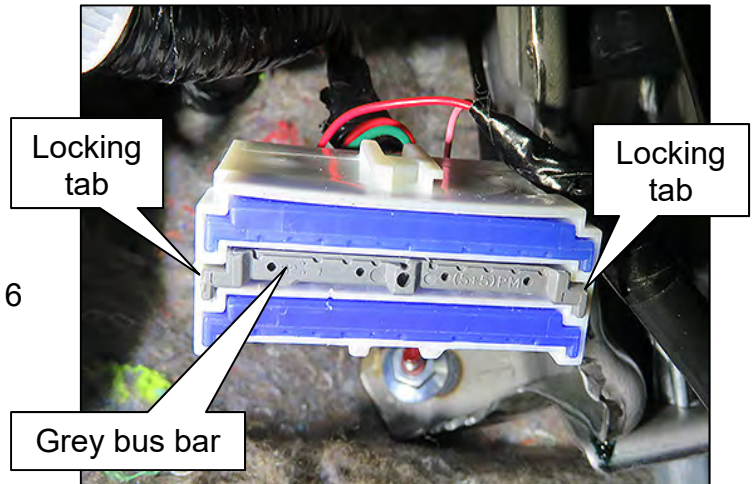
Figure 6

8. Release two (2) locking tabs, one on each side of the grey bus bar (Figure 6 and Figure 7).

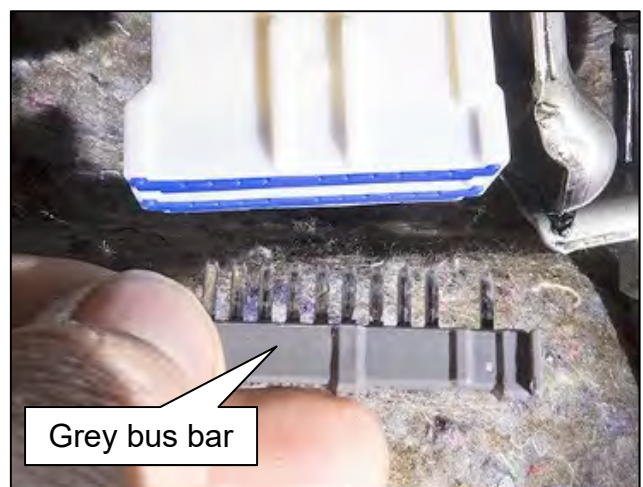
Figure 8

9. Push the bus bar out, and then remove it completely from the connector.

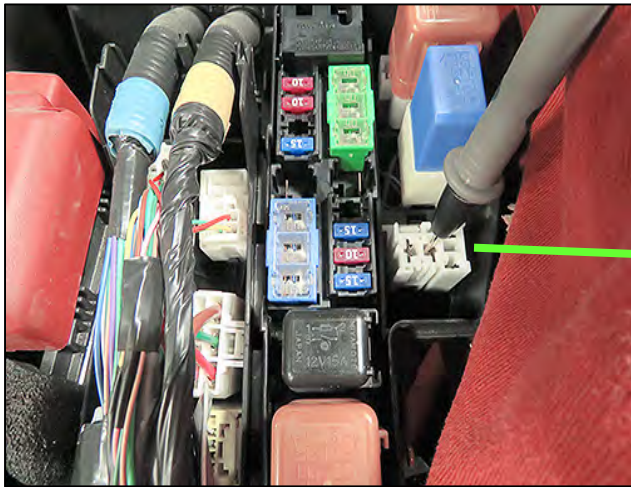
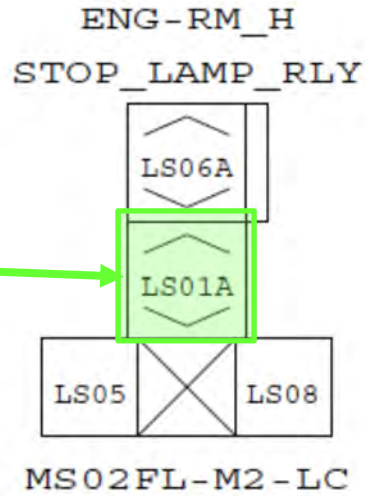
Figure 9

10. Connect a continuity tester to circuit LS01A to the relay circuit where shown in Figure 9.

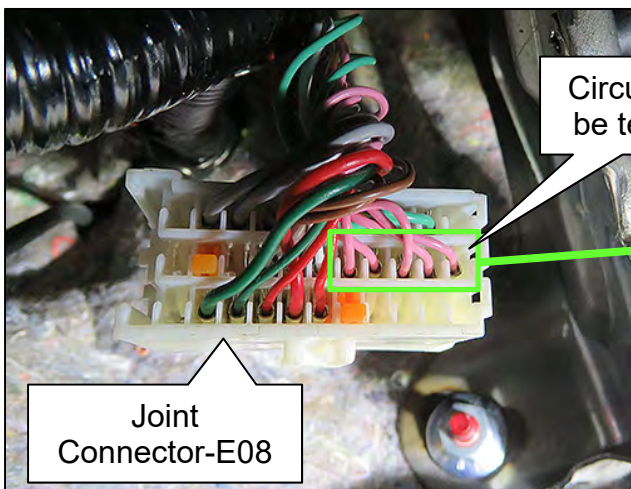
Figure 10

11. Test each of the five (5) Joint Connector-E08 circuits highlighted in Figure 10, as shown in Figure 11, until continuity with LS01A is found.

- The five (5) circuits to be tested all have pink wires.

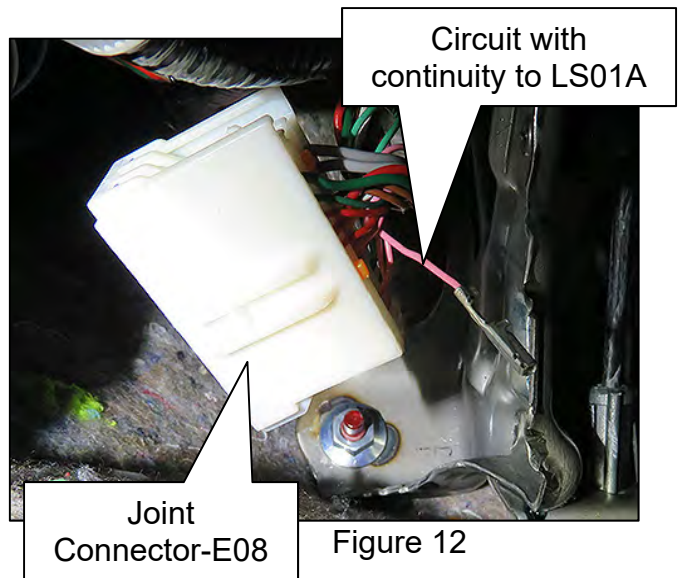
Figure 12

12. Using a terminal tool (J-48817-1, blade #01A), carefully remove the circuit with continuity to LS01A, from step 11.

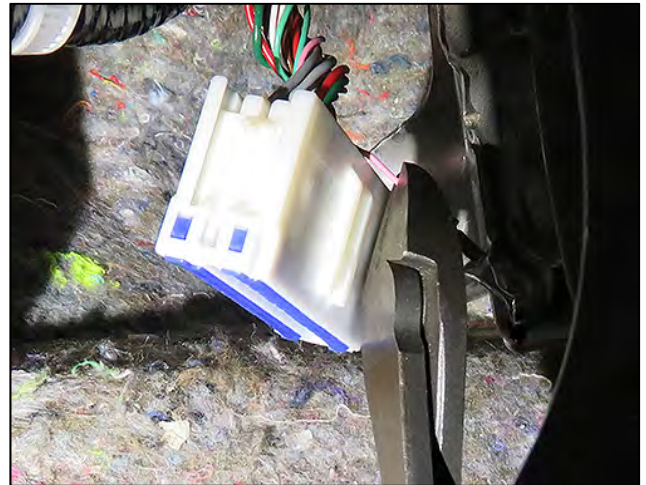
Figure 13

13. Cut the terminal off of the removed wire with an appropriate tool.

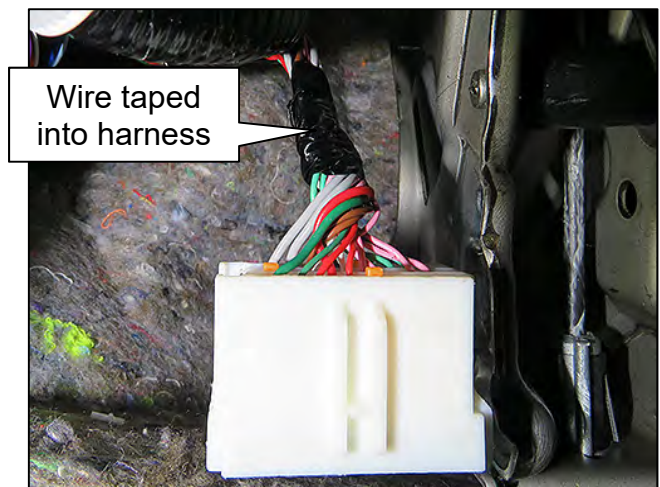
Figure 14

14. Fold the wire back onto the harness and tape it in place.

- Use 3M/Scotch Professional Grade Vinyl Super 88 Electrical Tape (3/4 inch wide) or equivalent.

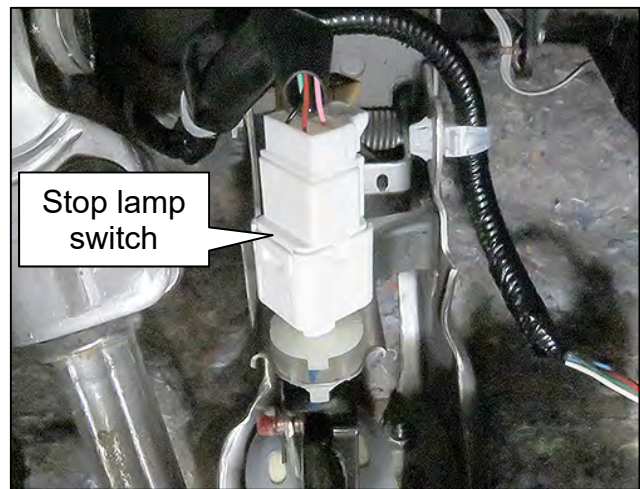
Figure 15

15. Locate the stop lamp switch.

**NOTE:** The original stop lamp switch will be white.

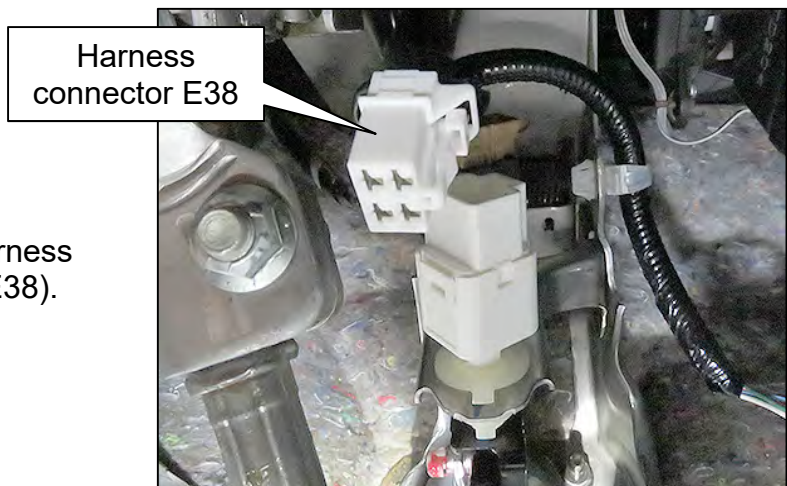
Figure 16

16. Unplug the stop lamp switch harness connector (harness connector E38).

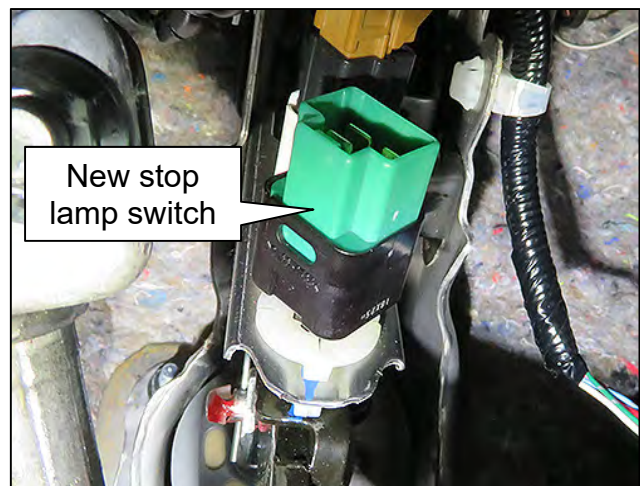
Figure 17

17. Remove the original white stop lamp switch, and then install the new one.

- The new stop lamp switch is green.
- See **PARTS INFORMATION** on page 14.
- Refer to the ESM for brake lamp adjustment: **BRAKES > BRAKE SYSTEM > SERVICE DATA AND SPECIFICATIONS (SDS) > SERVICE DATA AND SPECIFICATIONS (SDS)**.

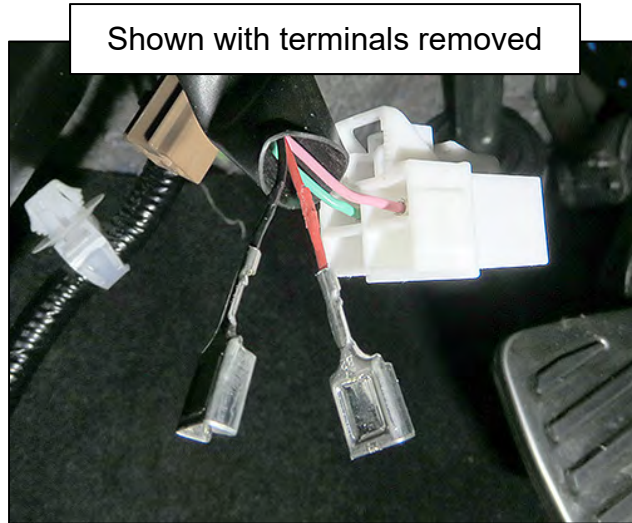
Figure 18

18. Using a terminal tool (J-48817-1, blade #09A), carefully remove the the wires from terminals 1 and 2 from the stop lamp switch connector #E38, shown in Figure 18.

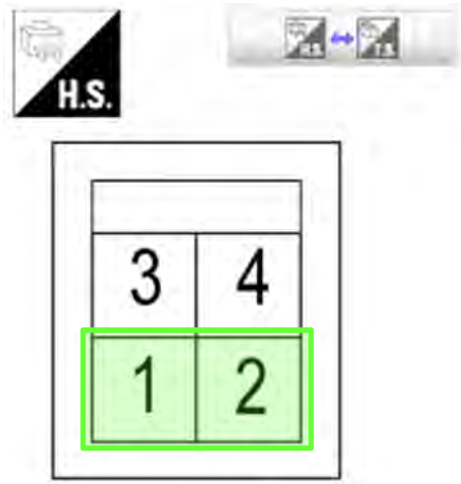
Figure 19

- Terminal No. 1 and Terminal No. 2 locations are shown in Figure 19, from harness side.

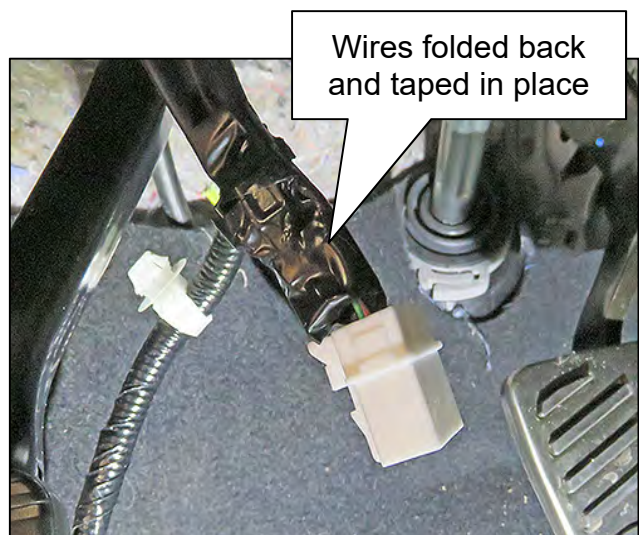
Figure 20

19. Cut the removed wire terminals off with an appropriate tool.

20. Fold the two (2) wires back onto the harness and tape them in place.

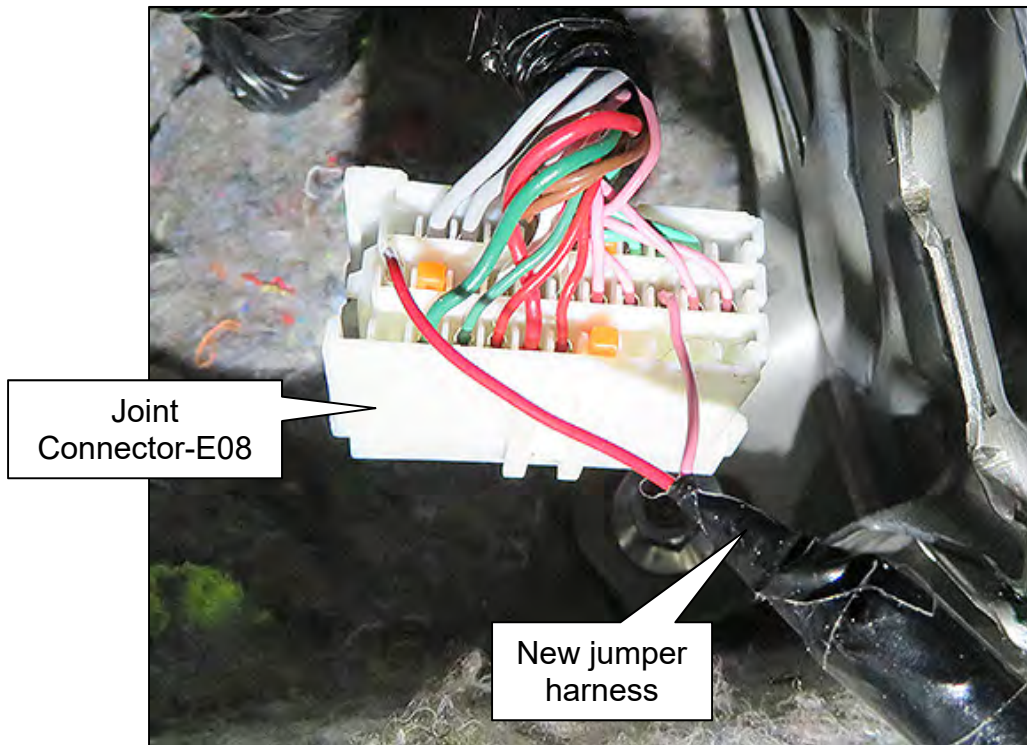
Figure 21

22. Insert the terminal of the red wire (of the new jumper harness) into the cavity of Joint Connector-E08 indicated in Figure 21.

**NOTE:** This location is an empty cavity.

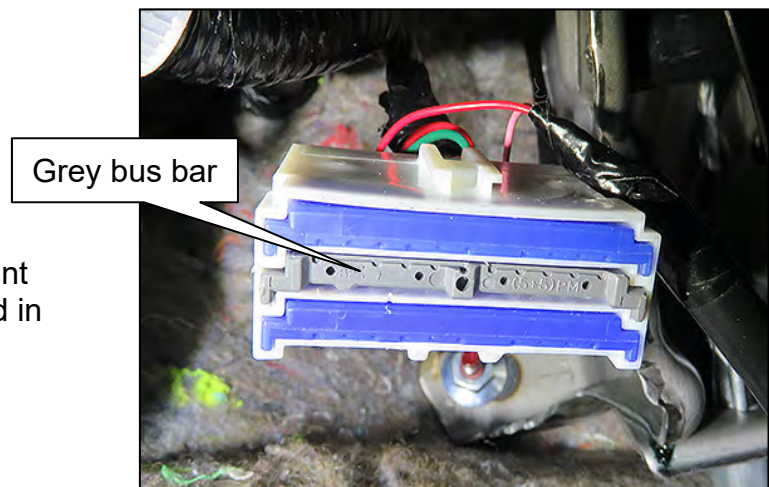
Figure 22

23. Reinsert the grey bus bar into Joint Connector-E08 that was removed in step 9.

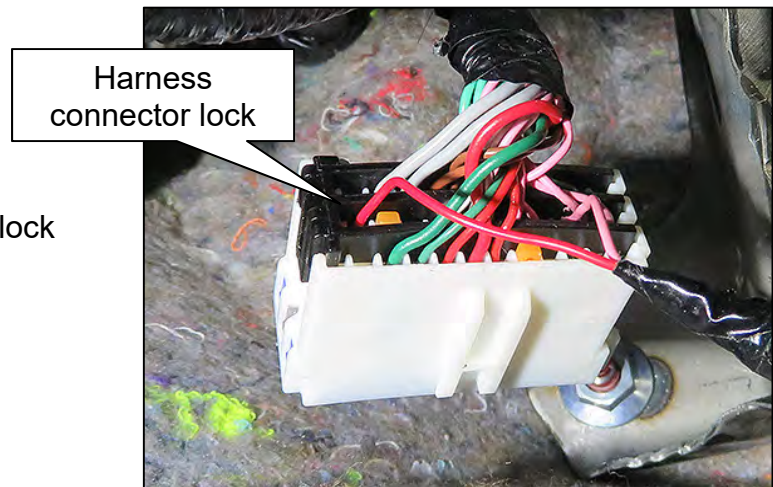
Figure 23

24. Reinstall the harness connector lock that was removed in step 7.

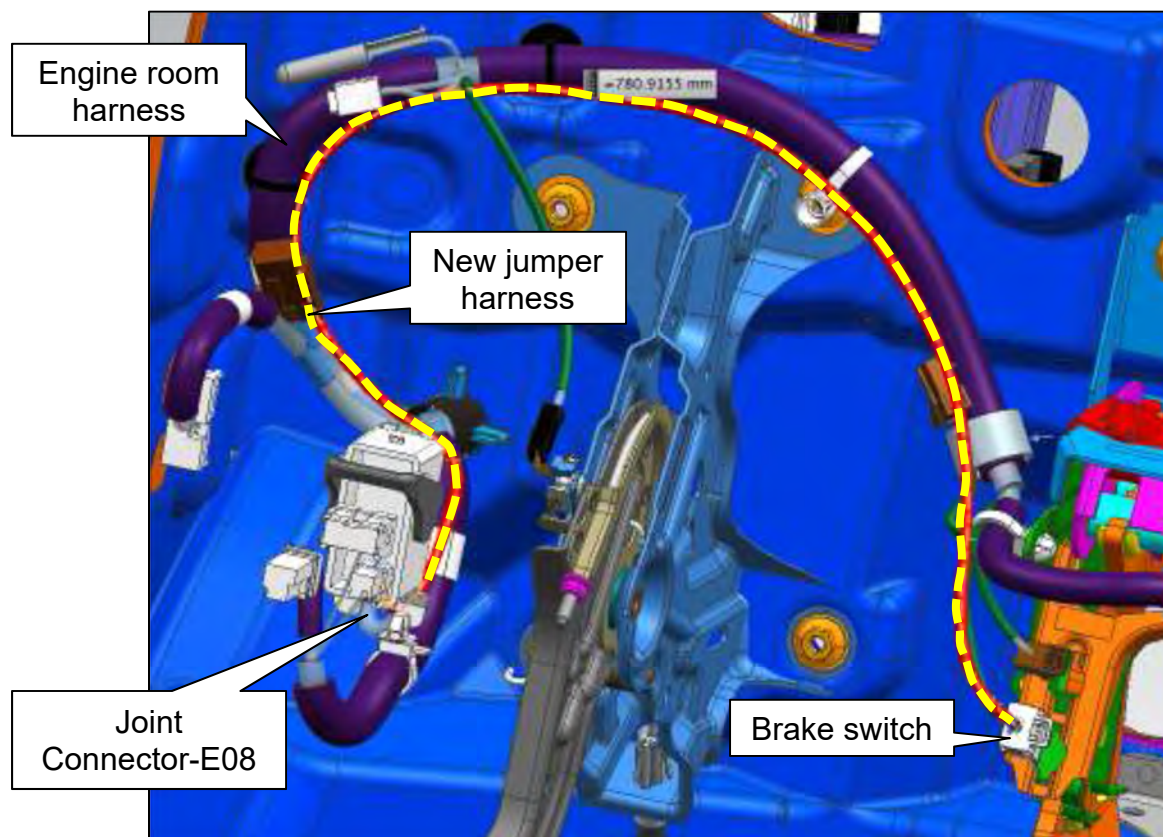
Figure 24

26. Route the new jumper harness along the engine room harness as shown in Figure 24.

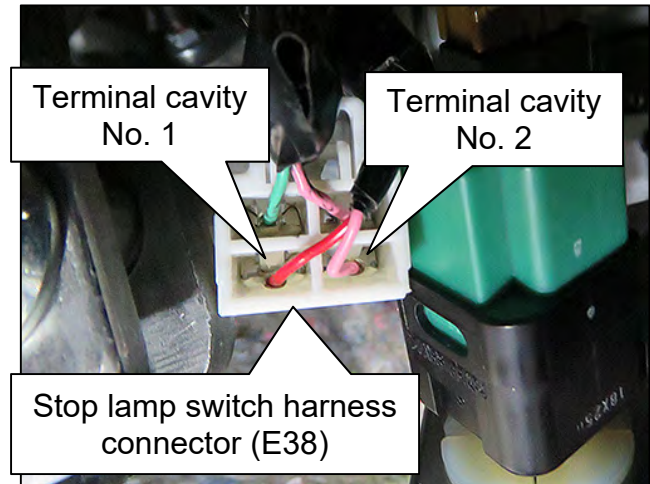
Figure 25

27. Insert the wire terminals of the new jumper harness into the stop lamp switch harness connector (E38).

- Red wire into terminal cavity No. 1.
- Pink wire into terminal cavity No. 2.

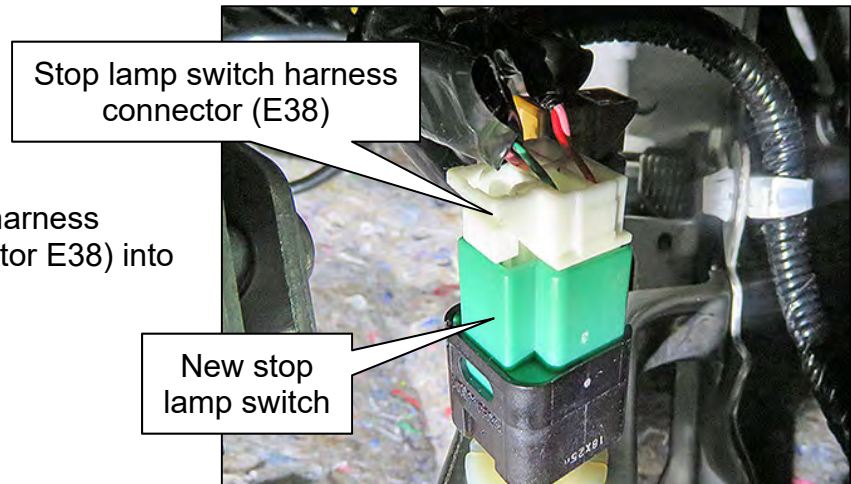
Figure 26

28. Plug the stop lamp switch harness connector (harness connector E38) into the new stop lamp switch.

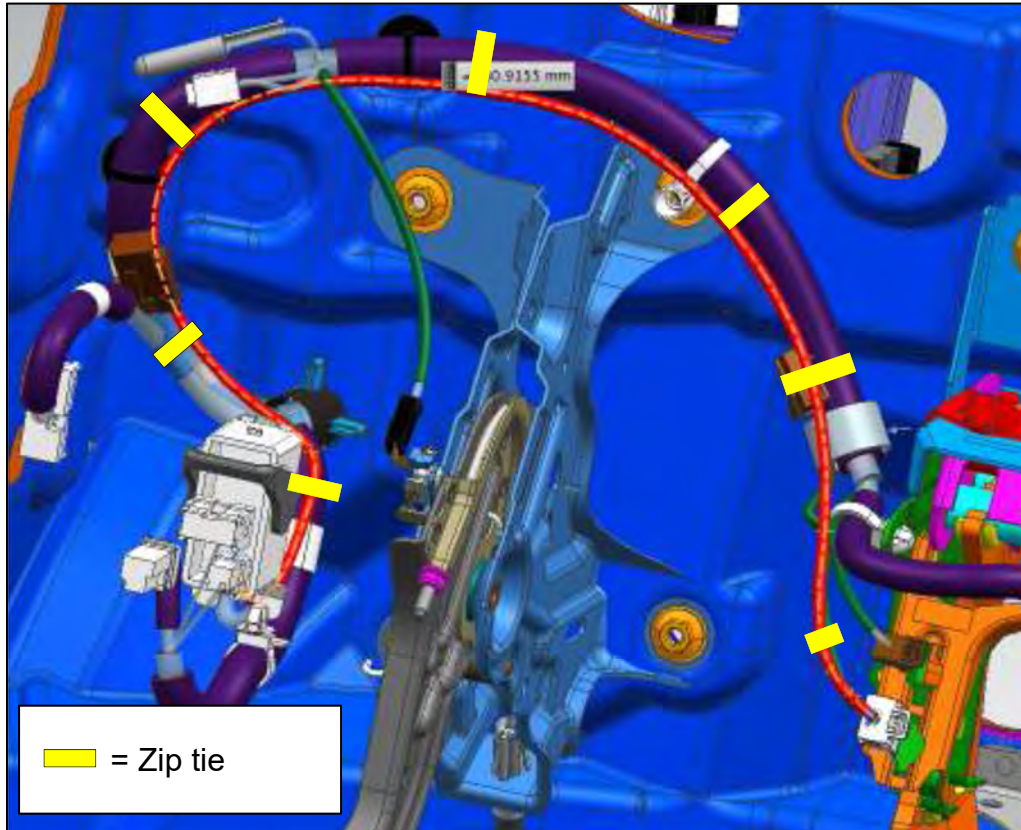
Figure 27

29. Attach the jumper harness with zip ties to the engine room harness as shown in Figure 27.

- Use as many zip ties as needed, to ensure that there is no interference with the surrounding components.

**NOTE:** Extra harness length can be coiled and zip tied to the engine room harness.
