SERVICE CAMPAIGN BULLETIN

VOLUNTARY SERVICE CAMPAIGN 2013 ALTIMA SEDAN; REAR LOWER LINK FOR OHIO, VERMONT AND WISCONSIN ONLY

CAMPAIGN ID #: P9324
APPLIED VEHICLE: 2013 Altima Sedan (L33)

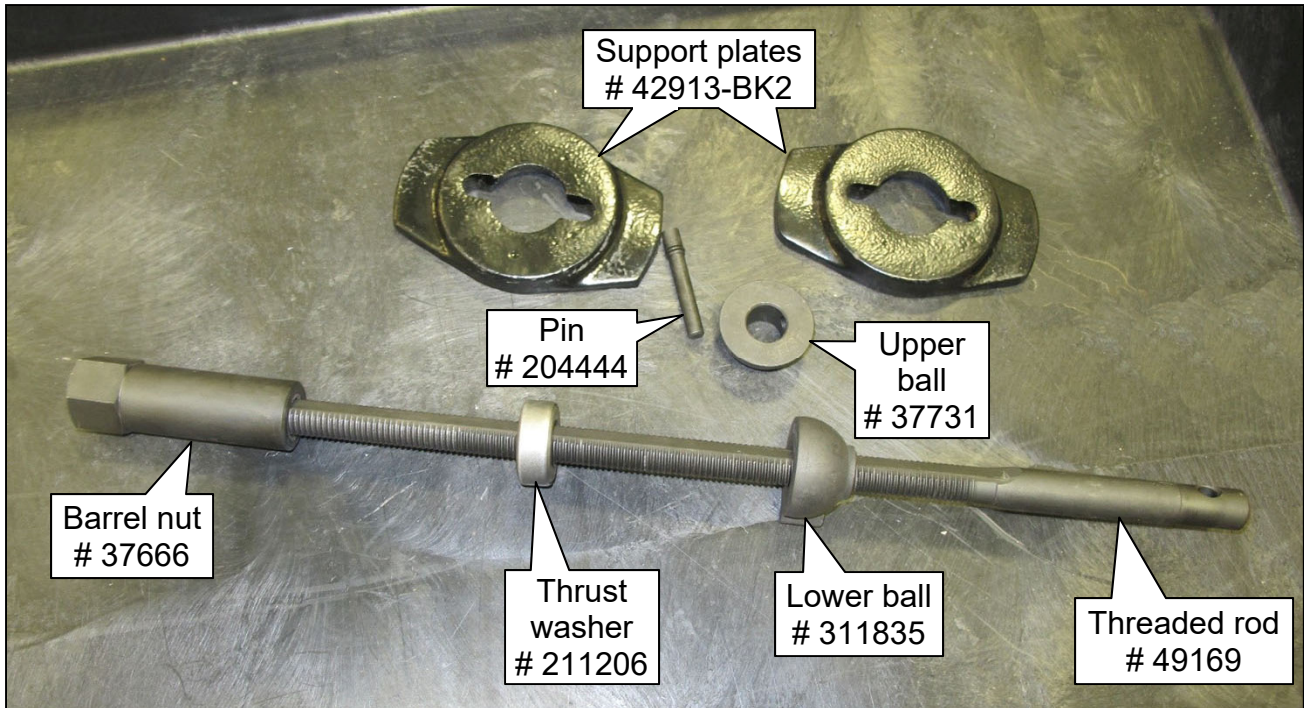
Figure 1

Coil Spring Compressor J-52929

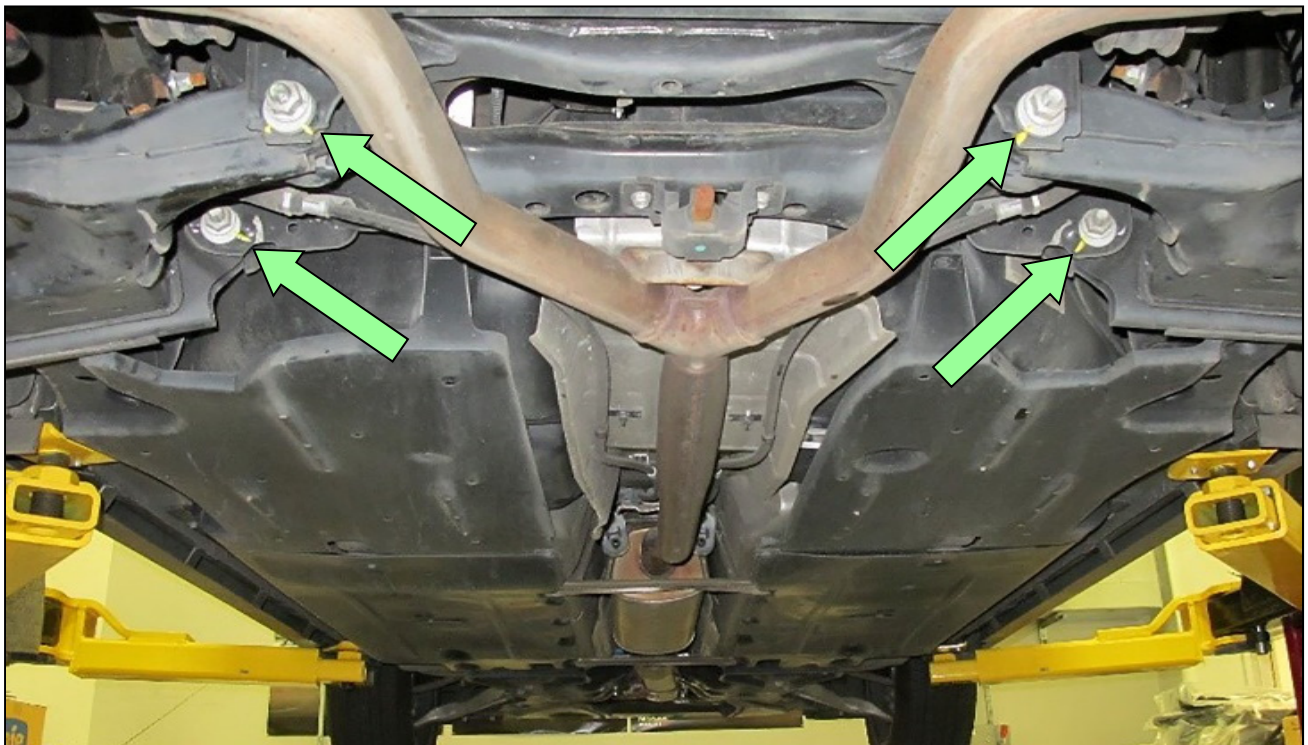
Figure 2

1. Set and raise the vehicle on a lift.
2. Remove both rear tire and wheel assemblies.
3. Mark the suspension alignment washer to the frame on all four (4) rear lower link alignment bolts (see Figure 2).

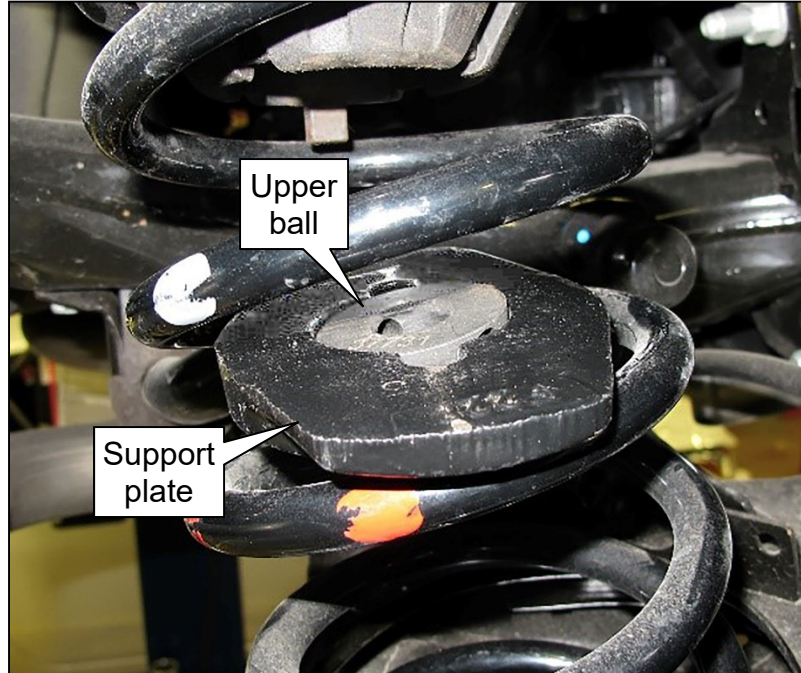
Figure 3

4. Install the upper ball in the cavity of one of the support plates of tool J-52929, upper ball facing upward, and then place the support plate midway inside the coil spring.

HINT: The upper ball can be identified by its cross drilled pin hole.

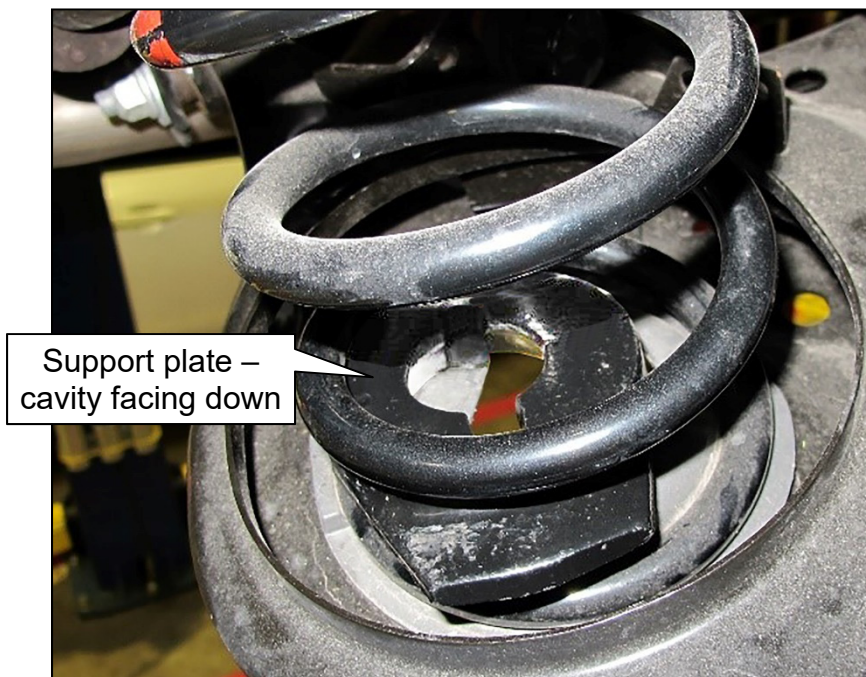
Figure 4

5. Install the other small support plate, with the ball cavity facing down, as low as possible inside the coil spring.

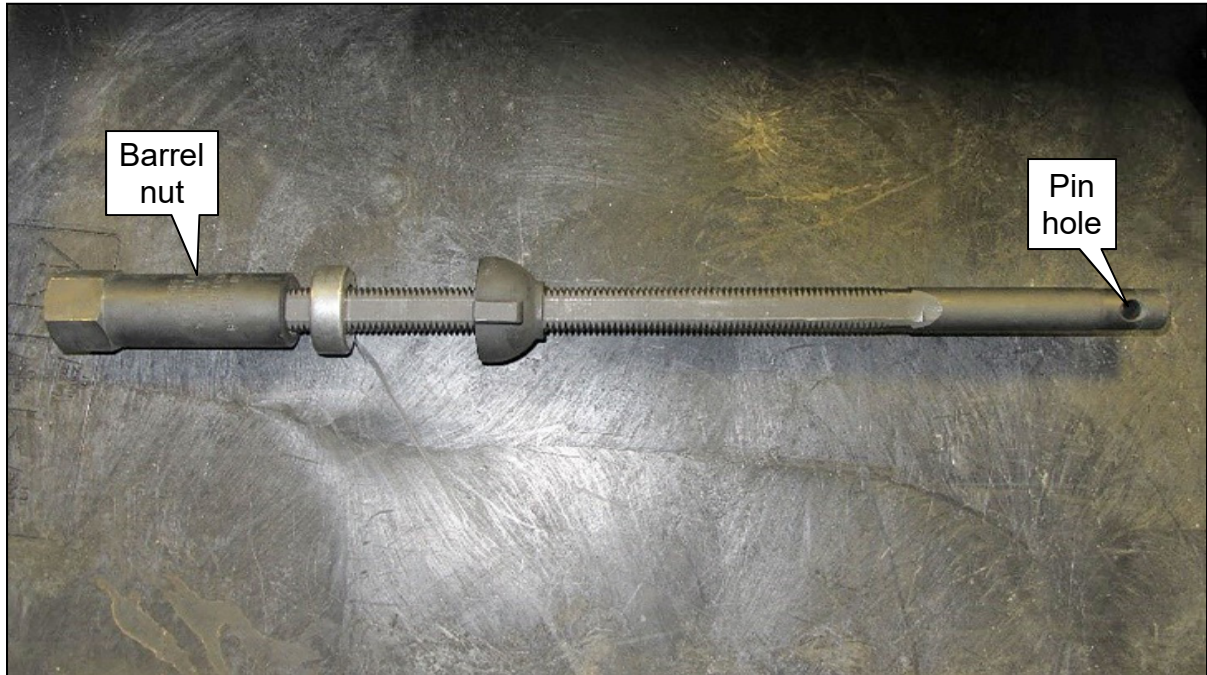
Figure 5

6. Assemble the following pieces of tool J-52929 as shown in Figure 5: The threaded rod, lower ball, thrust bearing, and barrel nut.
 - To keep the pieces together, thread the barrel nut onto the threaded rod.

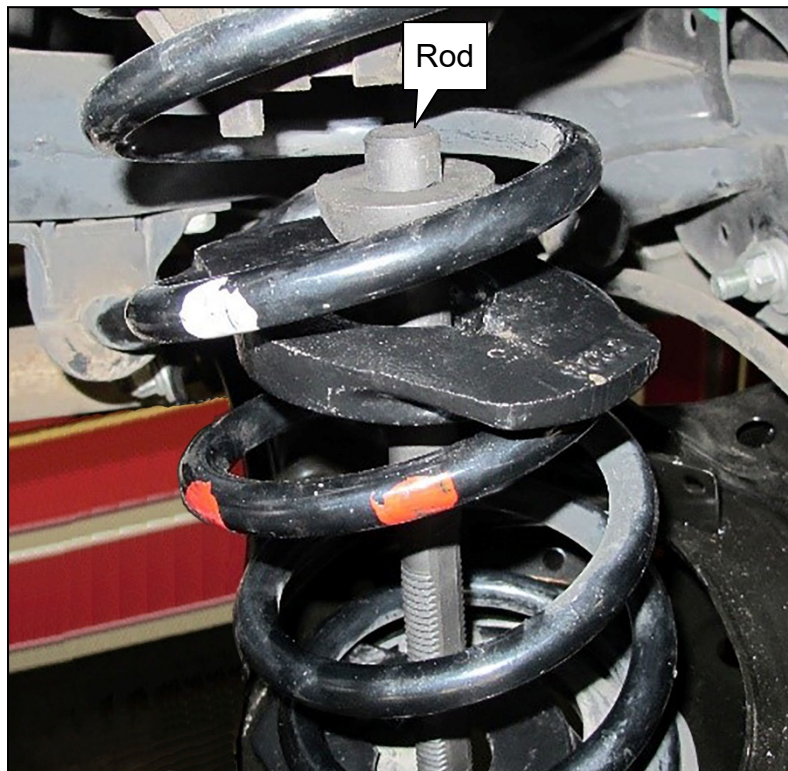
Figure 6

7. Install the assembled pieces, pin hole end first, from the bottom of the coil spring through both support plates and the upper ball.

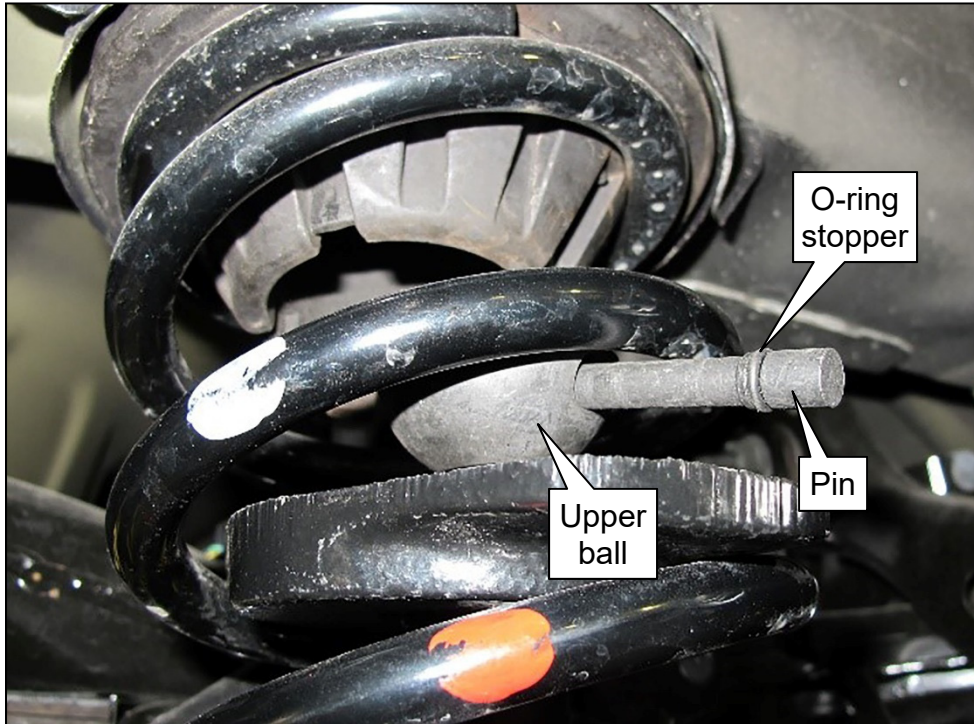
Figure 7

8. Install the pin of tool J-52929 through the upper ball and threaded rod up to its O-ring stopper.

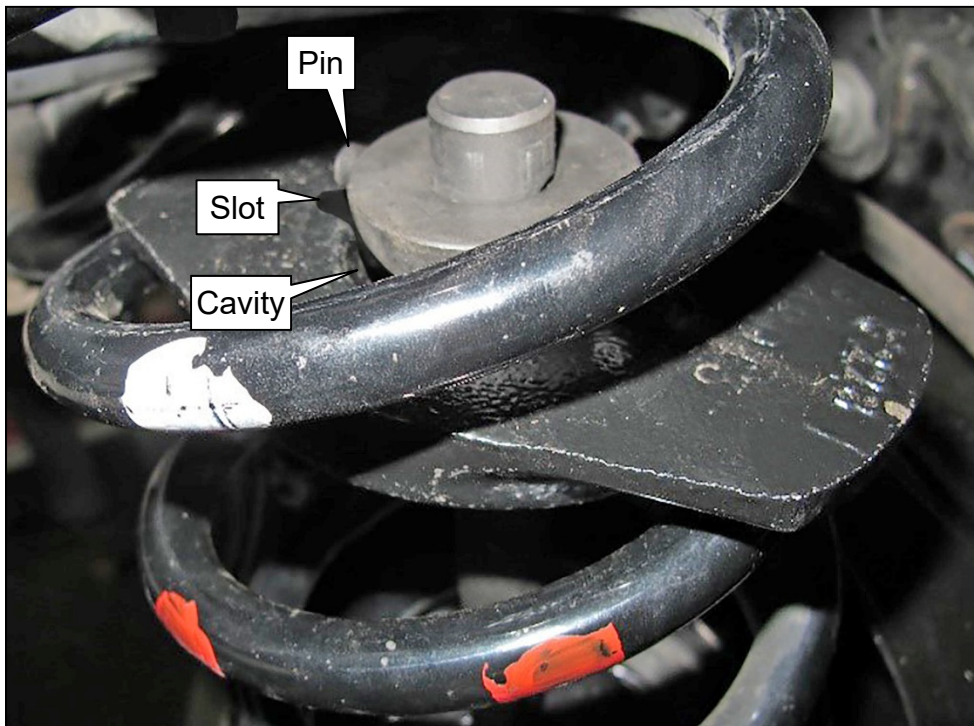
Figure 8

9. Align the upper ball into the upper support plate cavity so that the pin rests in the slots.

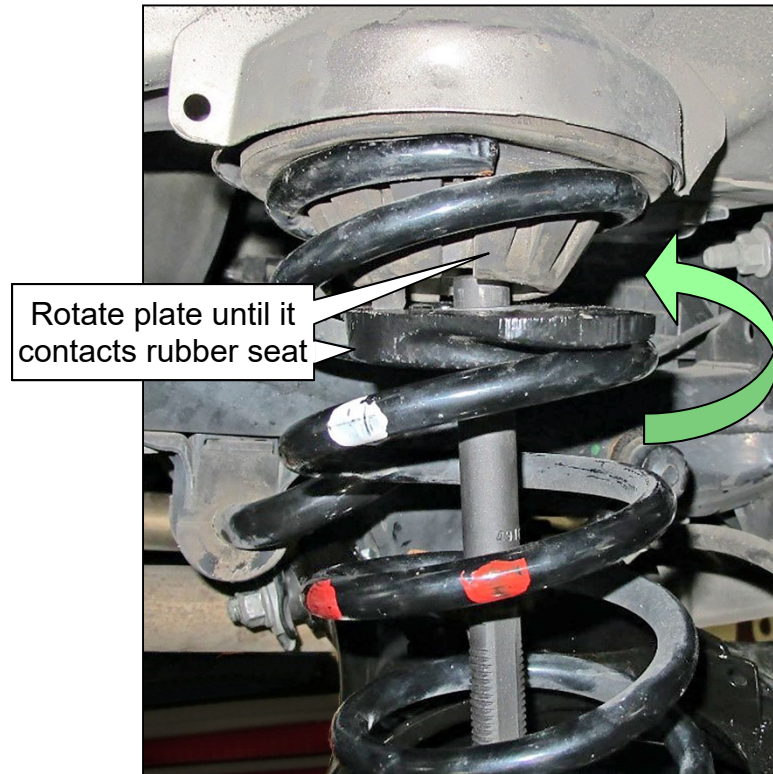
Figure 9

10. Rotate the threaded rod and upper support plate together as an assembly counterclockwise until the upper support plate contacts the upper rubber seat.

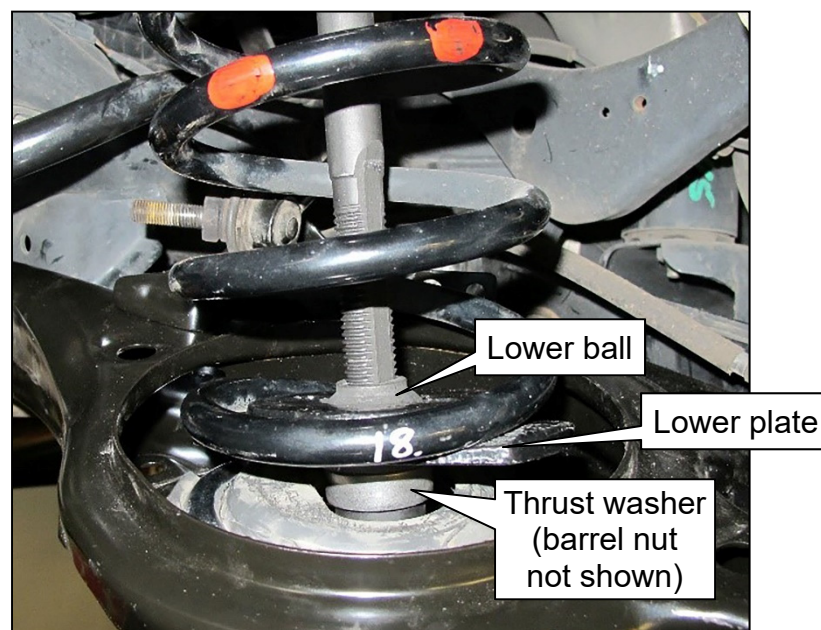
Figure 10

11. Slide the lower ball up the rod and into the lower support plate cavity while aligning the lower ball's notch into one of the lower support plate's slots.
 - Make sure the lower plate stays as low on the coil spring as possible.
12. Thread the barrel nut up the threaded rod until the thrust washer makes contact with the lower ball (see Figure 10).

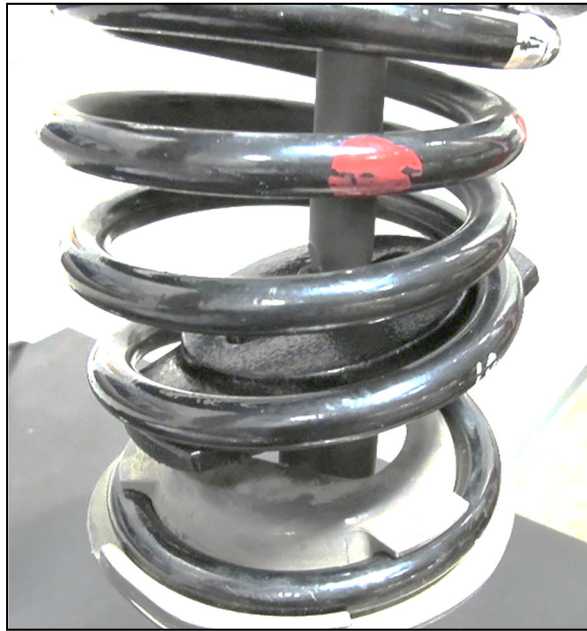
Figure 11

13. Compress the coil spring until the lower ball bottoms out on the threaded rod.
 - To compress the coil spring, use a wrench, deep socket, or other suitable tool to turn the barrel nut clockwise.

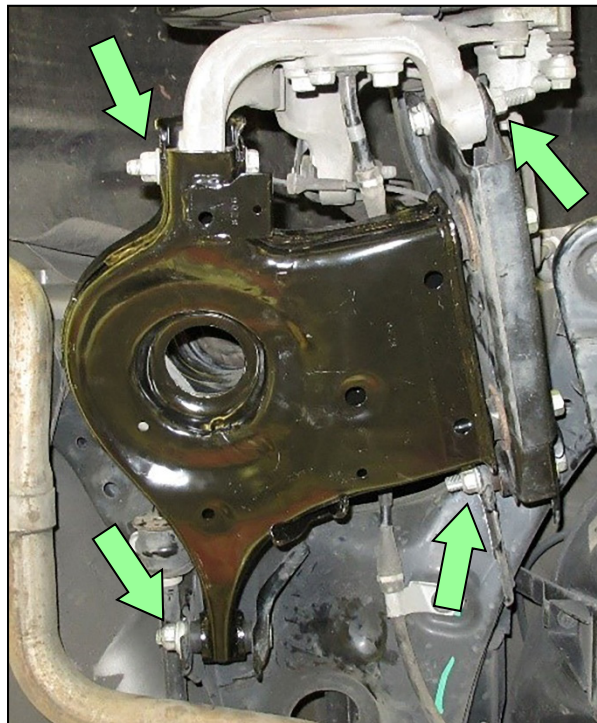
Figure 12

14. Remove the two (2) knuckle bolt nuts and two (2) alignment bolt nuts but do NOT remove the related bolts at this time.

HINT: These nuts will not be reused and will be replaced with new ones (see **PARTS INFORMATION** on the last page of this bulletin).

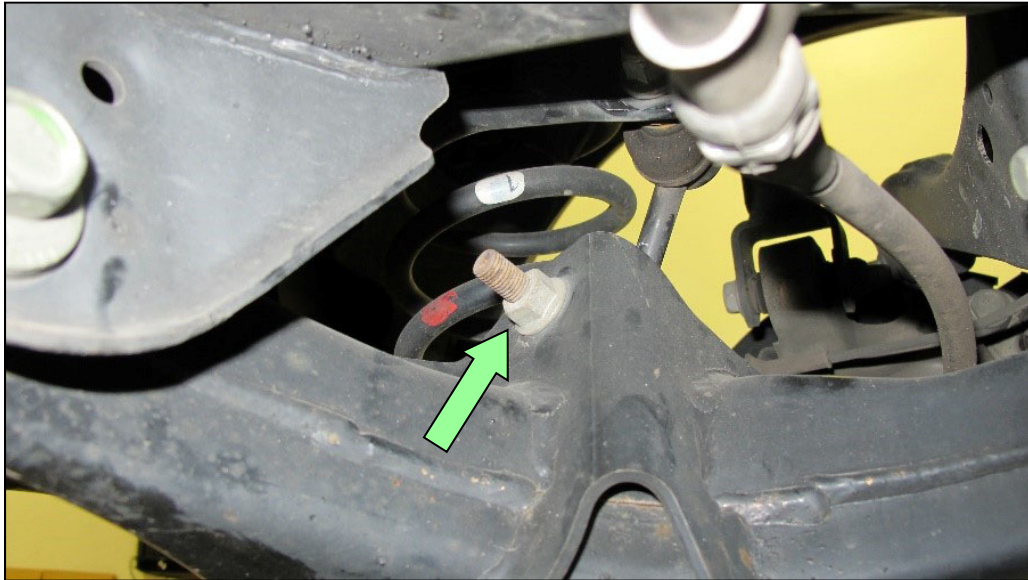
Figure 13

15. Remove the nut holding the rear stabilizer connecting rod to the rear lower link.

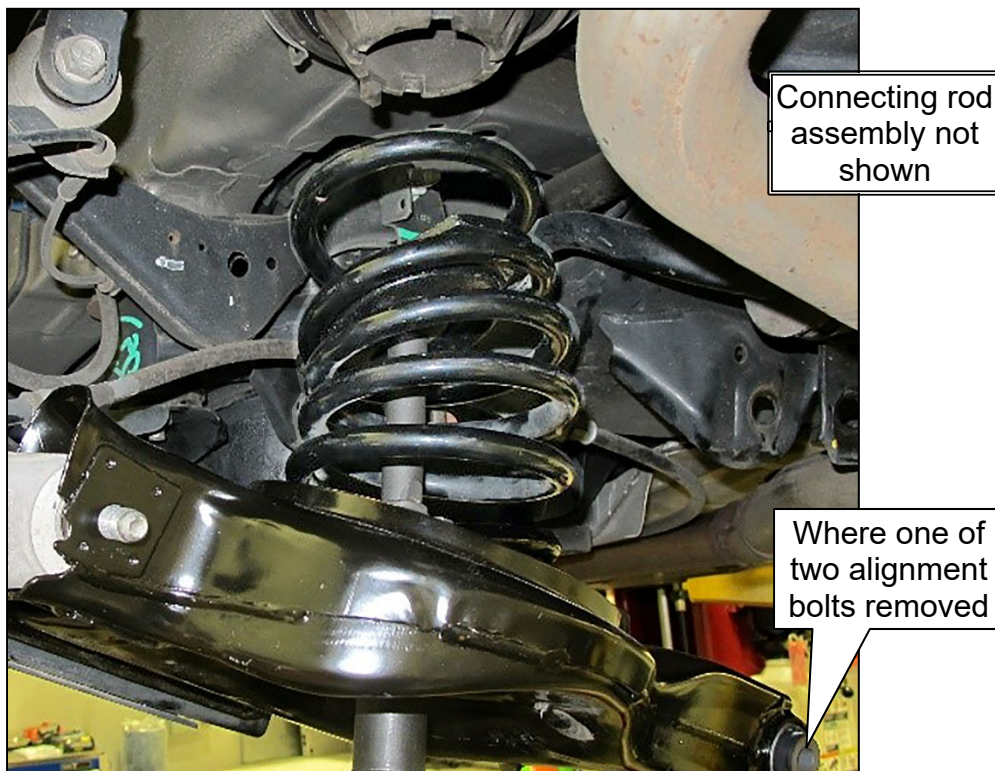
Figure 14

16. Remove the coil spring and tool J-52929 as an assembly:
 - a. Remove both inside rear lower link (alignment) bolts.
HINT: Due to being marked earlier, these bolts need to go back to their original locations during reassembly.
 - b. Swing the rear lower link downward.
 - c. Remove the connecting rod assembly from the rear lower link.
 - d. Remove the coil spring and tool J-52929 as an assembly.

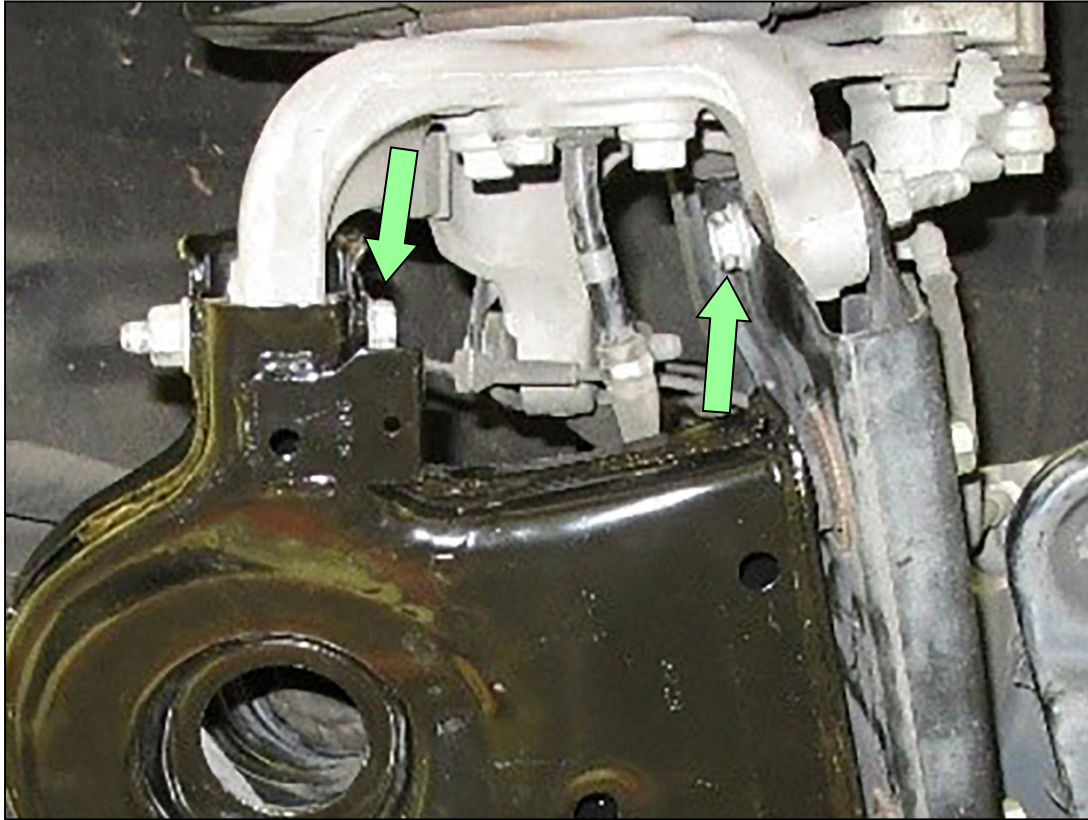
Figure 15

17. Remove the two (2) remaining (knuckle) bolts, and then remove the rear lower link from the vehicle.

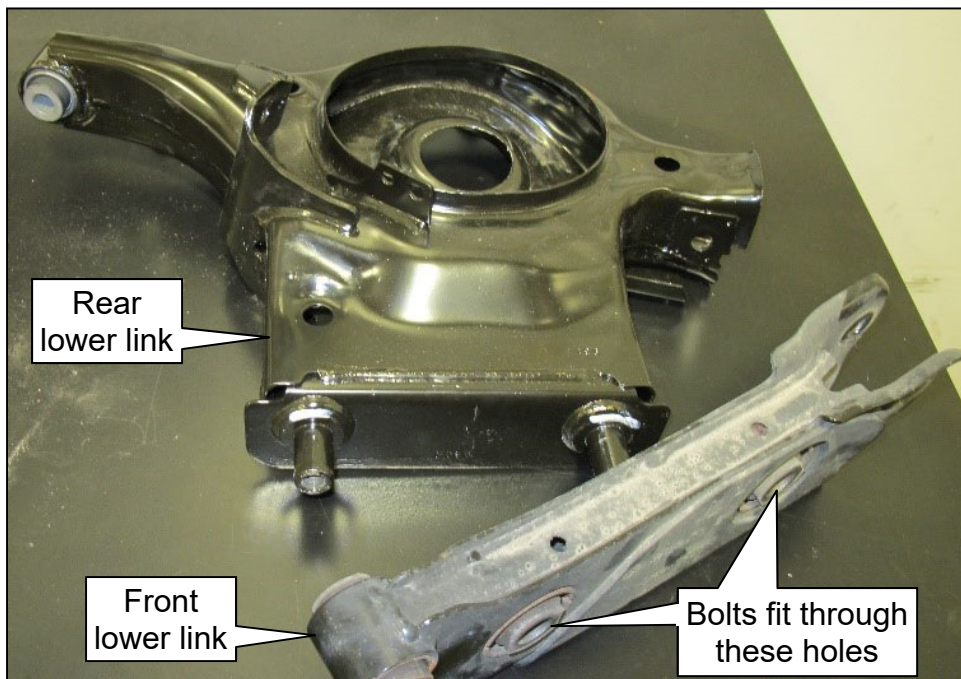
Figure 16

18. Remove the two (2) bolts, and then remove the front lower link from the rear lower link.

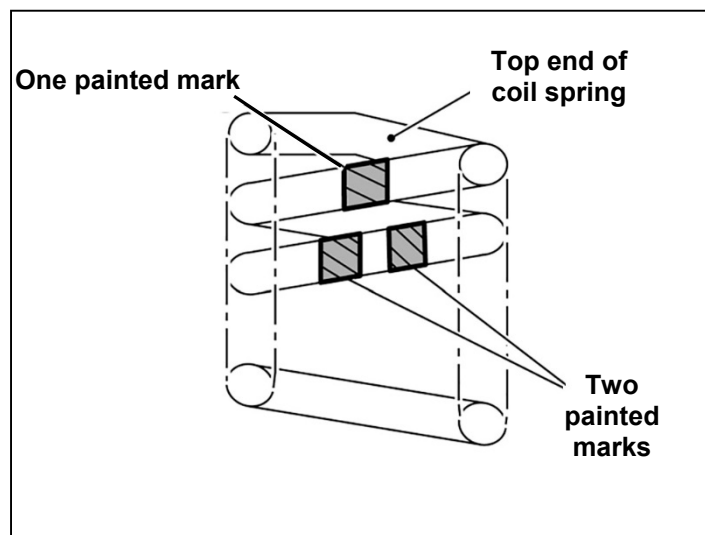
Figure 17

- Front lower link-to-rear lower link bolts torque: 111 N•m (11 kg-m, **82 ft-lbs**)
- When installing the coil spring (still compressed):
 - a. Make sure the orientation of the coil spring is as shown in Figure 17: A single painted mark is above the two painted marks.

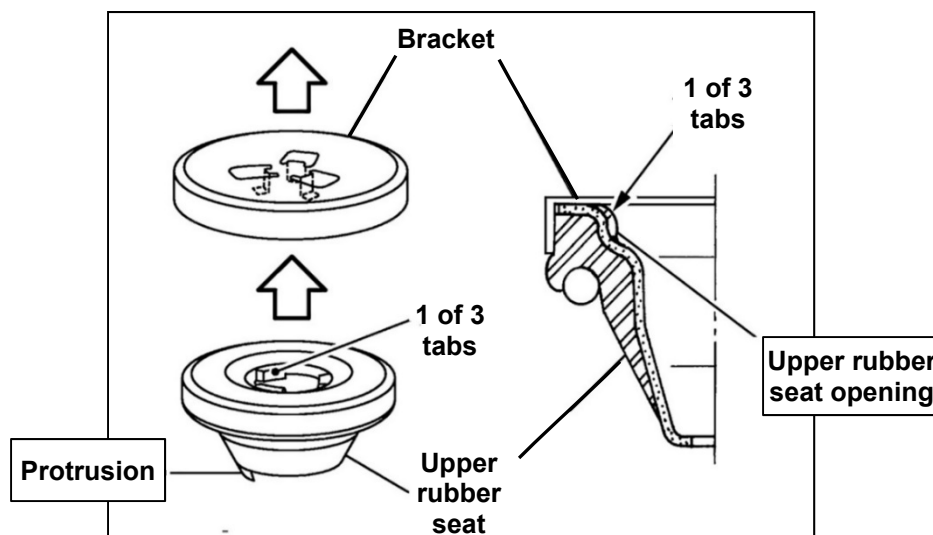
Figure 18

- b. Make sure the upper rubber seat is secured to the bracket, which is secured to the vehicle.
 - Make sure the protrusion is aligned, facing into the vehicle.

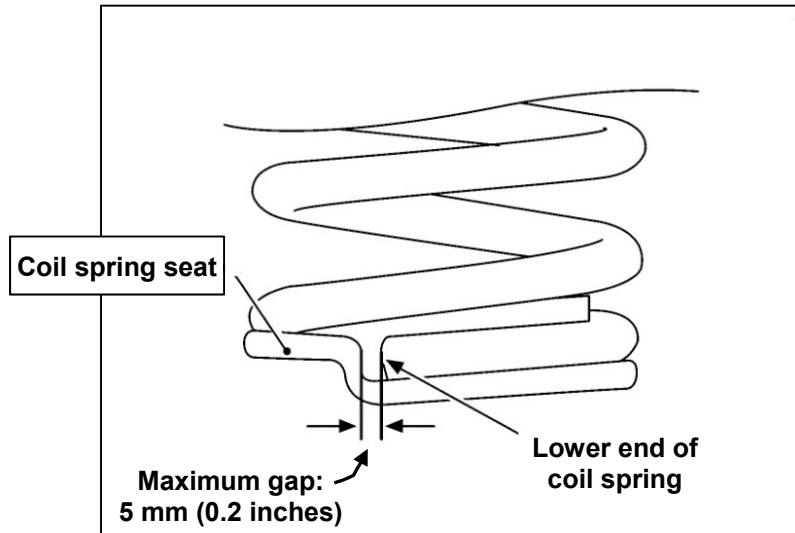
Figure 19

c. Align the coil spring by placing its lower end as shown in Figure 19.
