Seat belt wet, SRS light on

Topic number	LI91.40-N-056663
Version	1
Design group	91.40 Seat belts, emergency tensioning retractors
Date	07-23-2013
Validity	Model 906 with CODE (T16) Right load compartment sliding door and/or with CODE (T19) Left load compartment sliding door
Reason for change	
Reason for block

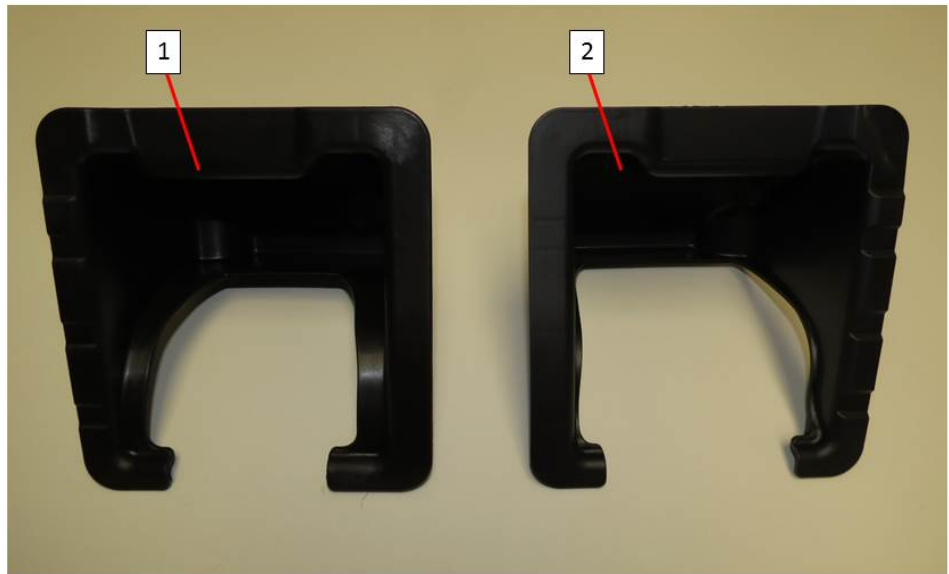
1.jpg:

Attachments	
File	Designation
1.jpg	New parts
2.jpg	Electrical connection of emergency tensioning retractor
3.jpg	Installation of covers

Parts							
Part number	ES1	ES2	Designation	Quantity	Note	EPC	Other make part
A 906 691 00 00			Cover	1	Cover (1) for left B-pillar. For vehicles with code (T19) Left load compartment sliding door.	X	
A 906 691 01 00			Cover	1	Cover (2) for right B-pillar. For vehicles with code (T16) Right load compartment sliding door.	X

3. Install cover (File 1, item 1 or 2) for emergency tensioning retractor (File 2, item 4).

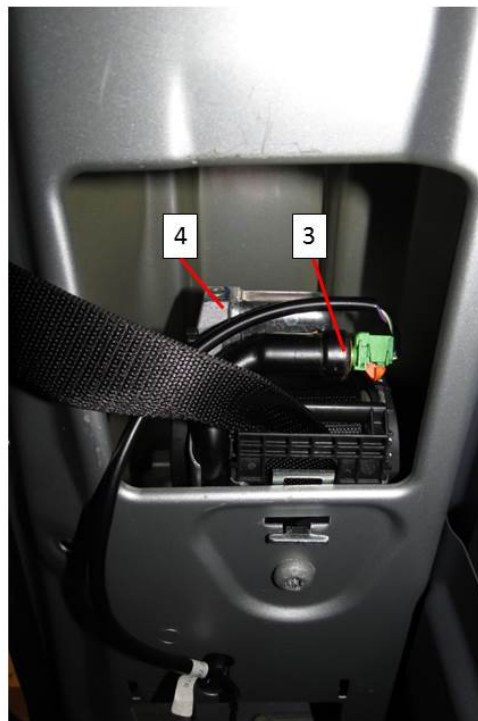
2.jpg:

Water ingress at the B-pillar (sliding door side), which can cause contact problems in the connector of the emergency tensioning retractor.

1. Unclip B-pillar trim and place to one side (see: AR68.30-D-4700A).
2. Clean and dry electrical connection of emergency tensioning retractor (File 2, item 3).

NOTE: To do this, separate the connection (File 2, item 3) and use suitable tools.

4. The emergency tensioning retractor (File 2, item 4) should only be replaced (see: AR91.40-D-0630B) if the following conditions are met:

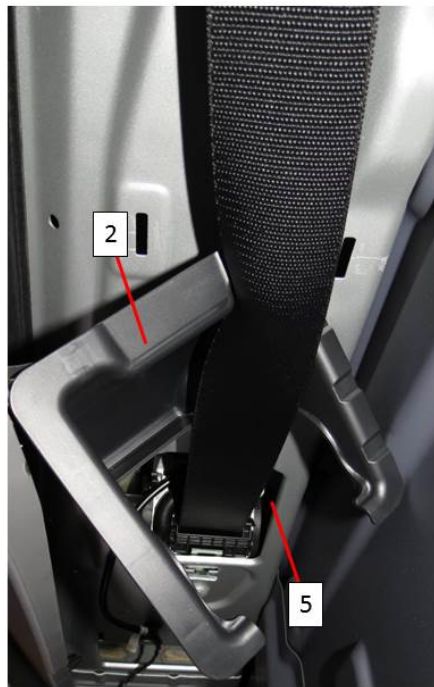
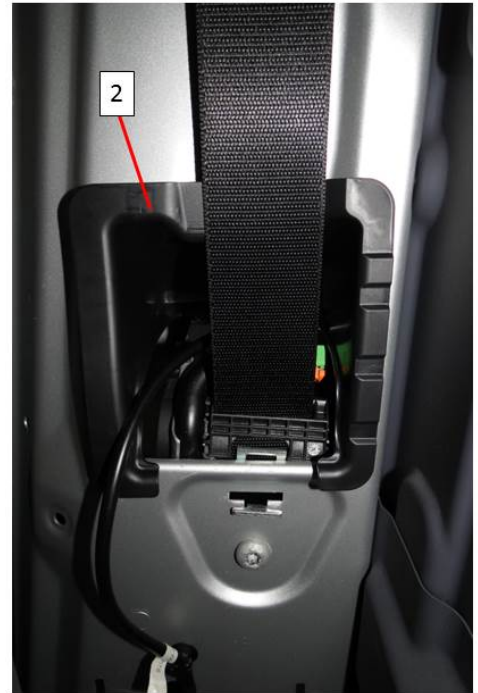
3.jpg:

Installing a cover on the opening in the B-pillar (inside) prevents water from entering the electrical connection of the emergency tensioning retractor.

The cover(s) are only to be installed on the side of the vehicle with the sliding door.

NOTE: Clip the cover (File 3, item 1 or 2) into the opening (File 3, item 5) in the B-pillar.
