Title	Vehicles With An Automated Manual Transmission (AMT) - Power Take-Off Diagnosis And Repair; PTO Air Leaks, Oil Leaks, Engagement, Noise
-------	---

Mack Model	AN - Anthem , CHU - Pinnacle, Axle back , CXU - Pinnacle, Axle front , GR - Granite , GU - Granite , PI - Pinnacle , TD - Titan
-------------------	---

Volvo Model	VN , VNL , VNM , VNR , VNX , VAH , VHD
--------------------	--

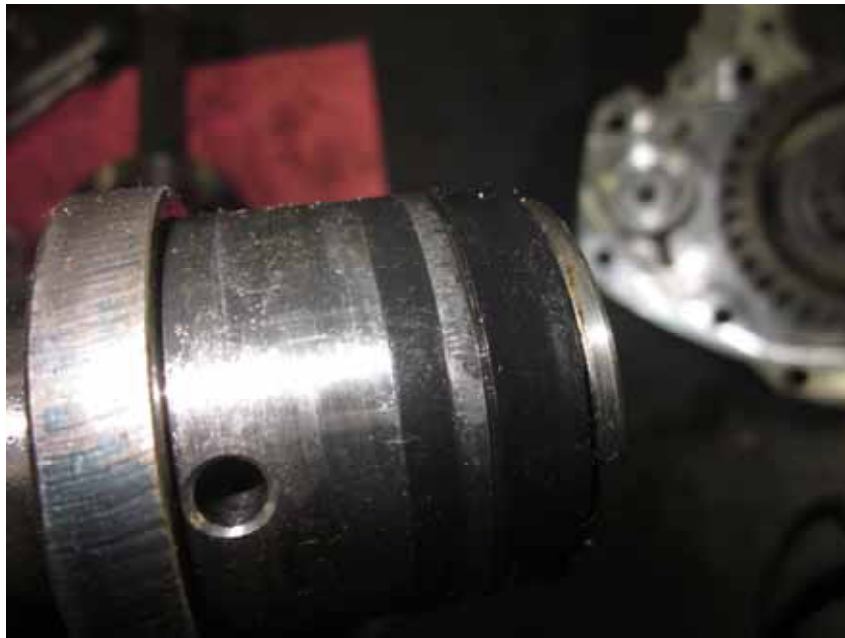
1. Inspect the air piston for wear. Look for evidence of the piston making contact with the bore as shown in the picture below.

- **If wear is found**, the bore needs to be inspected.

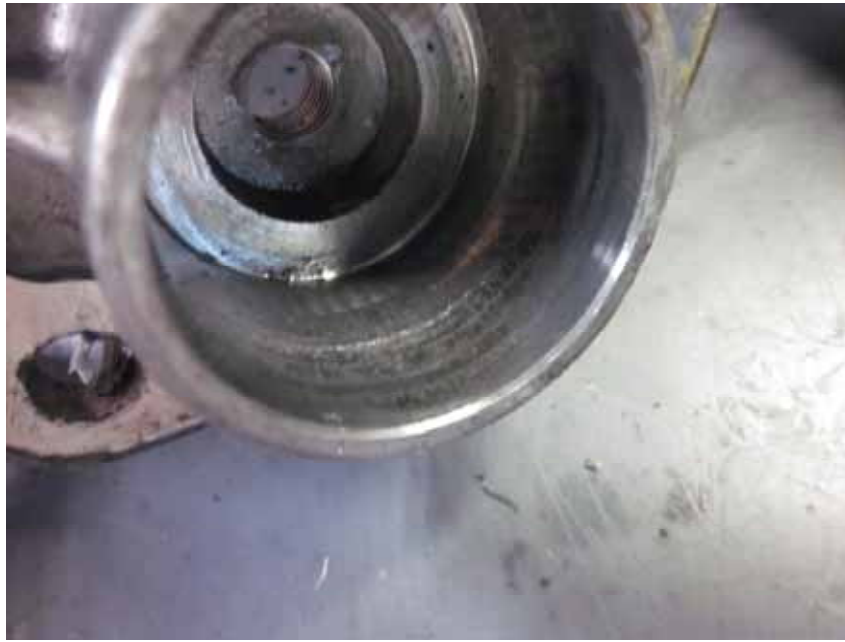
2. Inspect the piston bore. Check for any wear or damage as shown in the example below.

- **If the bore is worn**, replace the PTO. The piston bore is not repairable.

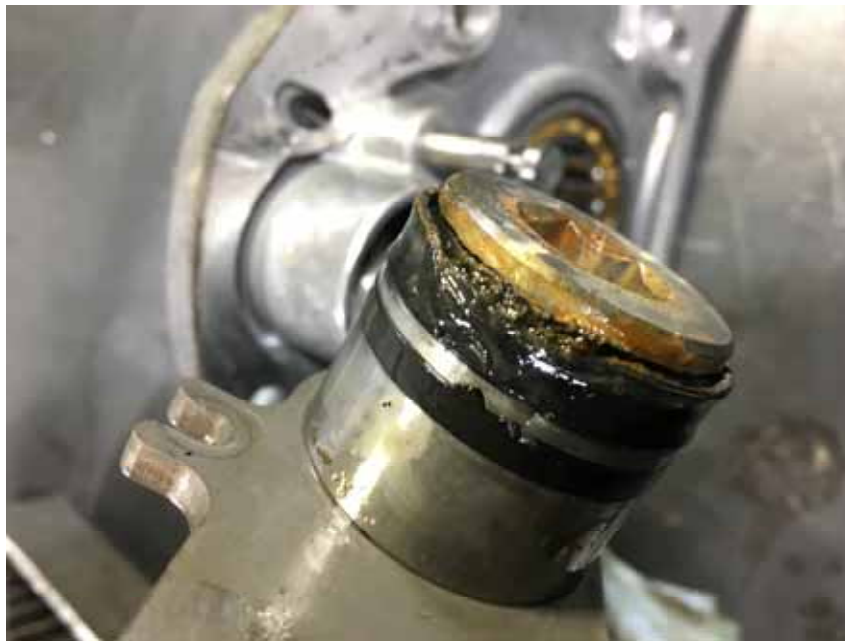
- **If the bore is serviceable**, the unit should be repaired. Replace the air piston and seals.

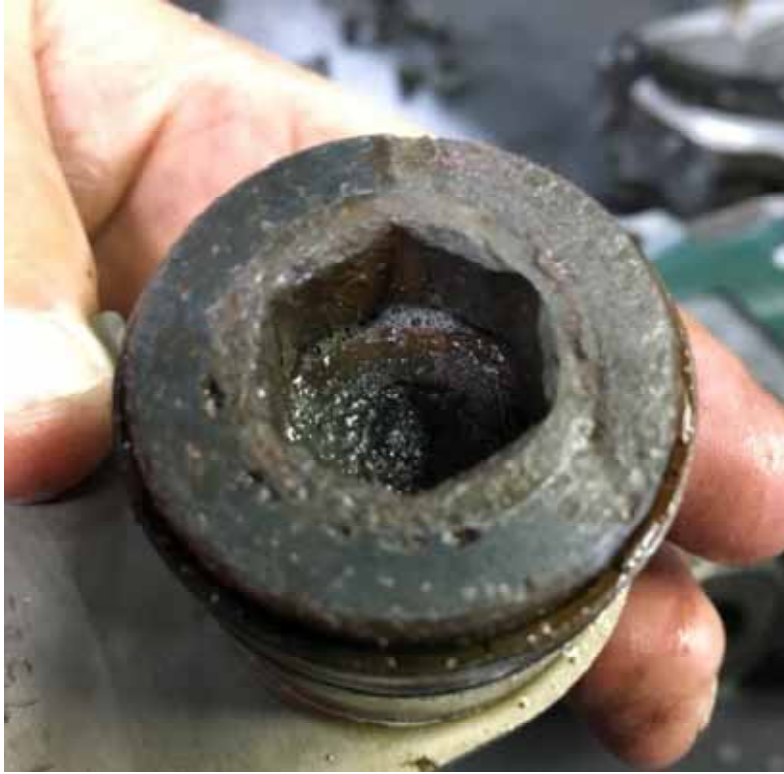
- **If Rust is found on the piston face**, then there has been water intrusion to the piston. An example is shown below.

Check the vehicle air system for moisture and correct the root cause of the water intrusion.

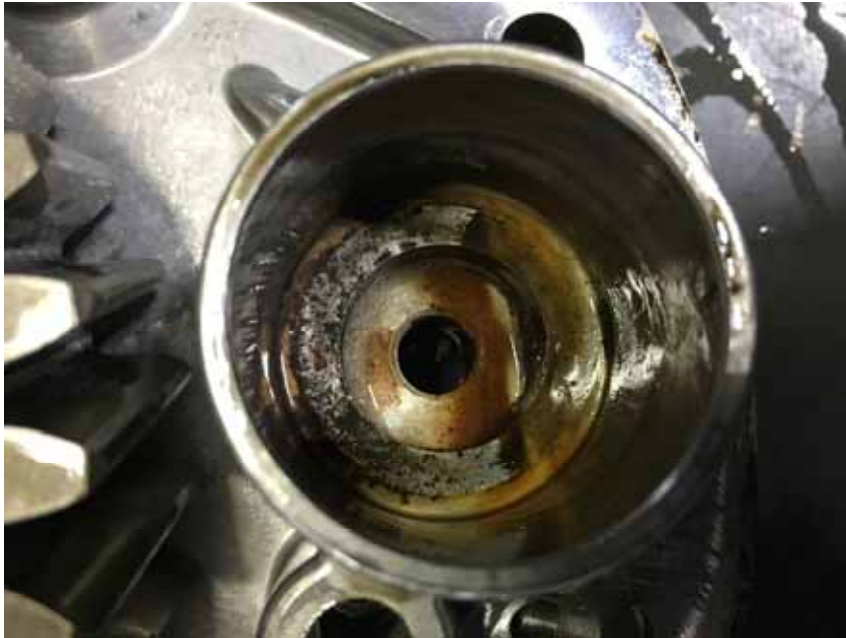
- **If rust damage is found in the bottom of the piston bore**, clean the bore and inspect the sealing surface for damage. Rust in the bottom of the bore will not affect operation.

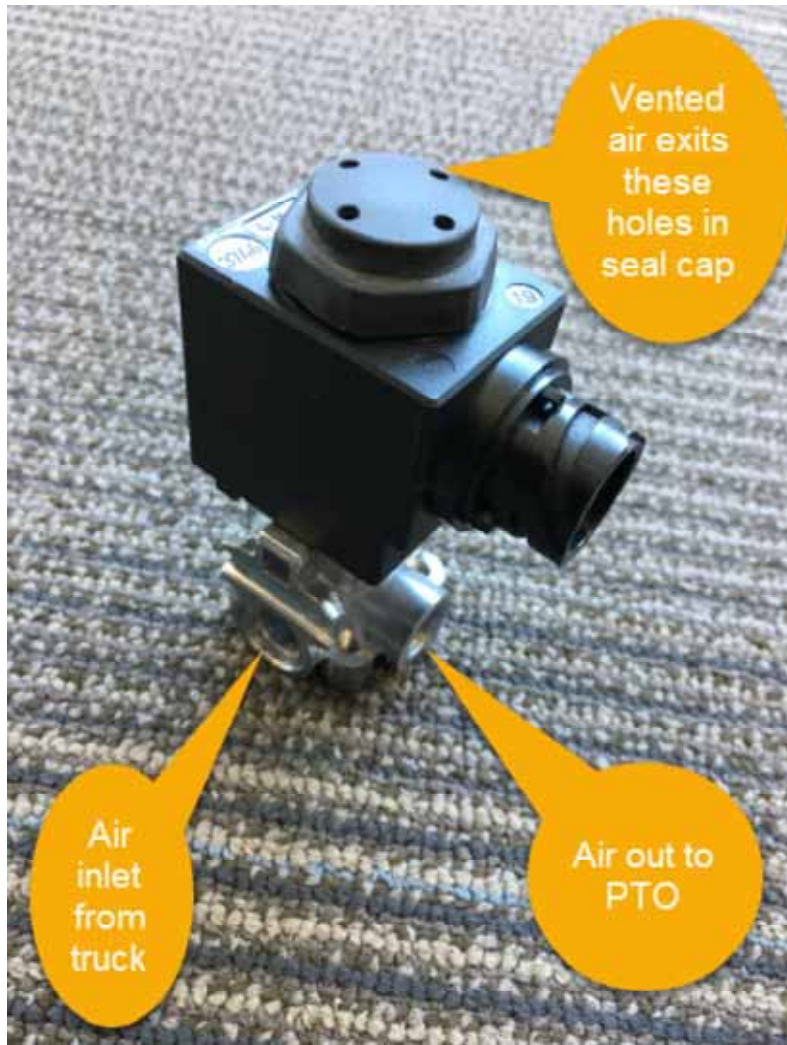
- **If the vehicle air system is dry and properly serviced**, the solenoid should be checked for a good rubber cap on the top.

If the cap seal is damaged then replace the solenoid.

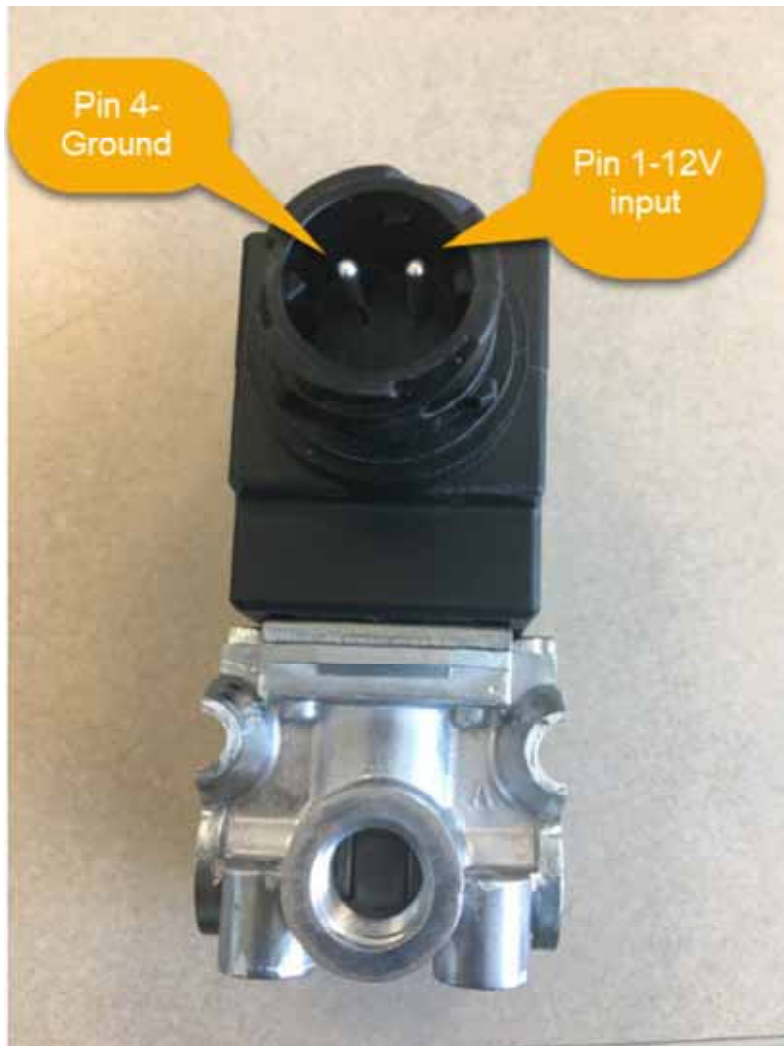
The PTO solenoid contains two fly-back/clamping diodes to prevent high voltage reverse voltage spikes from damaging the controlling ECU. Because of the orientation of these diodes, the unit will give unexpected readings for resistance with a multi-meter.

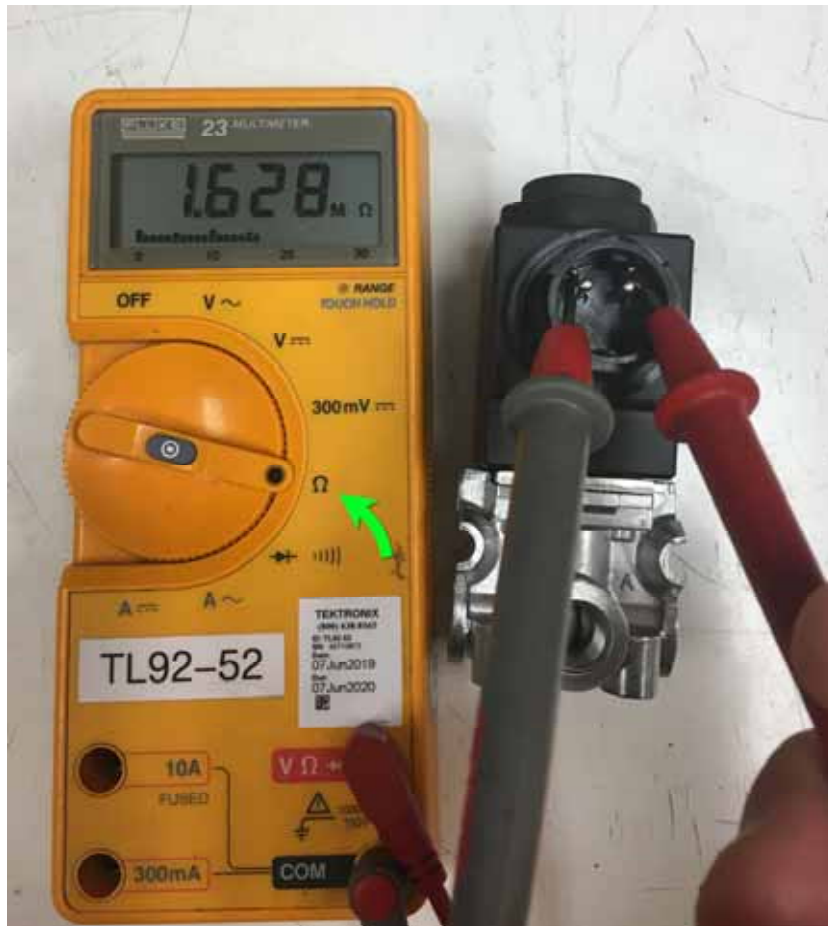
- **Resistance in the Mega OHM range when measured through normal polarity:**

Positive lead to Pin 1, Negative lead to Pin 4.

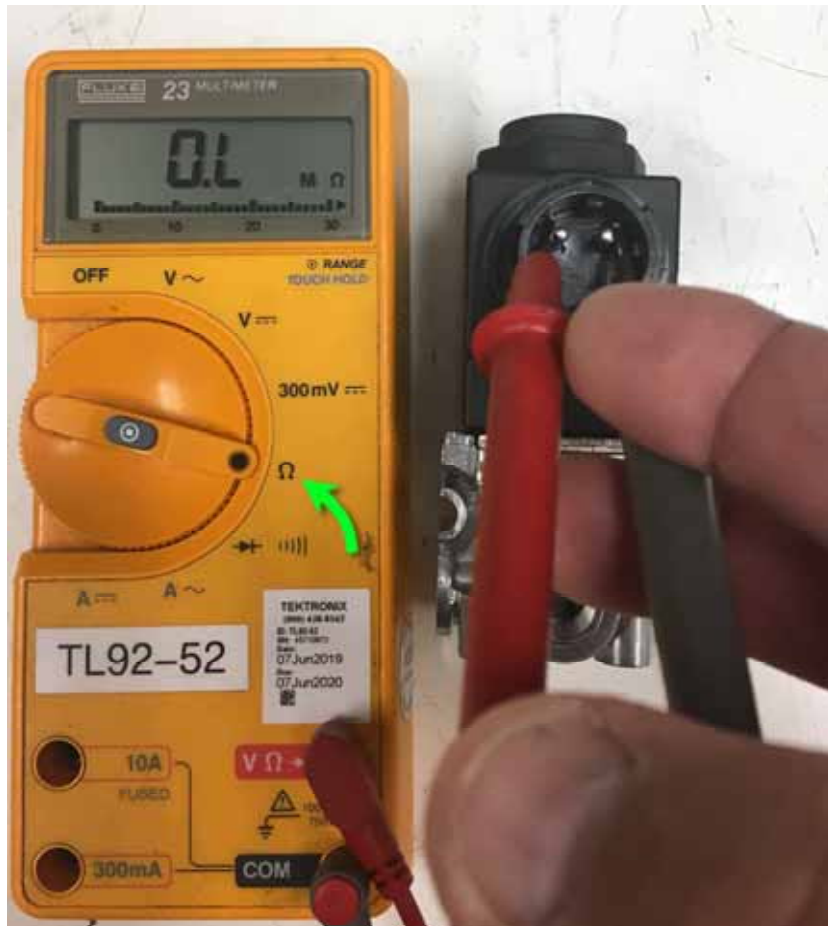
- **Open Circuit (OL)** when measuring Resistance through reverse polarity:

Negative lead to Pin 1, Positive lead to Pin 4.

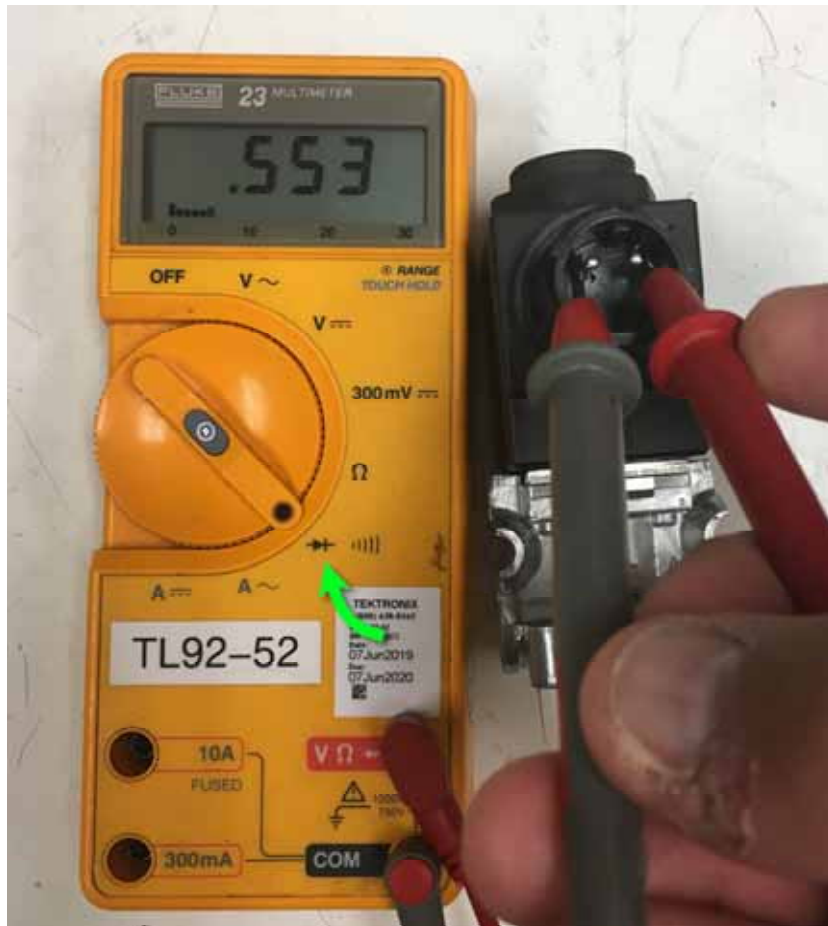
- **Diode Check function: Test voltage value when measured with normal polarity:**

Positive lead to Pin 1, Negative lead to Pin 4.

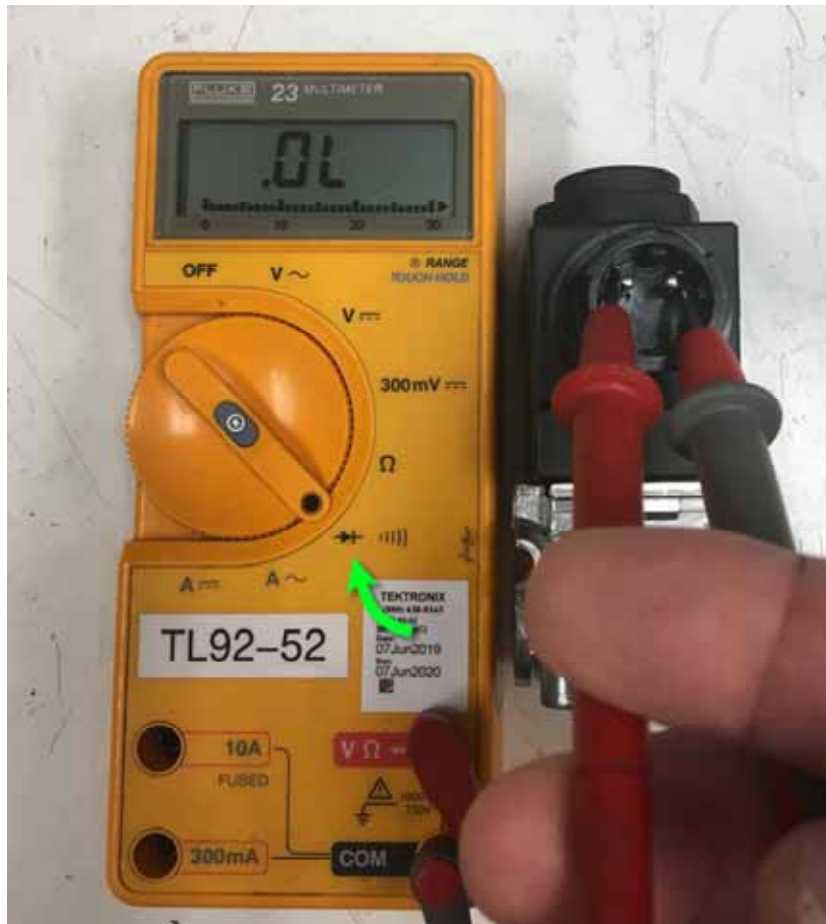
- Diode Check function: OL when measured with reverse polarity:

Negative lead to Pin 1, Positive lead to Pin 4.

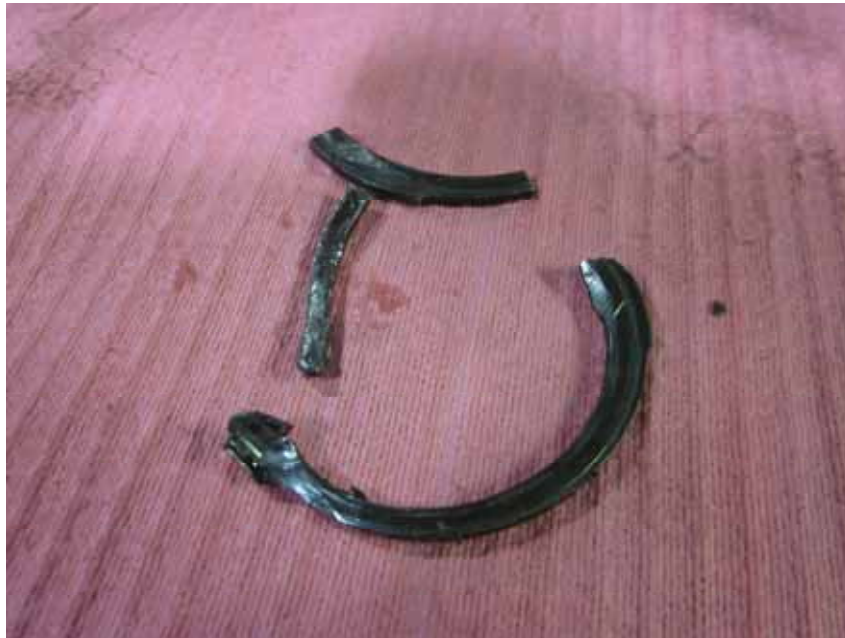
2. If the wiring is verified to be intact, the next likely item is a broken snap ring.

- The PTO drive shaft in the rear of the gearbox has a snap ring that contains the bearing to the shaft. If this snap ring breaks the pieces may end up in the PTO and get lodged under the shift fork and bind the fork.

- **If it is confirmed that the snap ring is the cause:**

- Repair as needed.

- Disassemble and inspect the PTO for repair or replacement.

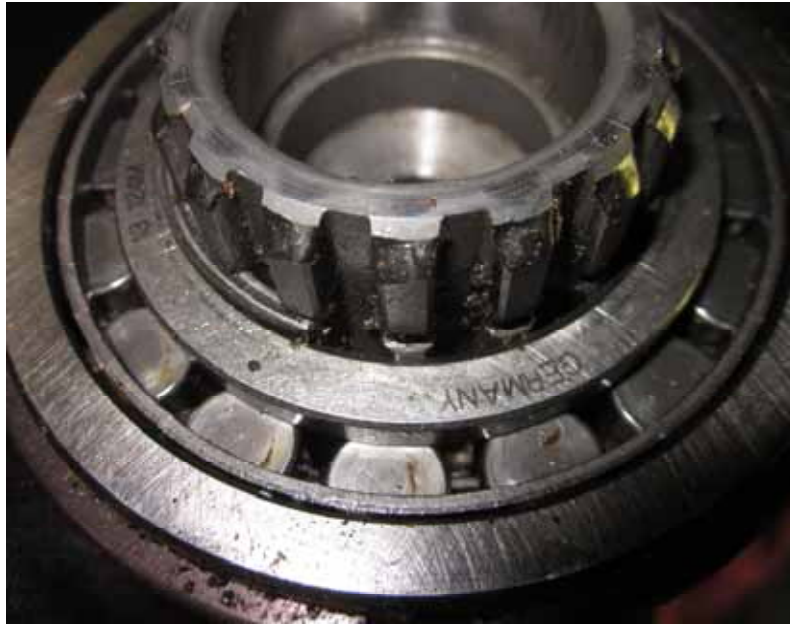
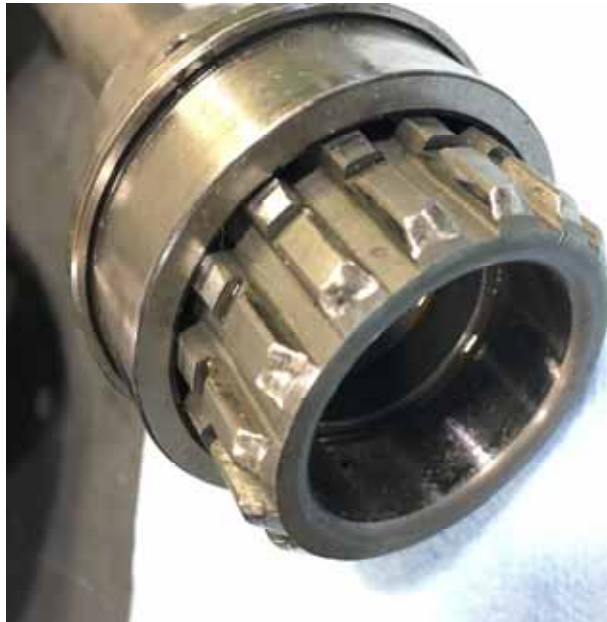
Pieces of ring get into the PTO and cause operational issues.

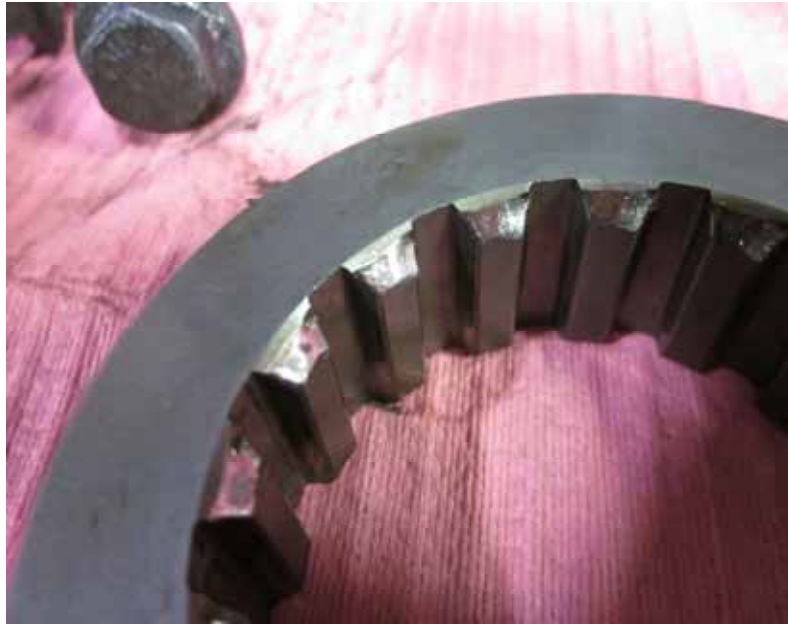
Spline and sliding clutch: Damaged components should be replaced

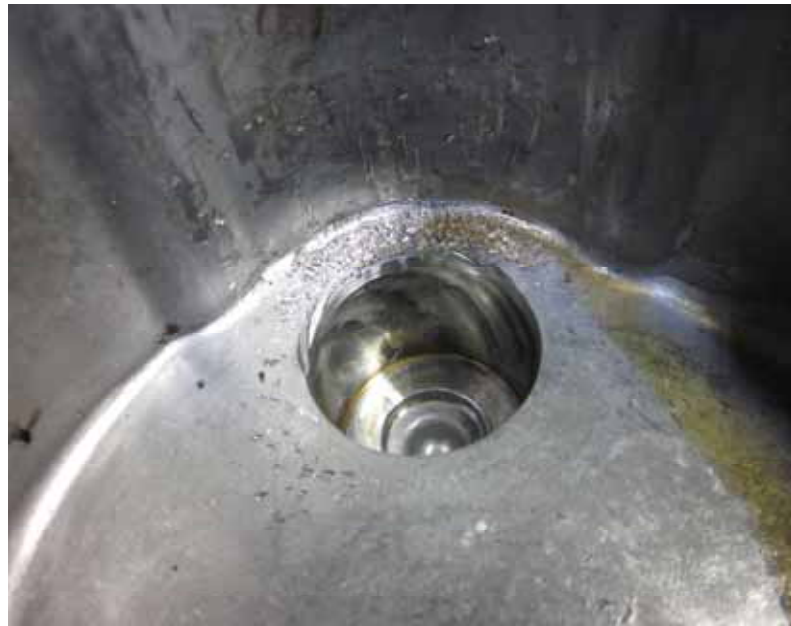
PTO case damage from snap ring or other debris can be cleaned up and inspected. If the damage does not affect the operation of the PTO shifter and piston seals the PTO can be repaired.

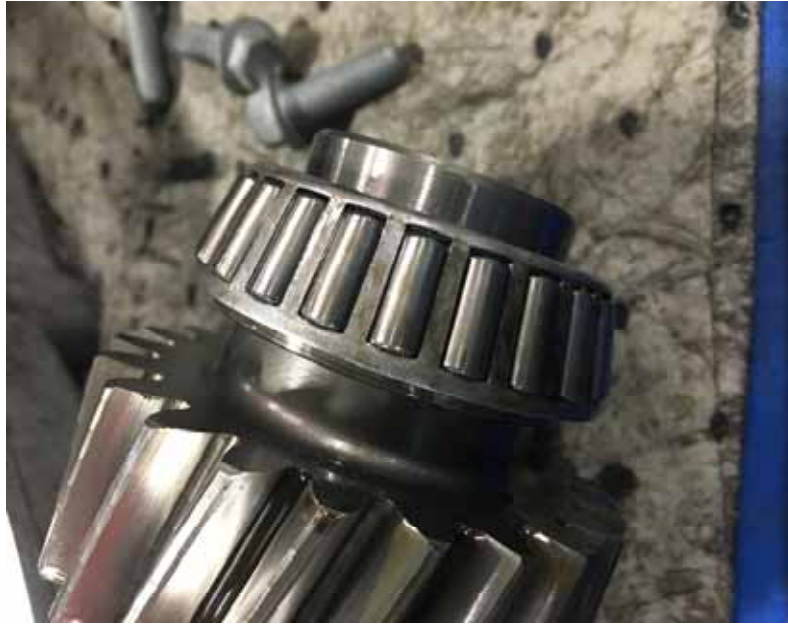
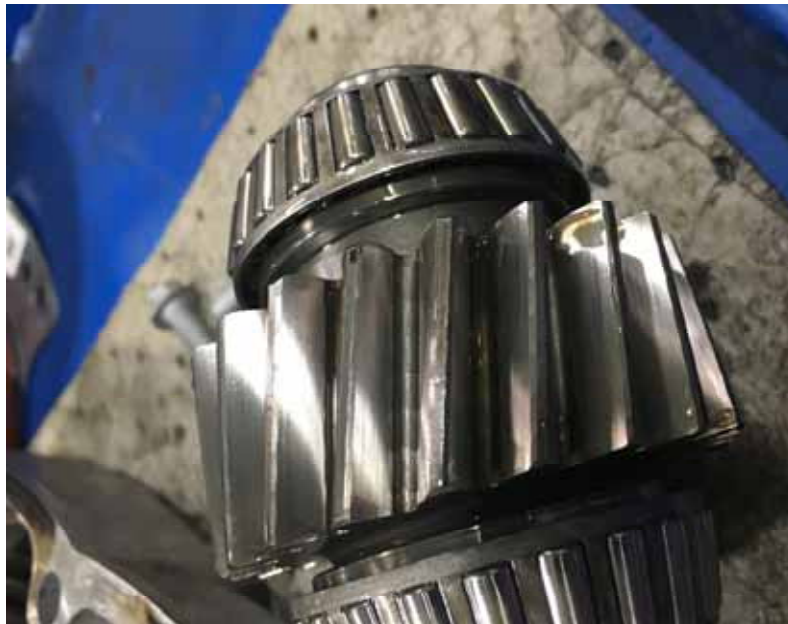
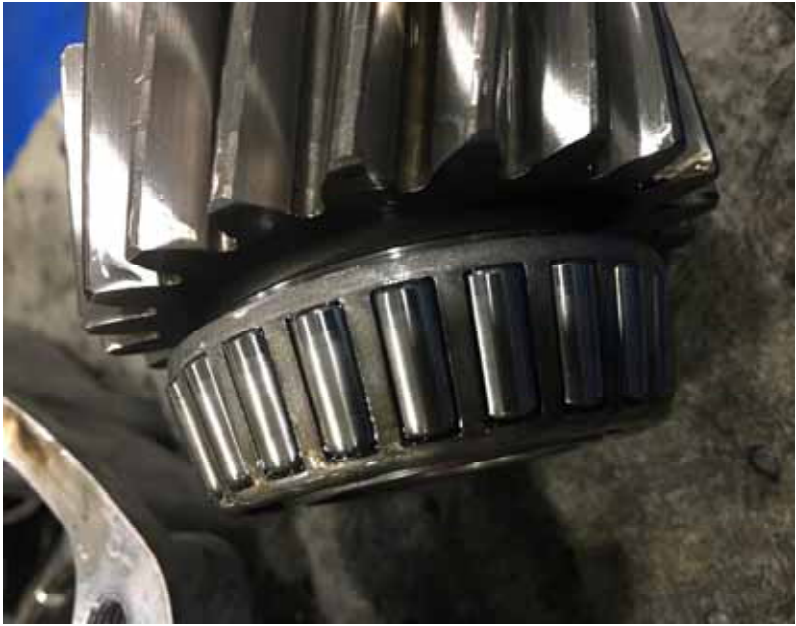
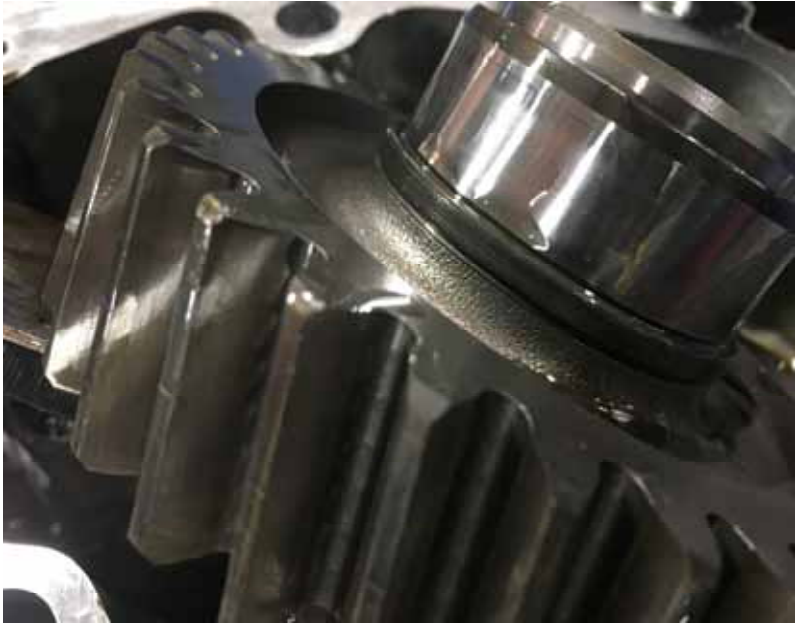
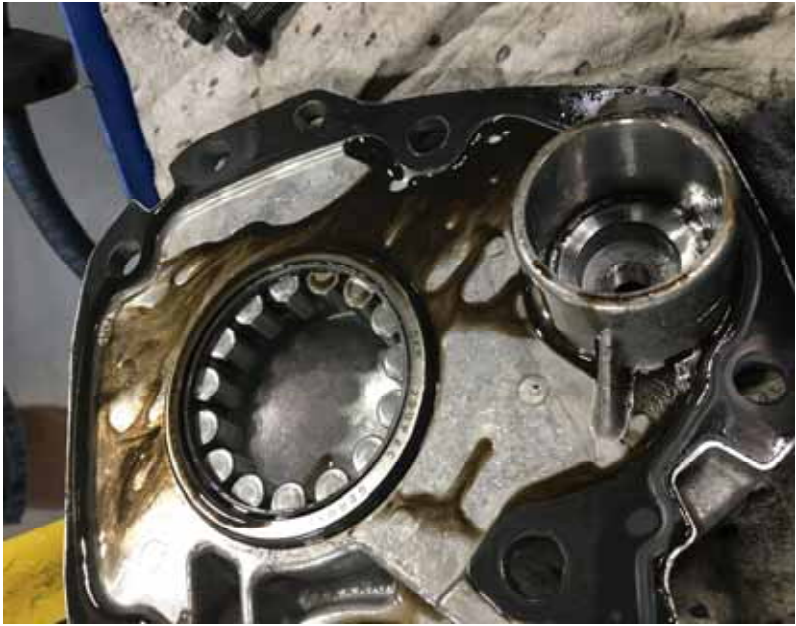
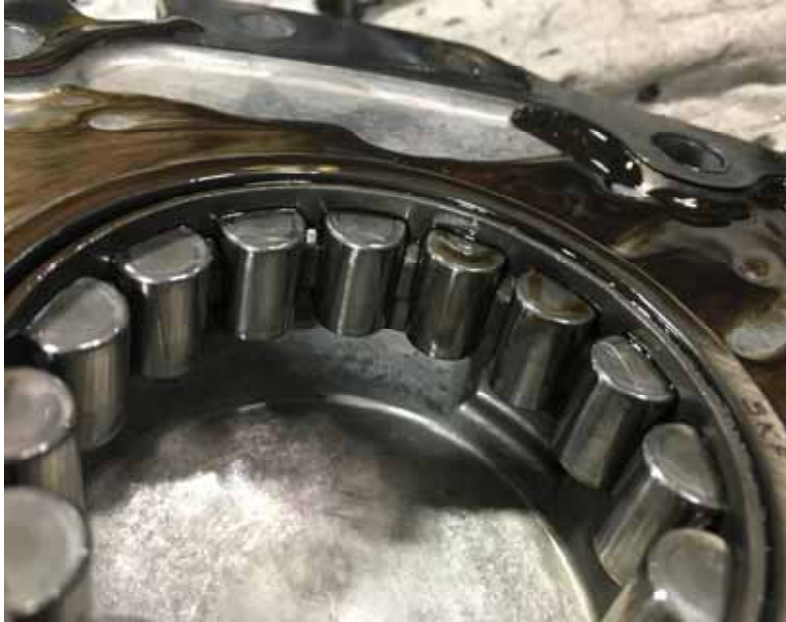
Except for the dark oil in the housing, this PTO was perfect even though the gearbox failed for low lube.

In cases of a gearbox failure of this nature, the PTO should be opened and inspected, cleaned, resealed and reused if the PTO is not failed.
