Title	Volvo Chassis - PTO Switch Installation For Vehicles With Updated Interior - Model Year 2018 And Newer
-------	---

Volvo Model	VNL , VNM , VNR , VNX , VAH , VHD
--------------------	-----------------------------------

Cause	Installation instructions to wire in a PTO switch for Volvo trucks with a modular harness.
-------	--

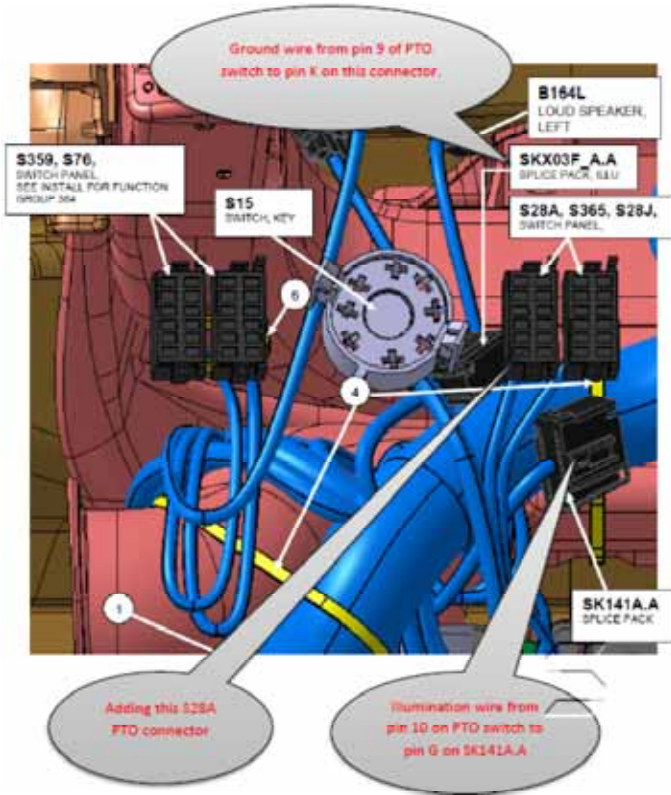
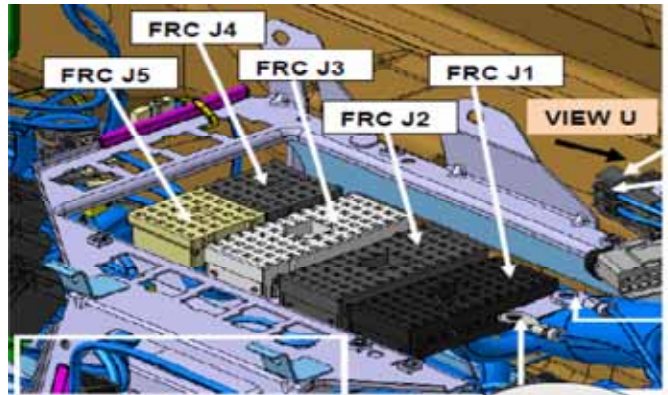
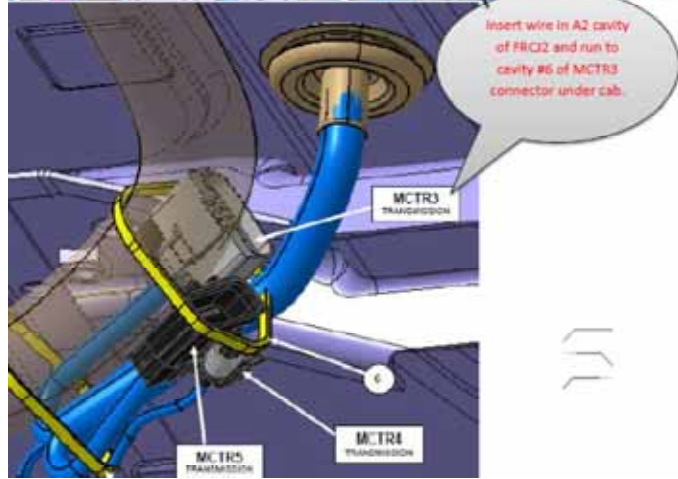
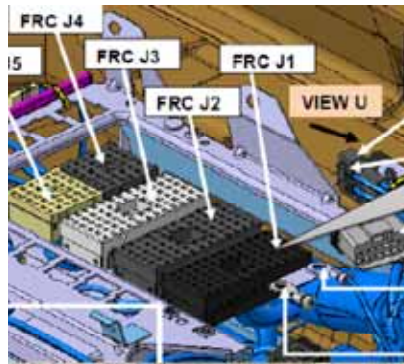
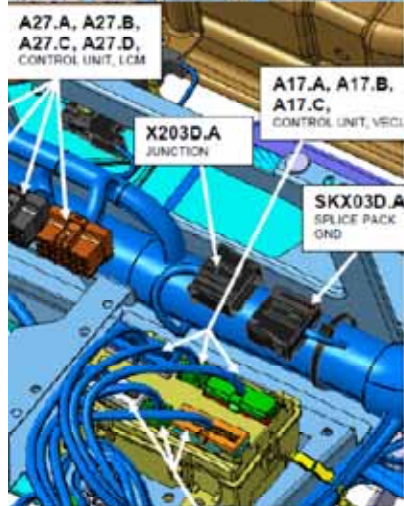
Instructions

- 1 roll of 18 gauge wire
- 2 - 978304 terminals for VECU
- 1 - 21046482 PTO switch connector
- 5 - 20864152 terminals for switch connector
- 4 - 8086231 terminals. 2-for FRC, 1 for SK141A, 1 for SKX03FA
- 1 - 20737026 terminals for MCTR connector
- 1 - 22542588 PTO switch

When switch installation is complete, run Accessory Kit #85137335.

NOTE: Program the VECU only on Type F AMTs
