Emissions Service Action

Code: 24EE

Subject Undisclosed Engine and/or Transmission Control Module Software

Release Date November 26, 2019

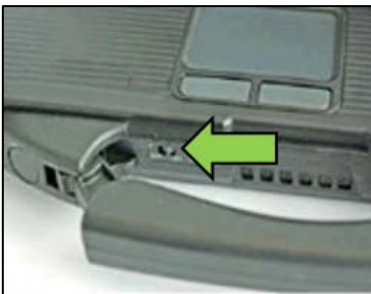
VAS 6150 & VAS 6150A
(Front panel behind handle)

- ✓ **The Bluetooth function of the scan tool is physically switched off <see pictures below>.**

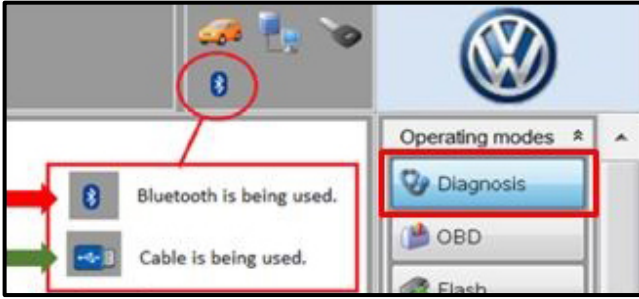
- Confirm that scan tool is communicating with the diagnostic head by USB <Green Arrow>.
 - If the Bluetooth symbol is shown <Red Arrow> then disconnect the diagnostic head from the vehicle and reconnect the USB cable to the diagnostic head and then reattach to the vehicle.
- Upon ODIS startup, verify the “Diagnosis” operating mode is selected <as shown>.

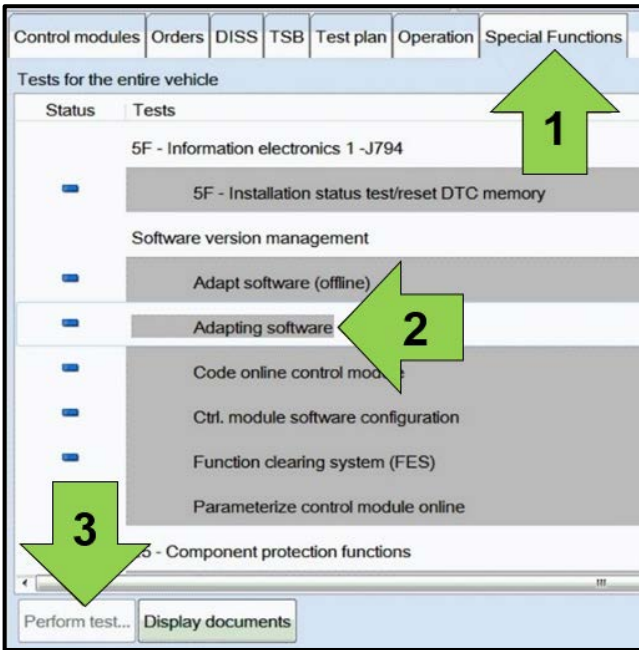
- Once the GFF scan is complete, select “Special functions” <arrow 1>, then “Adapting software” <arrow 2>, then select “Perform test” <arrow 3>.

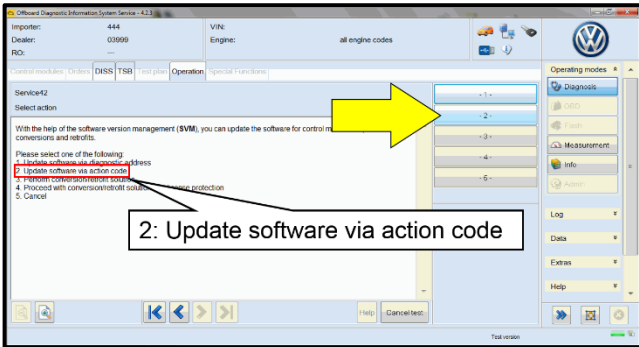
- Select option 2 to “Update software via action code”.

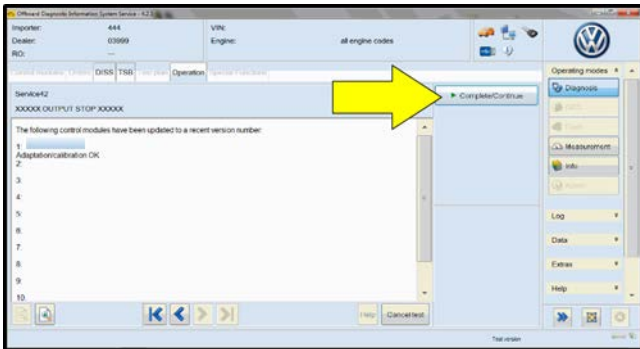
- Select “Accept” <arrow> and follow the on screen prompts.
- Select Complete/Continue <arrow> after each operation is completed.

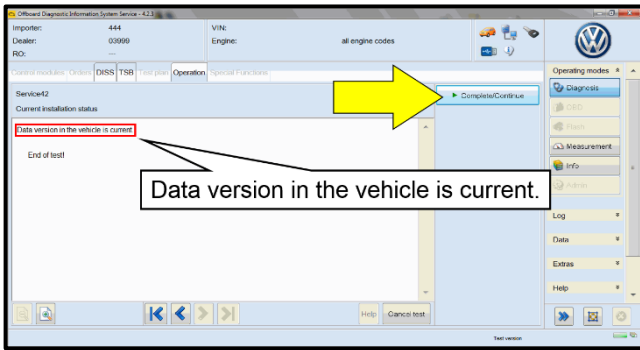
- When the SVM update is complete a confirmation message is displayed <as shown>.
- Select “Complete/Continue” <arrow>.
