WKJ1 - Replacing Fuel Tank Cap (Workshop Campaign)

Vehicle Type: **Cayenne S E-Hybrid (92A)**

Subject: **Fuel tank cap**

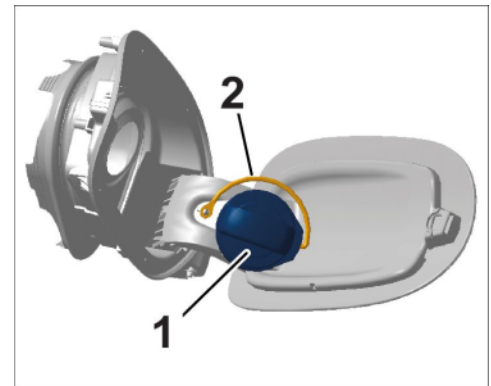
Fuel tank cap

Work Procedure: 1 Replace fuel tank cap ⇒ *Fuel tank cap-1-*.

1.1 Open the filler flap.

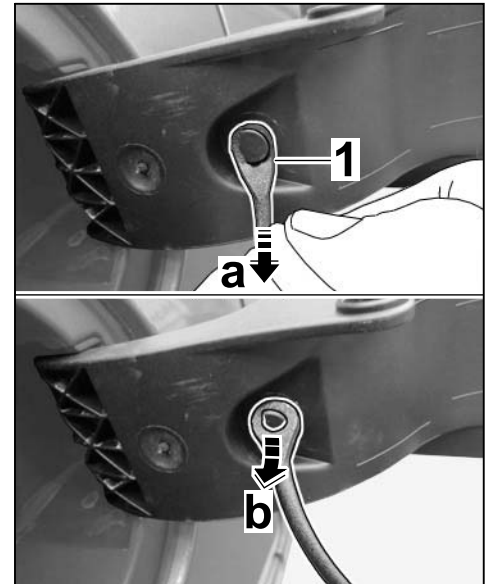
Removing retaining strap for fuel tank cap

- 1.2 Carefully pull the retaining strap ⇒ *Removing retaining strap for fuel tank cap -1-* down ⇒ *Removing retaining strap for fuel tank cap -arrow a-* and then guide it up over the retaining pivot ⇒ *Removing retaining strap for fuel tank cap -arrow b-* and remove it.

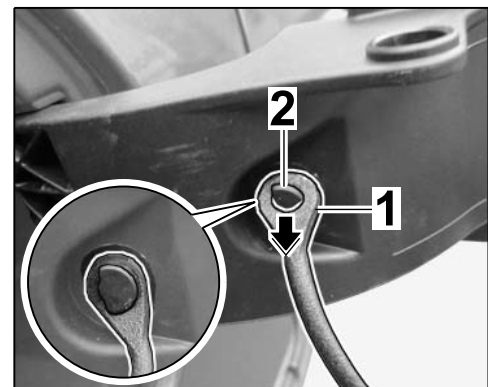
Attaching retaining strap for fuel tank cap

- 1.3 Carefully unscrew and remove fuel tank cap.
- 1.4 Fit new fuel tank cap on the filler neck and screw it on until it engages securely with an audible click.
- 1.5 Position retaining strap ⇒ *Attaching retaining strap for fuel tank cap -1-* on the retaining pivot ⇒ *Attaching retaining strap for fuel tank cap -2-*, pull it down carefully ⇒ *Attaching retaining strap for fuel tank cap -arrow-* and guide it over the retaining pivot.
- 1.6 Close the filler flap and press on the rear of the filler flap until it engages securely.
- 2 Enter the campaign in the Warranty and Maintenance booklet.
