Technical Journal

TITLE:
Oil in cooling system. New cleaning method developed

REF NO: TJ 21965.7.0	ISSUING DEPARTMENT: Technical Service	CAR MARKET: United States and Canada	
PARTNER: 3 US 7510 Volvo Car USA		ISSUE DATE: 2019-10-02	STATUS DATE: 2019-10-15
FUNC GROUP: 2600	FUNC DESC: Cooling system	Page 1 of 8

Volvo Car Customer Service	
	TJ Instruction
	No. T9318
	Date Nov - 09 Issue 01
Title	Cooling system, flushing
Model	All (see exception in the method)
Model Year	All
Competence requirement	Volvo Level 1 Technician

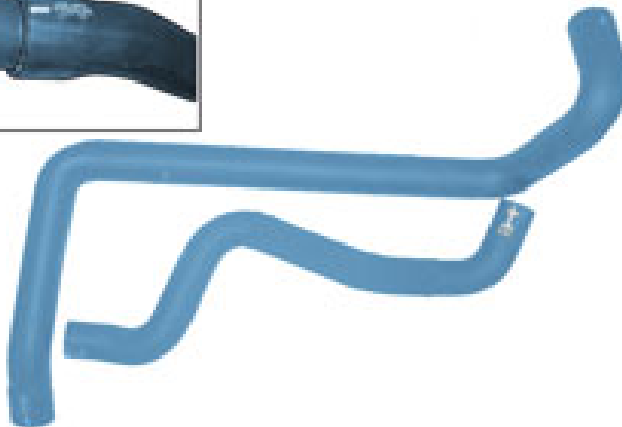
IMG-333508

The hose that is connected to the thermostat housing during flushing must reach outside the engine compartment.

Tip! Use radiator hoses 30776224 and 30761633 as tools. These are suitable for the different diameters on the outgoing connector on the thermostat housings.

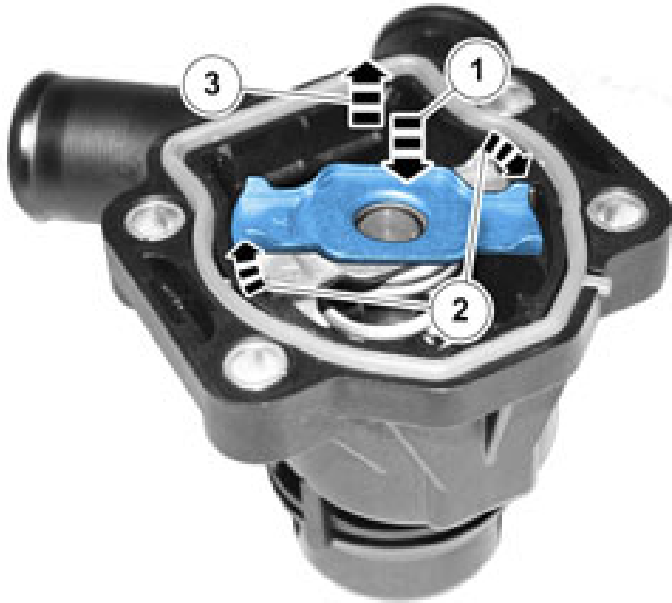
IMG-333180

B6324S, B6304T2, Step 1
