Technical Service Bulletin	Transaction No:	2055190/2
57-19-02 - Remo	ote Key Battery Replacement	Release date:	12/03/2019

#### **Condition**

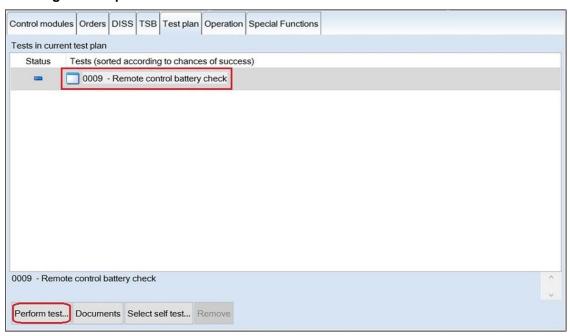
- Key battery diagnosis is performed using the GFF test plan "0009 Remote control battery check".
- If the test plan was attached automatically based on DTCs, click "Perform test" to begin.

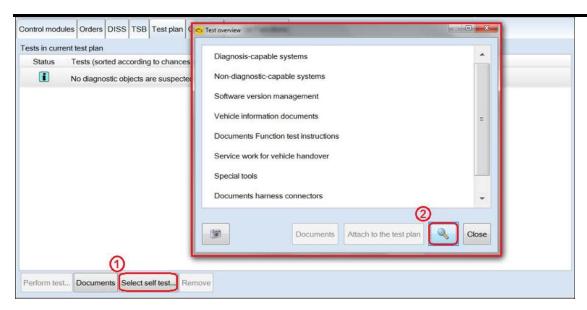
If the test plan was not attached automatically, it will be necessary to locate and add it manually.

- Click "Select self-test" (1).
- Click the magnifying glass icon (2).

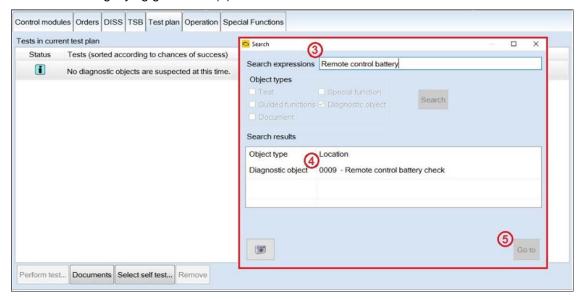
- Then enter "Remote control battery" as the search term (3).
- Select the result "0009 Remote control battery check" (4).
- Click "Go to" (5).

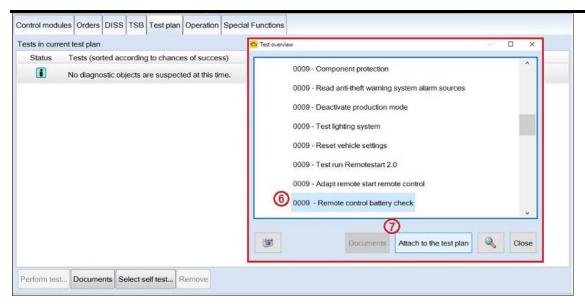
- Select the test plan "0009 Remote control battery check" (6).
- Click "Attach to the test plan" (7).
- Once the test plan is attached, select it, and click "Perform test".

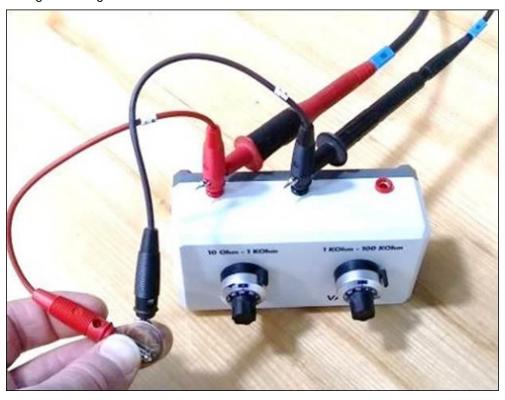
The test plan will require setting up the test instruments to provide 320 Ohms across the key battery during the voltage measurement.

During the GFF test plan, the VAS 6345 resistor decade will be used together with the VAG 1594/19A extension leads.

- The voltage measurement is performed within the test plan, using the VAS 6356 test instrument box.
- The resistance will be validated within the test plan before proceeding to measure voltage.
- The free ends of the leads are held against the positive and negative sides of the key battery during the voltage measurement.

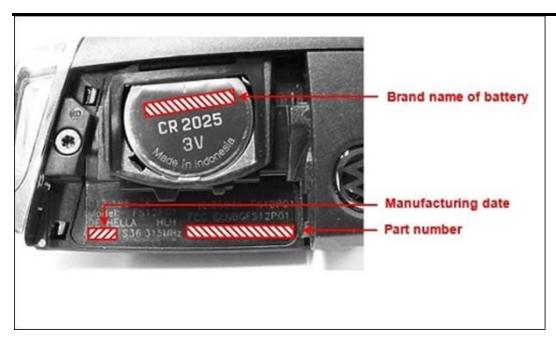
Identification of data for Hella remote key.

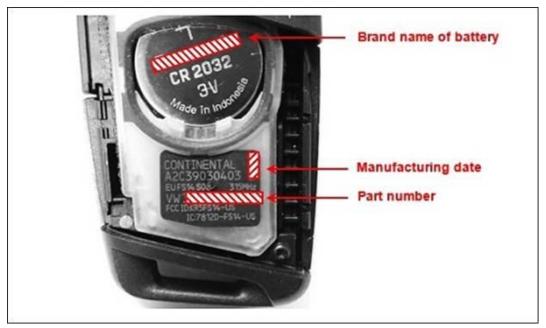
Identification of data for Continental remote key.
