SUBJECT: PRODUCT NOTICE – K500351

PART NUMBER: **K500351**

PART DESCRIPTION: **Ball Joint**

BRAND: **MOOG**

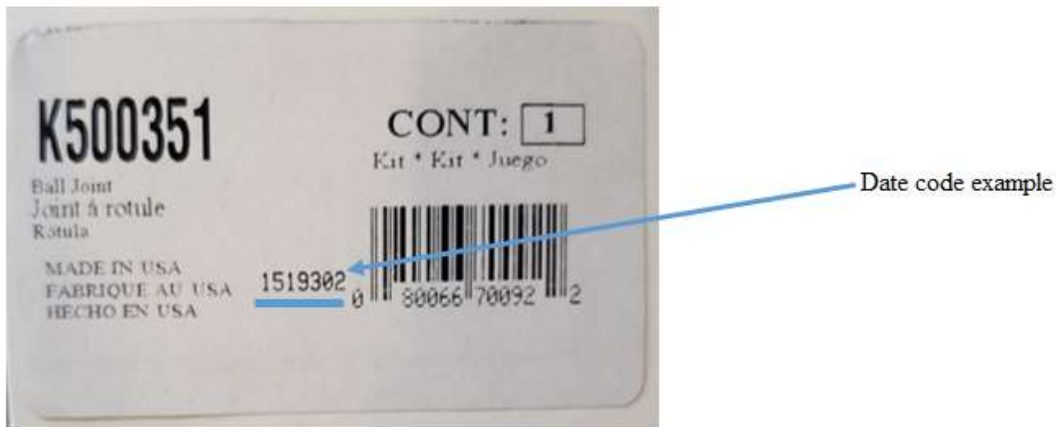
LABEL IMAGE EXAMPLE

- 1) The date code: It can be found by a seven-number sequence shown in the table below.

Beginning Date Code	Ending Date Code
1519152	1519243

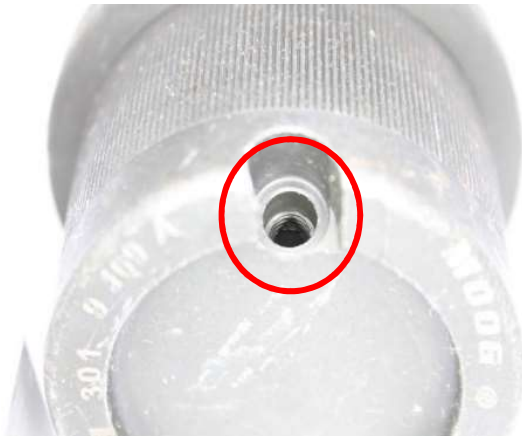
NON-CONFORMING

The suspect ball joint will install on the vehicle properly, but the part cannot be greased, due to the grease fitting plunging into the grease fitting hole.

- If grease fitting engages properly, the part is conforming.
- If grease fitting plunges into fitting hole, the part is non-conforming

As shown on the left hand ball joint.

Inspect and return non-conforming inventory for MOOG ball joint K500351. Please be sure to visually inspect parts within the packaged label date code range based upon images shown above.

Non-conforming product should be returned along with RGA form to: DRIV™ return center, 2599 AL-21, Jacksonville, AL 36265.

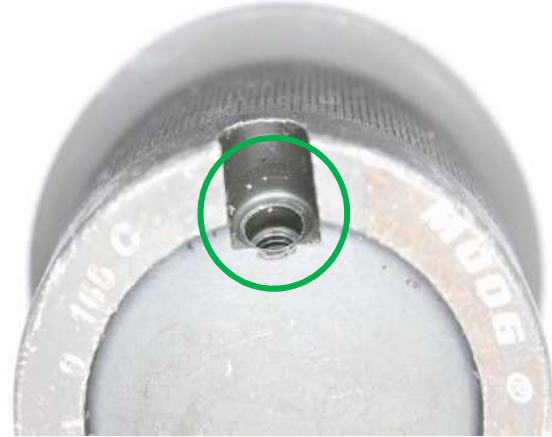
CONFORMING

As shown on the right hand ball joint.
