Service Update

N192275090 Fuel Tank Filler Clamps Loose At Tank

Release Date: November 2019

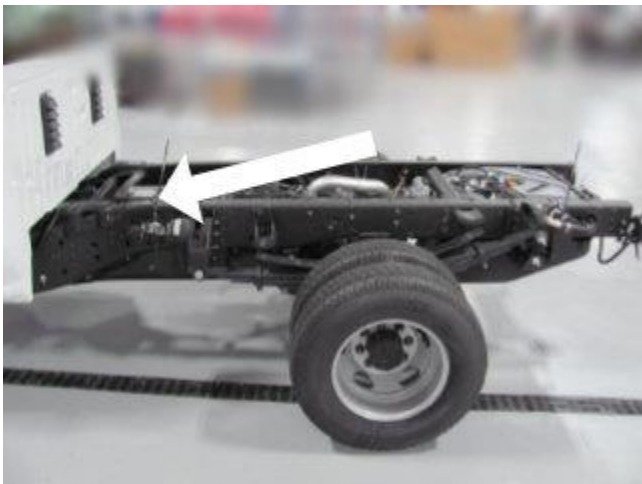
5436584

NOTE: The following procedure shows the front tank as the primary tank. Some vehicles may be built with a rear tank only.

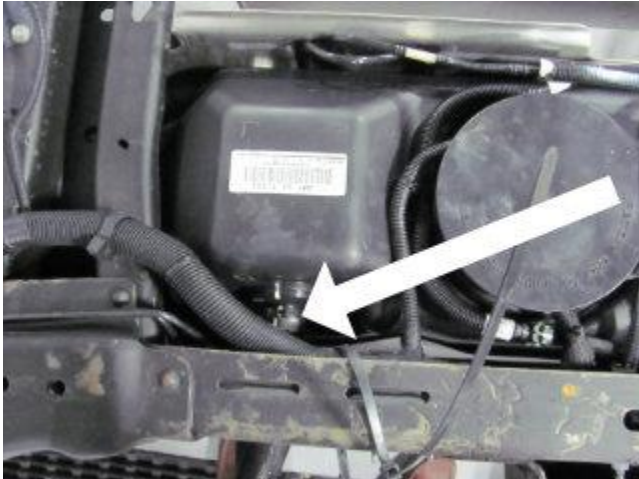
5436587

1. Locate the fuel tank filler hose to fuel tank connection.
