Solution	Once the PM Sensor is determined to be replaced, follow the steps below to remove the failed sensor.
	A procedure has been developed to prevent damage to the threads on the exhaust pipe, necessitating replacement of the complete SCR assembly.
Cause	When removing a PM sensor for replacement, the threads may be damaged during extraction of the failed sensor.
** SOLUTION **	
Emission Standard	US17+OBD16, US17+OBD18, US17+OBD19
Emission Standard	
Volvo Model	VNL, VNR, VNX, VAH, VHD
Volvo Models	
Mack Model	LR, TE - TerraPro, AN - Anthem, GR - Granite, PI - Pinnacle
Mack Models	
Title	Updated PM Sensor Removal Procedure - US17+OBD16 and Newer Emissions

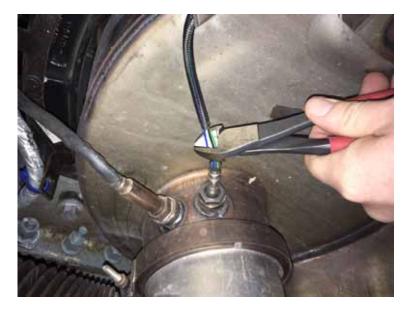
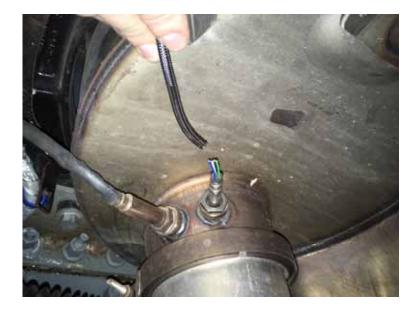
1. Cut the harness at the top of the sensor.

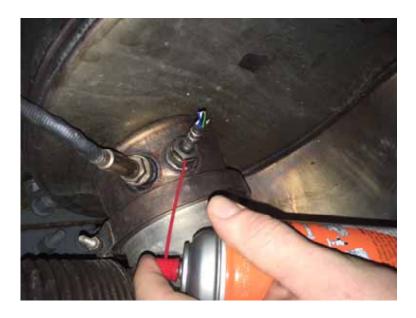
2. Spray the sensor nut with a suitable rust penetrant and let soak for approximately 5 minutes.

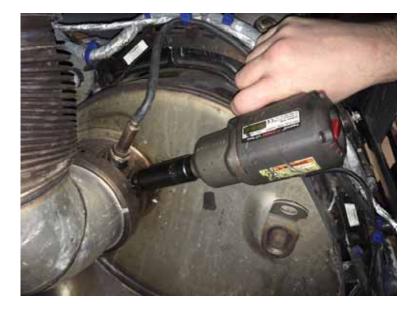
3. Remove the sensor with a $\frac{1}{2}$ " drive impact and appropriately sized deep socket.

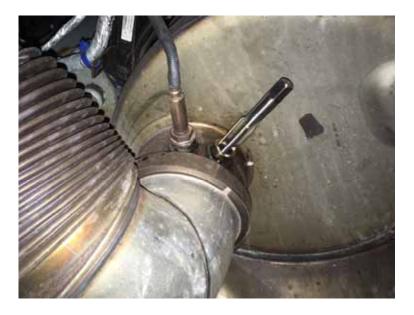
- **4.** Use an M18 x 1.5mm **<u>bottoming</u>** tap to chase the SCR boss threads.
 - Example bottoming tap Grainger part # 2LWT5

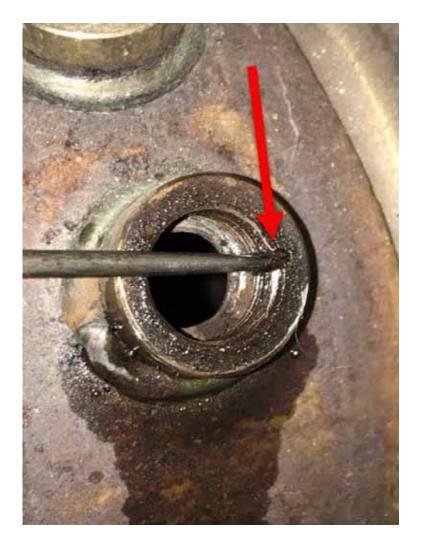
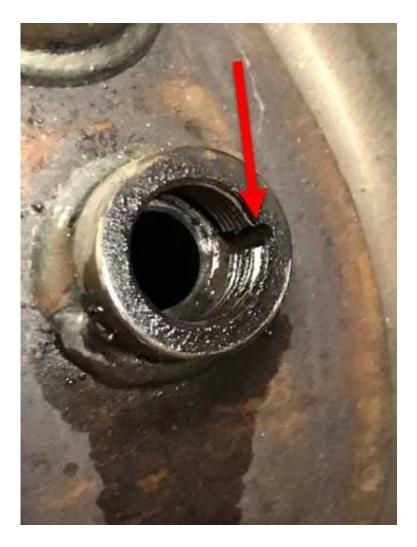
5. Inspect the boss threads and PM Sensor alignment notch for debris and clean if necessary.
