Technical product information

Topic	New Continental GT Convertible – Front seat belt webbing twisted
Market area	Worldwide Bentley (1WBE)
Brand	Bentley
Transaction No.	2038562/1
Level	EH
Status	Approval
Release date

Front seat belt webbing twisted

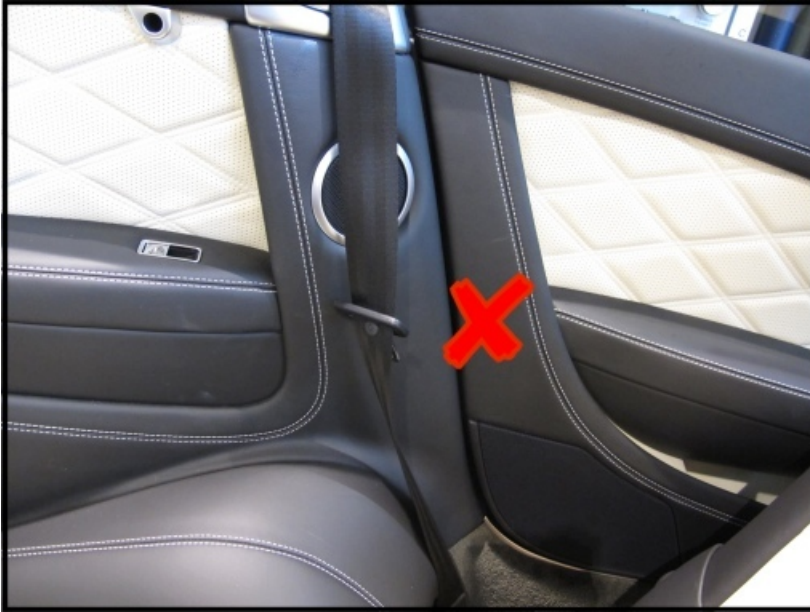
The front seat belt webbing is twisted this is evident in both the stowed position and also when the seat belt is worn see Figure 1

The plastic seat belt webbing guide, a plastic moulding incorporated in the seat belt upper 'D' loop assembly, may not have been fully clipped onto the metal 'D' loop. When this is the case a twist in the seat belt webbing is possible

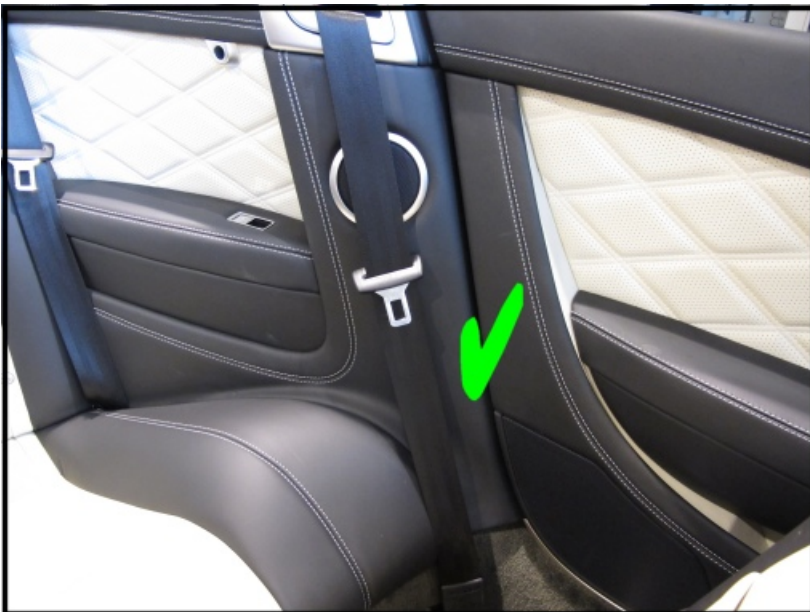
Figure 2

The front seat belt in the stowed position should be as shown in figure 2

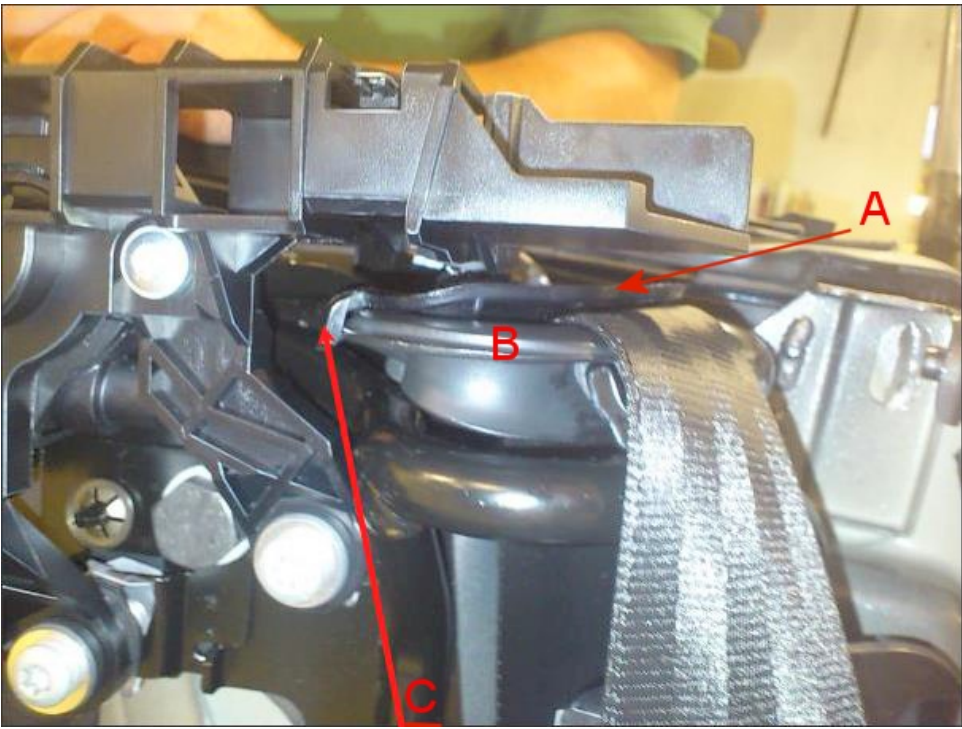
Figure 3

2. Referencing figure 3 and 4 inspect the seat belt webbing plastic guide (A). Ensure the three clipping points (C) are securely clipped to the 'D' ring (B).
3. If the guide is not securely clipped then remove and discard the guide and fit a new replacement guide.
4. On completion the guide must be correctly secured to the 'D' ring paying close attention to both outer clipping features (C)
