SS 1034615 Western Star Velvac Door Mirror Seal Curling

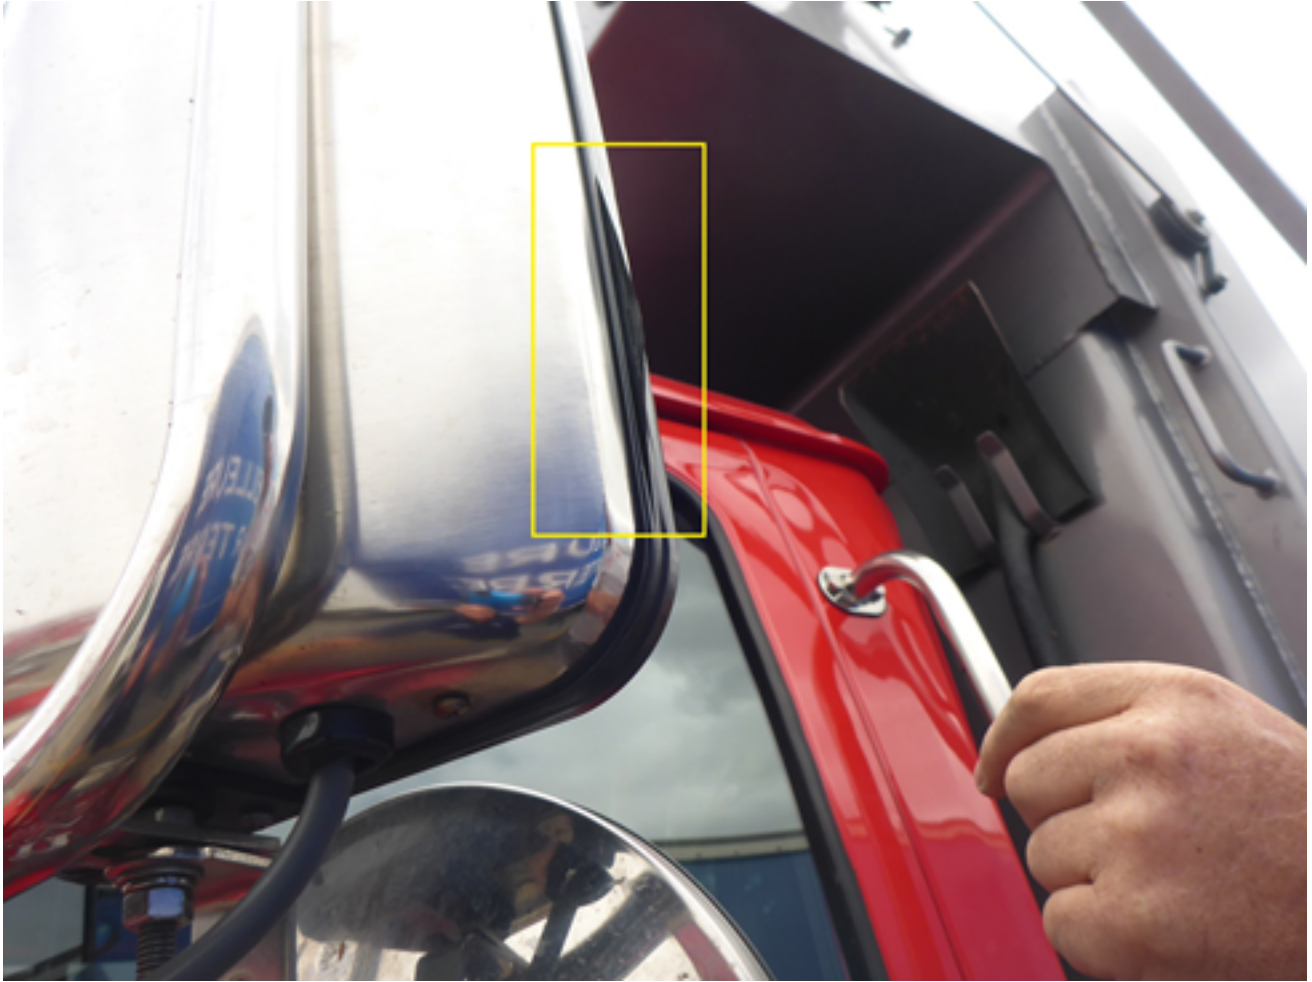
On some Velvac door mirrors the rubber seal begins to curl impacting truck appearance

The rubber that is rolling back is actually a rubber tape. Originally, the mirrors did not have this tape. Velvac added the tape to address some whistling complaints from customers. Keep in mind many OEMs use this mirror so at this point I am not sure if any of the whistling complaints came from us.

- Leave the seal as is until the new design is ready. (the seal does not impact mirror functionality)
- Pull the tape off from the main seal. (Could cause a whistle)

Note: the supplier is working on a new seal design that will eliminate this concern. Approximate timing when the new mirrors will be available is Late February 2020.
