Technical Service Bulletin

| SUBJECT: | | No: TSB-13-22-001 | |
| TC-SST TRANSMISSION AND MECHATRONIC ASSEMBLY DIAGNOSIS & REPAIR PROCEDURES | | DATE: January, 2013 | |

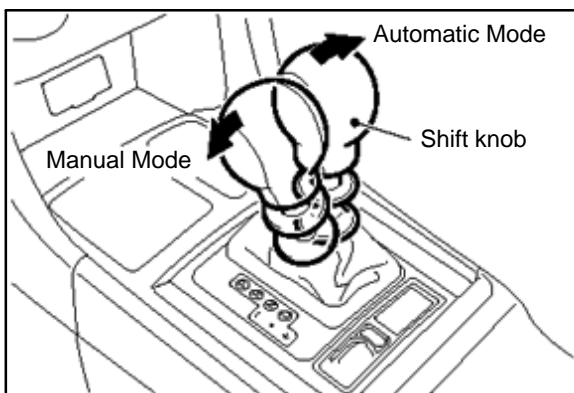
The driver can select either “Automatic Mode” or “Manual Mode” using the shift lever.

In automatic mode, the transmission shifts gears based on shift mapping programmed into the transmission control module, similar to a conventional automatic transmission. In the manual mode, sequential gear shifting is performed using either the floor shifter (+ for upshifts, — for downshifts), or the steering column mounted paddle shifters (right hand for upshifts, left hand for downshifts).

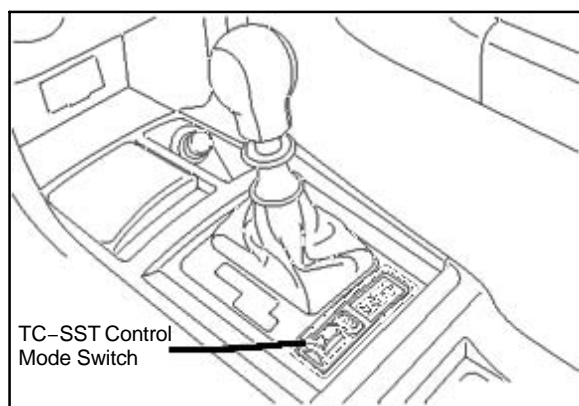
Drive Mode

Ralliart models have two drive modes: Normal and Sport.

Lancer Evolution models have three drive modes: Normal, Sport and Super Sport.

Each drive mode has a specific shift “feel.” The softest shift feel occurs in the default Normal mode. In Sport mode, shifts are quicker and occur at higher RPM. In Super Sport mode, shifting is the most aggressive. Shifts occur at even higher engine speeds and even more quickly than Sport mode. (Super Sport is not recommended for normal street use as shifting is very harsh).

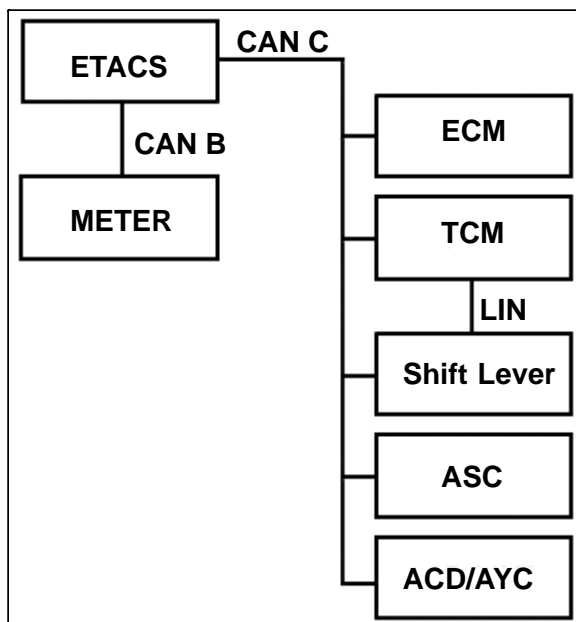
Network Communication

The TC-SST, like most of the vehicle's major components, is constantly communicating with other control units linked via the CAN C bus line. When diagnosing electrical issues, it is important to focus on proper electrical connections and communication. It also means that, similar to the vehicle's other control units, MUT-III must be used to program the TCM after replacement. Part of this TSB will focus on procedures for proper coding when replacing Mechatronic assemblies.

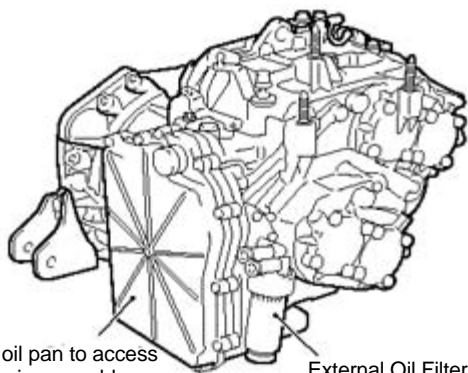
Current Replacement Parts

Remove oil pan to access Mechatronic assembly

External Oil Filter

The TC-SST transmission has two filter elements. Only the external oil filter element and the Mechatronic Assembly can be replaced at this time.

The combined Mechatronic Valve Body and TCM are accessible under the oil pan.

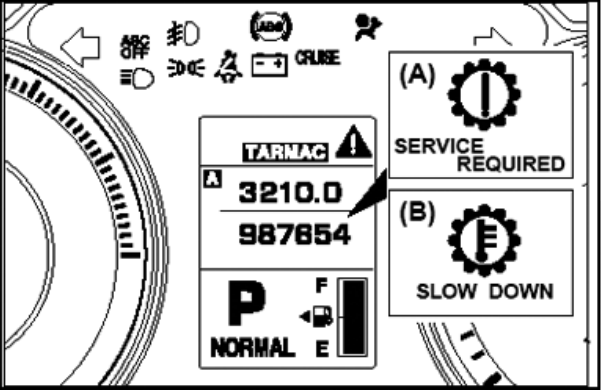
| DIAGNOSTIC STEP | ACTION TO TAKE |
|---|--|
| | <p>A. If the Service Required message is displayed, check for DTCs.</p> <p>B. If the Slow Down message is displayed, the transmission is overheating. Ask the customer if they have noticed this message displayed.</p> <p>The SLOW DOWN message displays if transmission temperature exceeds 250°F. If the transmission temperature exceeds 260°F, the ECU and TCM will take steps to cool down the transmission including reducing power and disengaging the clutches.</p> |

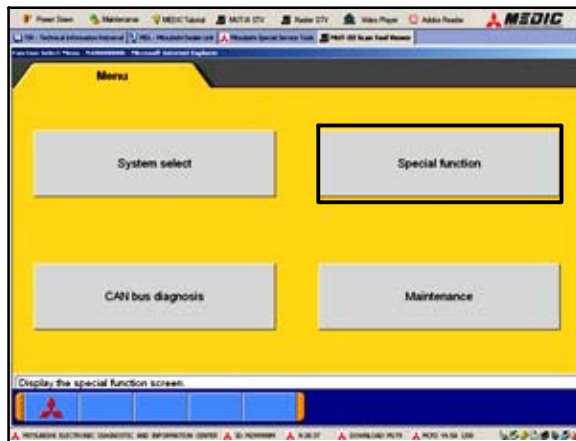
1. Connect MUT-III to the vehicle and turn the ignition switch to ON (RUN).
2. At the MUT-III main menu, choose **System Select**.

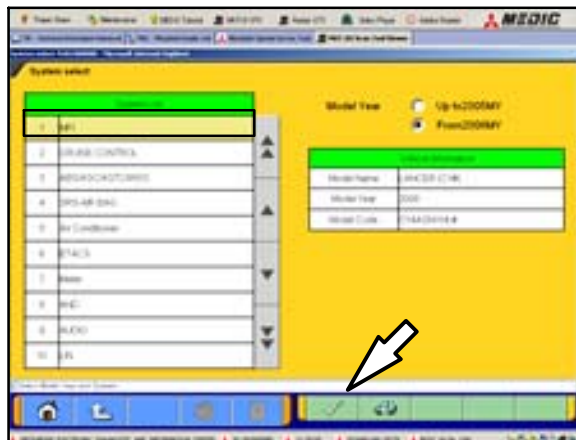
3. Select "From 2006 MY."
4. Click the car icon at the bottom of the screen.

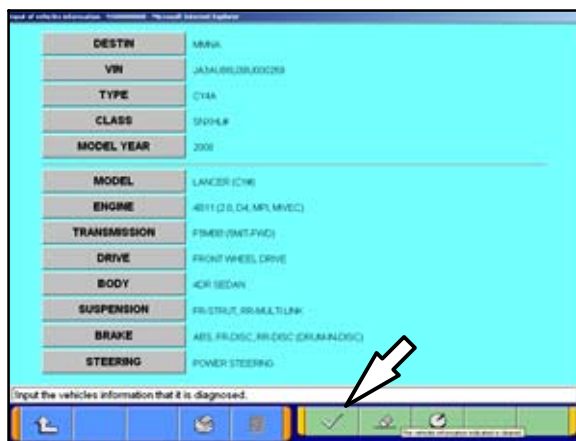
5. Click the eraser icon at the bottom of the screen to erase all vehicle data.

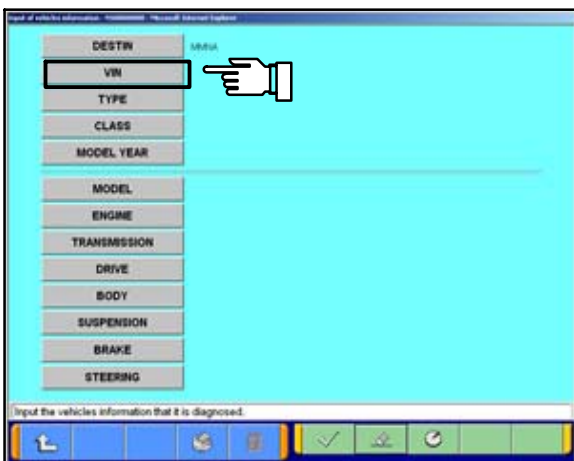
6. Click the VIN button.

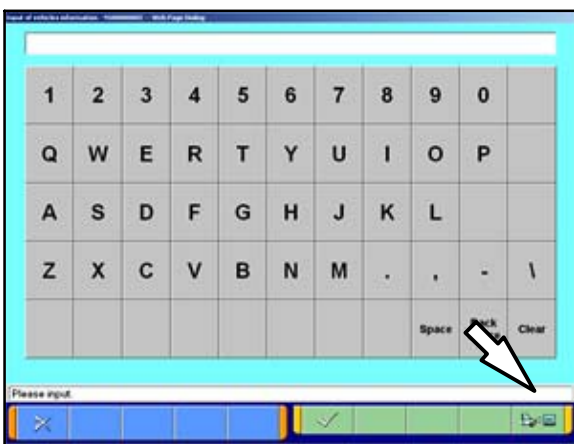
7. Click on the icon in the lower RH corner of the screen to have MUT-III automatically read the VIN. If a message appears advising the VIN cannot be input automatically, enter the 17 digit VIN.

Confirm VIN is correct and click the **check mark** to continue.

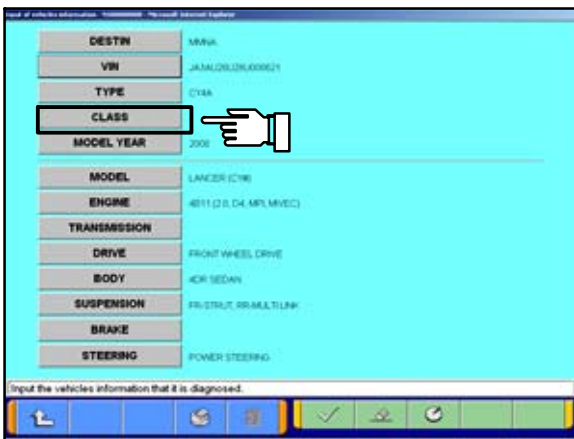
8. If the vehicle class is not complete, click the CLASS button.

NOTE: in some cases, selecting the proper transmission (arrow) automatically fills in the proper "CLASS."

9. Vehicle class can be found on the model plate attached to the right side B-pillar.

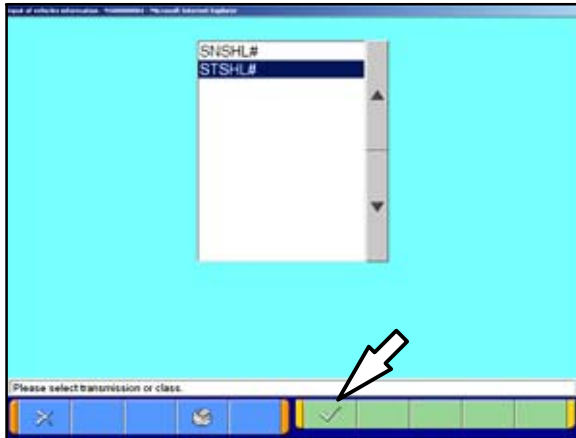
10. Make the selection for the class found on the Model Code Plate.

Click on the **check mark** at the bottom of the page.

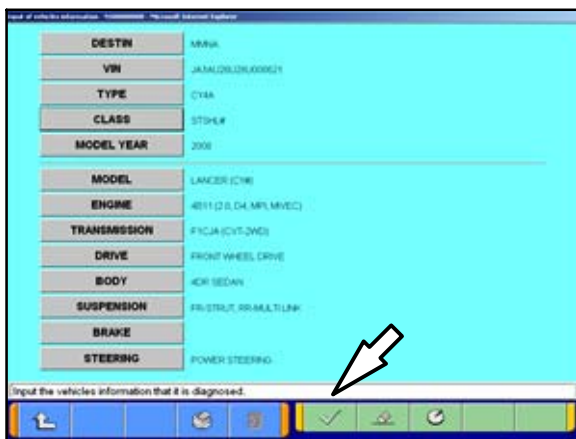
11. A completed vehicle information screen appears.

12. Select the **check mark**. You are now finished setting up the scan tool.

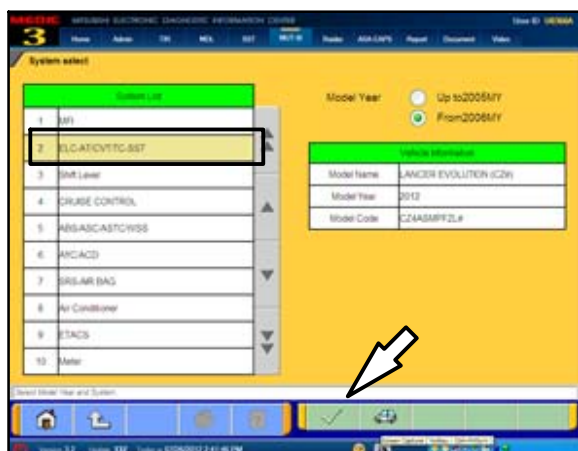
1. From the MUT-III Main Menu, click **System Select**.
2. Confirm the “**From2006MY**” button is selected and vehicle information matches the vehicle you are working on.
3. Highlight **ELC-AT/CVT/TC-SST** and click the **check mark**.

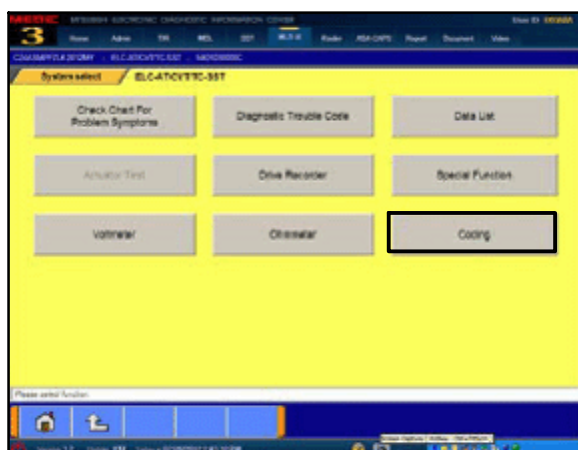
4. Click the **Coding** button.

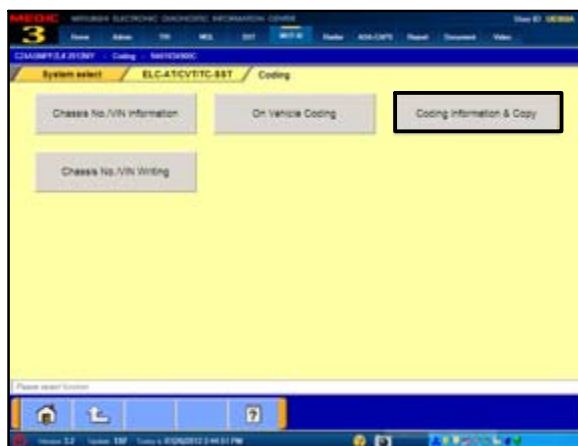
5. Click the **Coding Information & Copy** button.

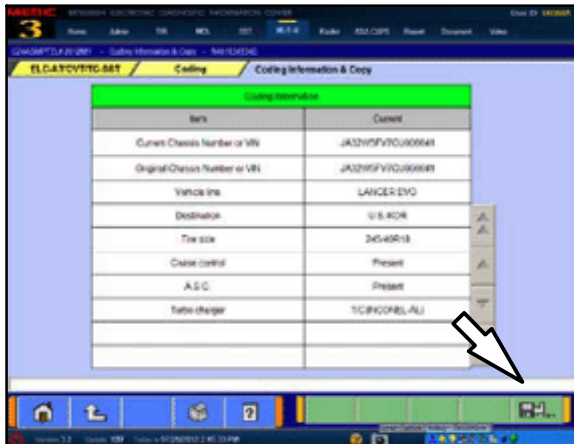
6. Click the **Computer Disc** button at the lower right corner of the screen.

!! IMPORTANT !! The **CURRENT VIN** must be correct for the vehicle.

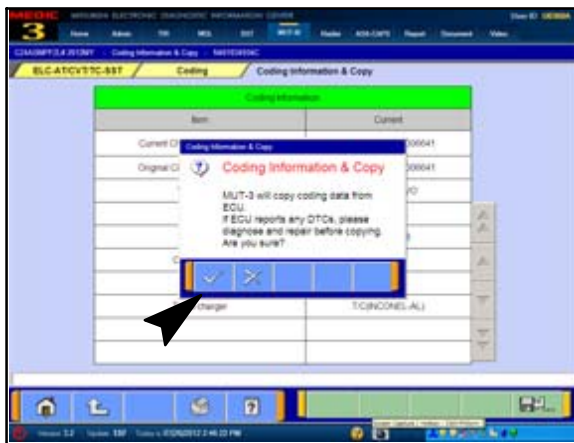
7. The **Coding Information & Copy** dialog box appears. Verify no DTC's exist in the system prior to saving this information.

If there is, the data you collect may be corrupt leading to future transmission problems once this data is uploaded to the replacement TCM.

Click the **check mark** to continue.

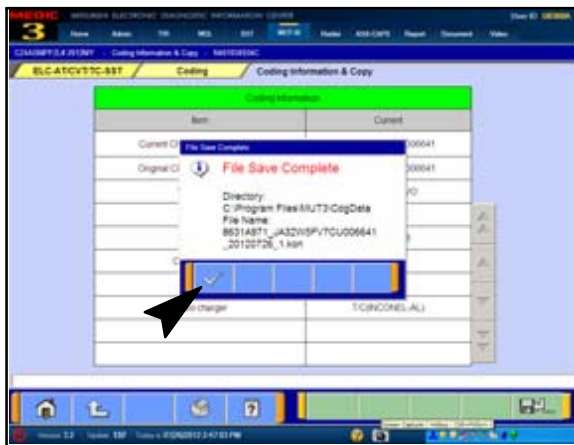
8. The **File Save Complete** dialog box appears. The file name contains the vehicle VIN along with the current date. Click the **check mark** to continue.
9. Click the "Home" icon at the bottom left of the page to return to the MUT-III main page.
10. Turn off ignition and disconnect MUT-III from the data link connector.
11. Replace Mechatronic Valve Body & TCM assembly. Instructions begin on page 14.

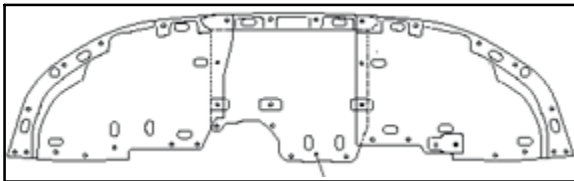
1. Record the customer's radio presets.
2. Disconnect the battery (—) terminal.
3. Remove center section of lower engine cover.

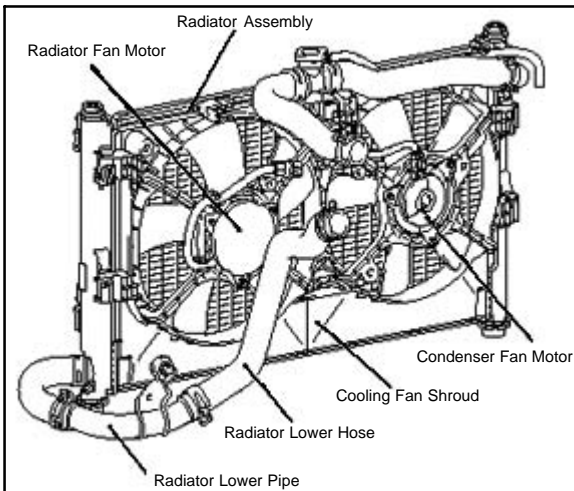
4. Loosen radiator drain plug. Drain coolant.

Drain coolant into a clean container. It will be reused for this procedure.

5. Remove lower radiator hose and pipe.
6. Remove fans, fan motors, and fan shroud.
7. Remove battery & tray (Ralliart only).

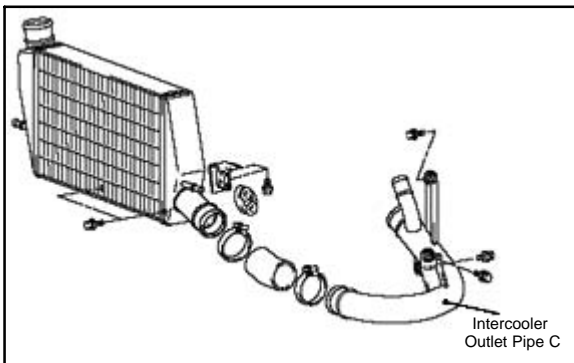
8. Remove Intercooler Outlet Pipe C.
9. Remove air cleaner element and intake duct.

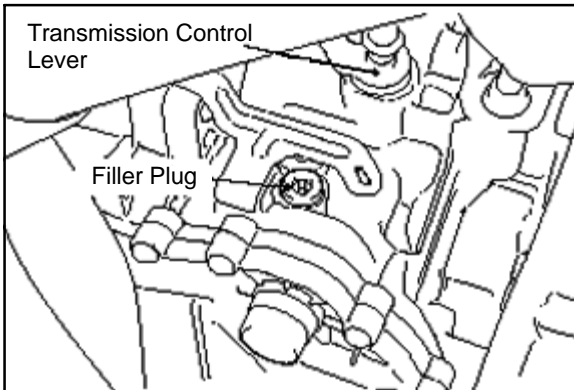
10. Remove filler plug on the top of the transmission.

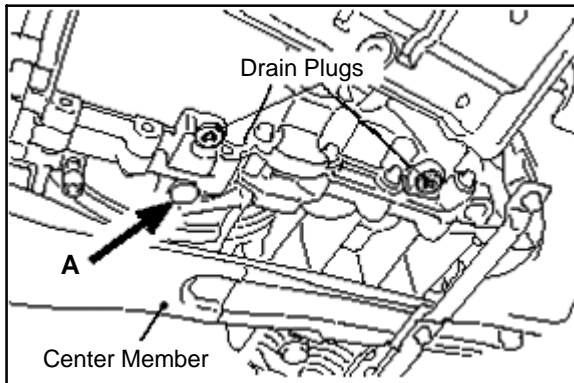
11. Remove drain plugs as shown at left and allow transmission fluid to drain for at least 3 minutes.

NOTE: If there is a plug located at point A, leave it installed.

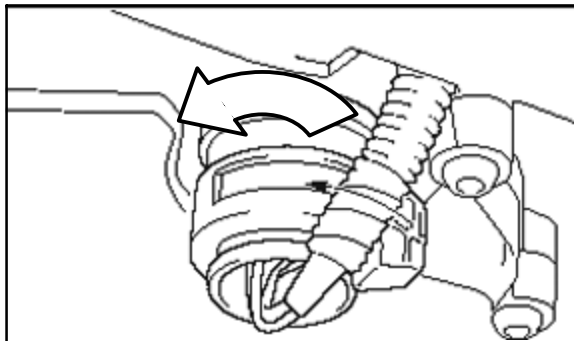
12. Rotate the transmission harness connector 90° and remove.

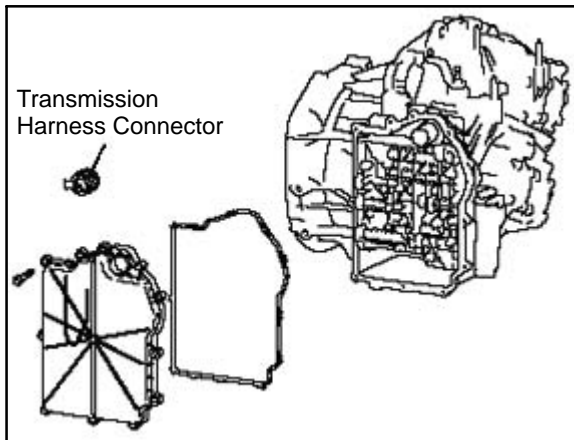
13. Remove and discard the transmission side cover and bolts. You will install a new side cover during reassembly.

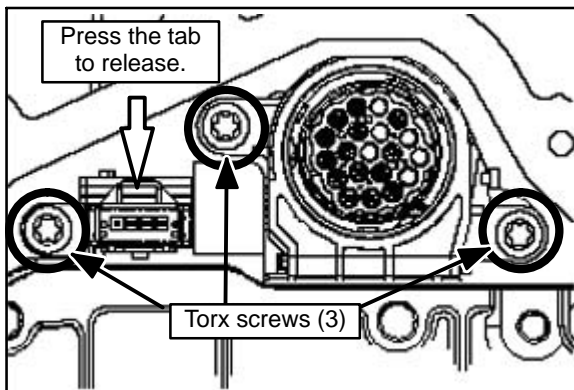
14. Using a small screwdriver to depress the release tab, carefully remove the internal 4-pin transmission electrical connector.

15. Remove 3 torx screws retaining the valve body connector. They can be discarded. New bolts for the connector are included with the new Mechatronic assembly.

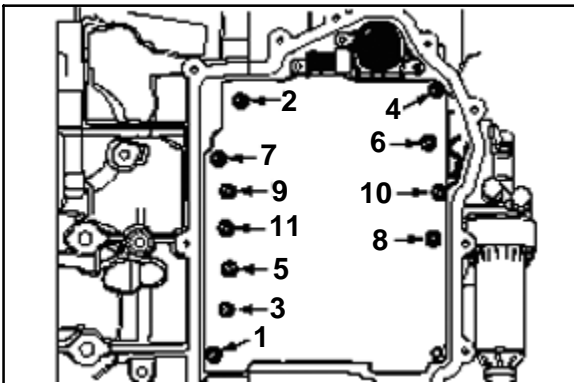
- 17. Remove the valve body bolts in the order shown. They can be discarded. New bolts for the valve body are included with the new Mechatronic assembly.
- 18. Carefully remove the Mechatronic assembly.

TAKE EXTRA CARE WHEN REMOVING THE VALVE BODY. THERE ARE LONG SENSORS THAT CAN BREAK. BROKEN PIECES CAN EASILY FIND THEIR WAY INTO THE TRANSMISSION.

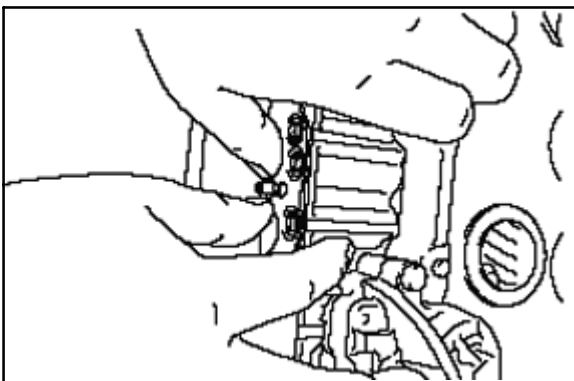
- 20. Clean and dry the valve body gasket surface.

NOTE:

New valve body gaskets are included with the new Mechatronic assembly. They can only be installed in one direction.

- 21. Install the new left side (engine side) valve body gasket over the dowel pin.

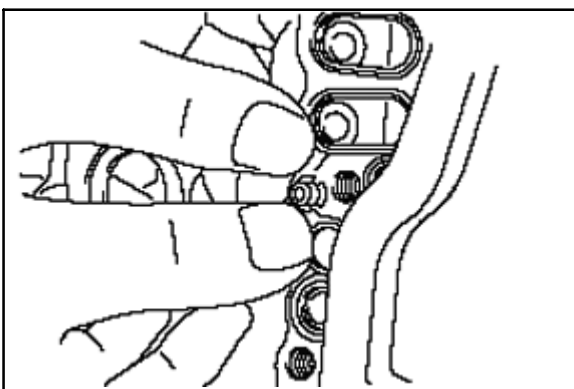
- 22. Install the new right side (external filter side) gasket over the dowel pin.

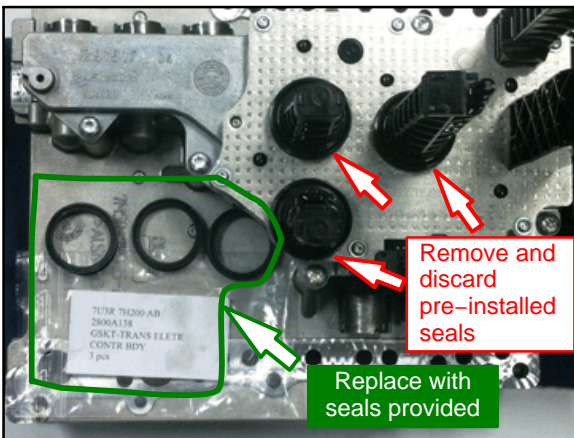
The new Mechatronic assembly is packaged with three seals pre-installed on the tall plastic sensors (see photo left).

REMOVE AND DISCARD THESE SEALS.

23. On the new valve body, thoroughly lubricate the replacement sensor seals with TS-SST fluid and install them to the valve body.
24. Install the new Mechatronic assembly to the transmission using new bolts included with the new Mechatronic assembly.

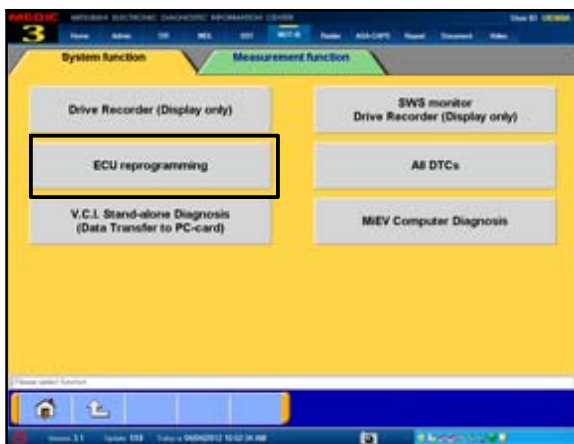
1. On the MUT-III Main Menu, click **Special Function**.
2. Click **ECU reprogramming**.

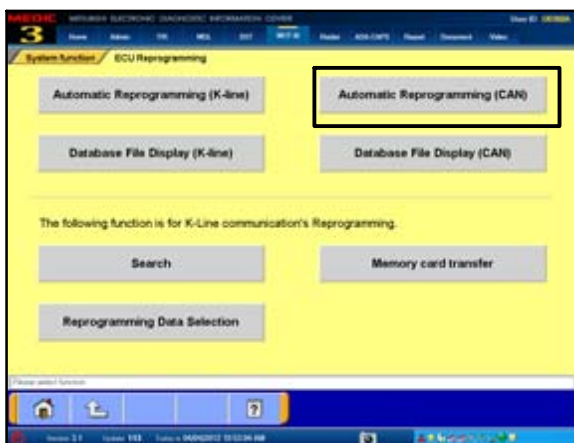
3. Click **Automatic Reprogramming (CAN)**.

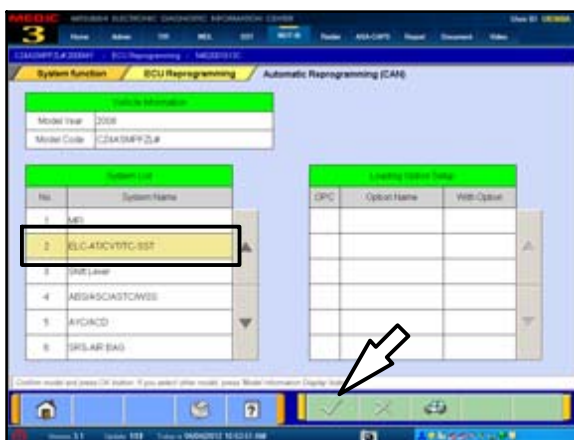
4. Select **ELC-AT/CVT/SST** and click the **check mark** to continue.

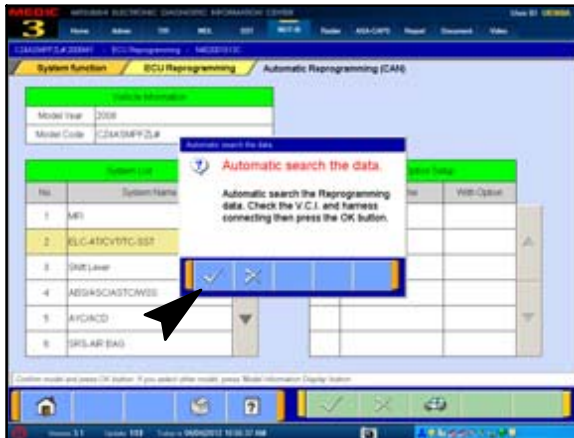
5. In the “Automatic search the data” dialog box, click the **check mark** to begin a search for reprogramming data.

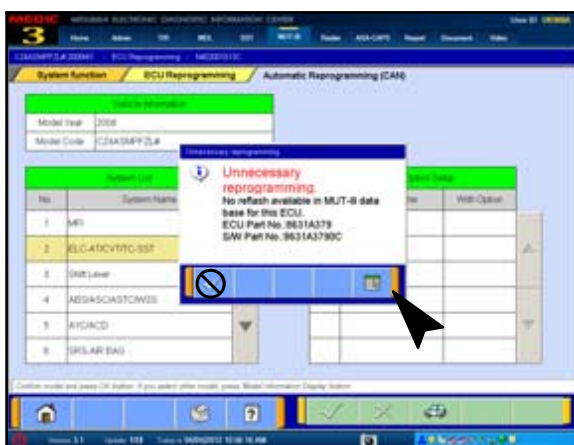
6. In the “Unnecessary Reprogramming” dialog box, click the **Data Screen icon** (not the check mark).

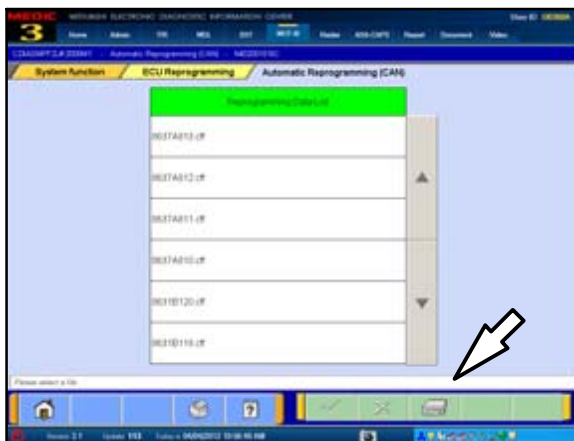
7. Once the **Automatic Reprogramming (CAN)** screen appears, all data contained in the data storage system is displayed.

To access the needed TC-SST data, Click the **Data Drive icon** at the bottom of the screen.

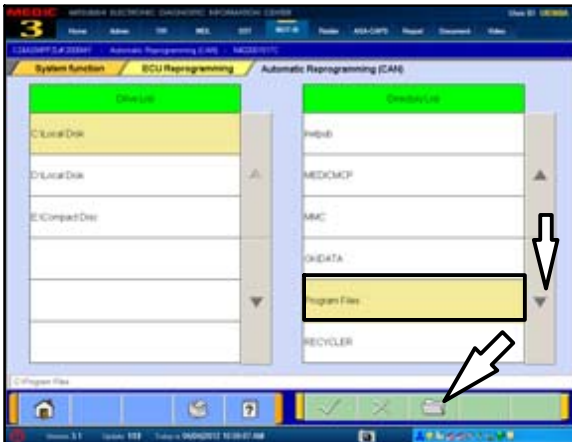
8. Scroll down the **Directory List** until **Program Files** is displayed.

9. Select **Program Files** and click the **file folder** icon at the bottom of the screen.

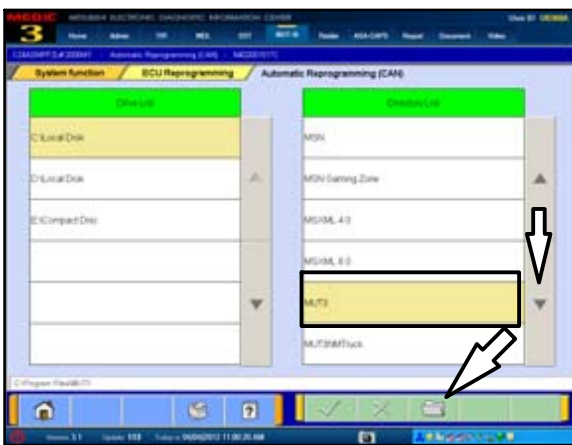
10. Scroll down the **Directory List** until **MUT3** is displayed.

11. Select **MUT3** and click the **file folder** icon at the bottom of the screen.

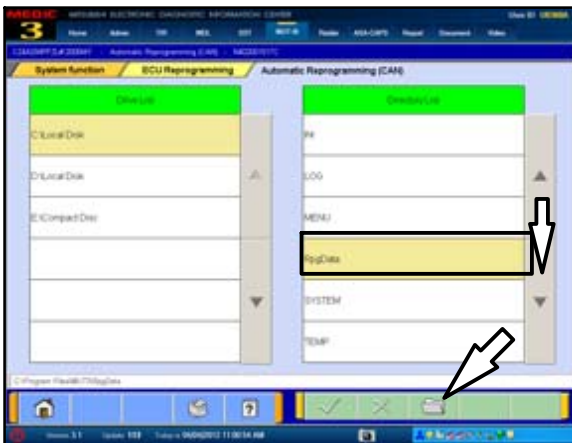
12. Scroll down the **Directory List** until **RpgData** is displayed.

13. Select **RpgData** and click the **file folder** icon.

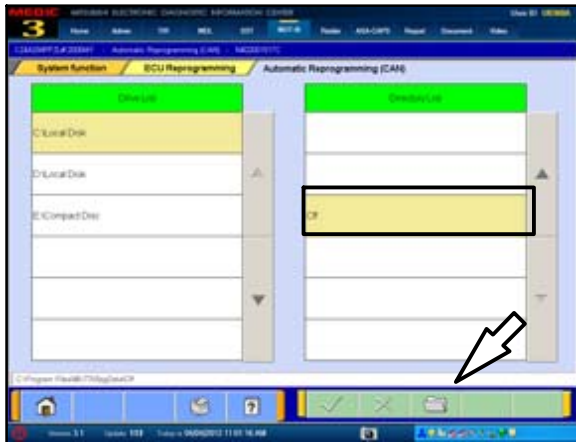
14. Select **CFF** and click the **file folder** icon.

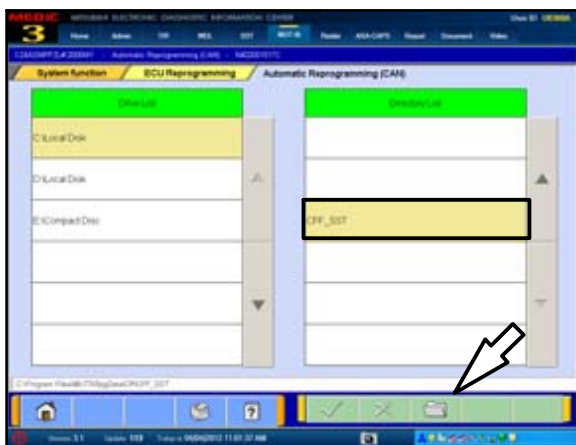
15. Select **CFF_SST** and click the **file folder** icon.

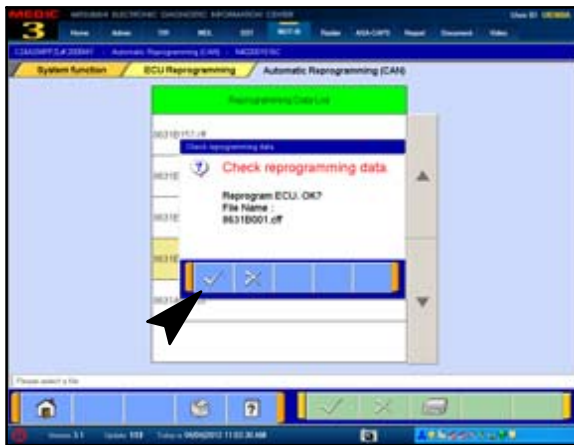
17. Select file 8631A749.cff from the **Reprogramming Data List** and click the **check mark** to continue.

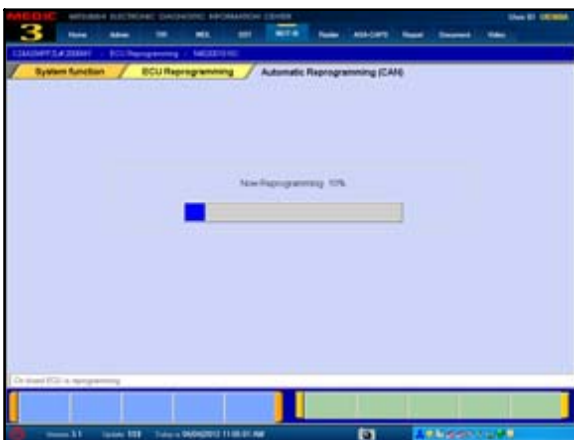
18. Click the **check mark** in the **Check Reprogramming Data** dialog box to continue.

The Daytime Running Lights and both the engine and condenser fans will automatically be turned on during reprogramming. Care should be taken to insure nothing gets caught in the moving blades. The radio will be turned off and you will also hear a chime in the interior for a short period of time. These are normal conditions.

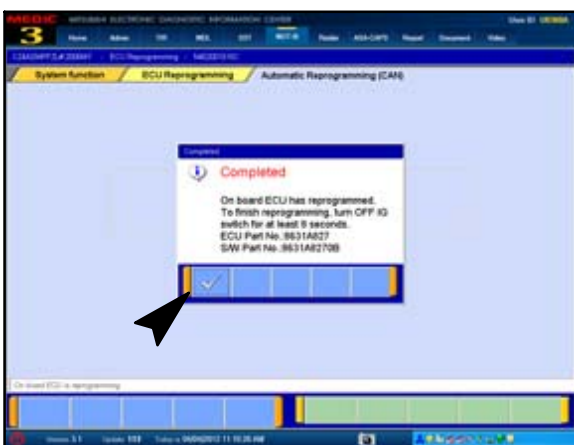
19. Data will load from MUT-III to the TCM.

NOTE: This process takes approximately seven minutes to complete. A battery charger should be attached to the vehicle battery and the MUT III should be plugged into it's charger to prevent the program from stopping prior to completion.

Stopping prior to completion could permanently damage the TCM.
