HYUNDAI

Technical Service Bulletin

GROUP	NUMBER
CAMPAIGN	20-01-003H
DATE	MODEL(S)
January, 2020	2016-2017MY SONATA HYBRID

SUBJECT: 2016-2017MY SONATA HEV MAIN RELAY / POWER RELAY ASSEMBLY / HIGH VOLTAGE CABLE ASSEMBLY REPLACEMENT (SERVICE CAMPAIGN T4M)

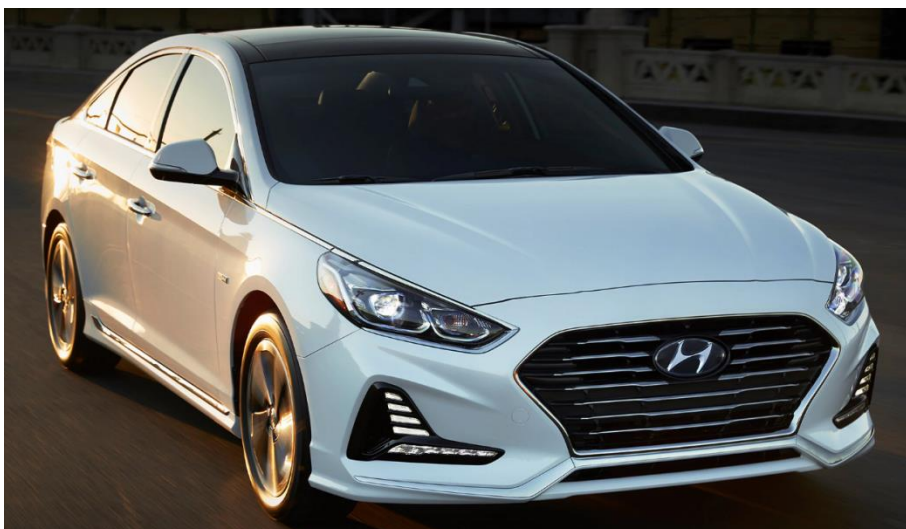
Description: 2016 – 2017 model year Sonata LF HEV vehicles contain a Power Relay Assembly ("PRA"). The PRA is equipped with a main relay and High Voltage Cable, which in some instances may have a loose connection. If the vehicle continues to operate in this condition, a loose connection could cause a no start condition or a Check Engine and Hybrid Warning Light On with either or both of these DTCs stored:

- DTC P1B77 – High Voltage Battery Precharging Fault
- DTC P1990 – Oil Pump Unit Input High Voltage Wiring Line Open

This bulletin describes the procedure to inspect the PRA, High Voltage Cable, and main relays and replace them if necessary.

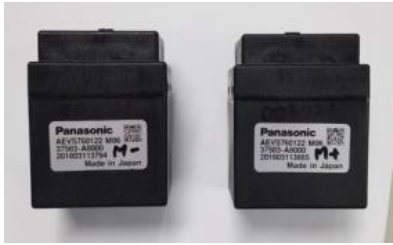
Part Name	Part Number / Figure	Qty	Note
MAIN RELAY

<p>37583-A8000QQH</p>	1	<p>Only required based on vehicle inspection results. Refer to Service Procedure.</p> <p>Note: The main relays are packaged as a set of two.</p>
POWER RELAY ASSEMBLY

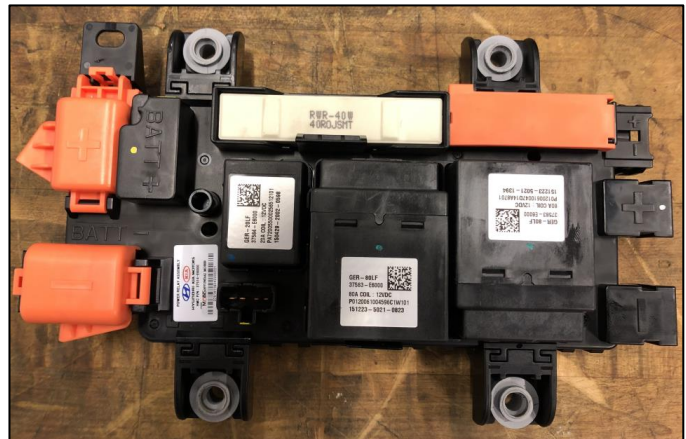
2. The Power Relay Assembly (“PRA”) and main relays will be inspected. Remove the PRA assembly according to the Shop Manual.

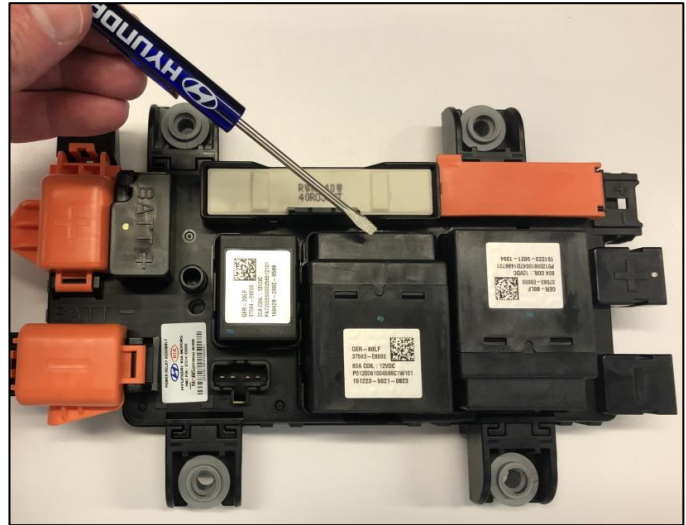
3. Spread the main relay hooks at the top and bottom of the relay using a flat head screwdriver.

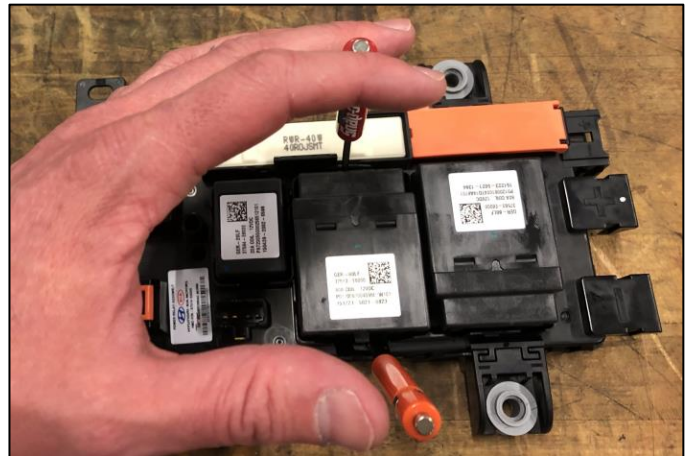
4. Insert screwdrivers between the PRA housing and main relay to hold and disengage the top and bottom hooks.

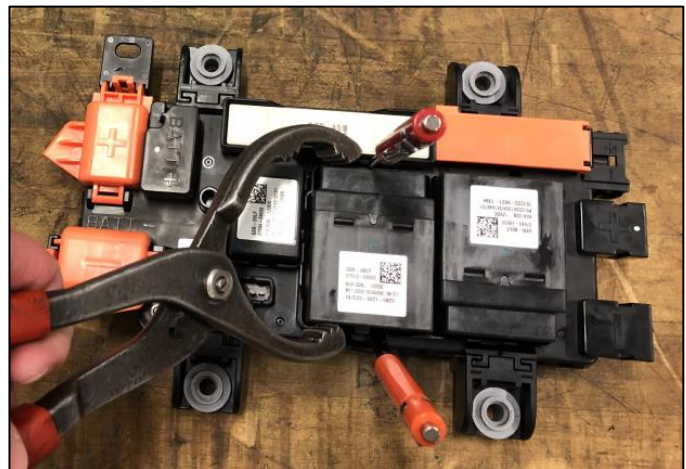
5. With the screwdrivers inserted remove the main relays with Oil Filter Pliers, Water Pump Pliers, or a similar tool.

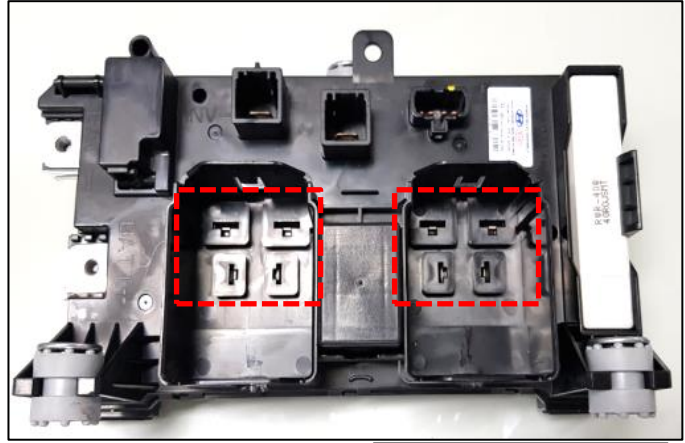
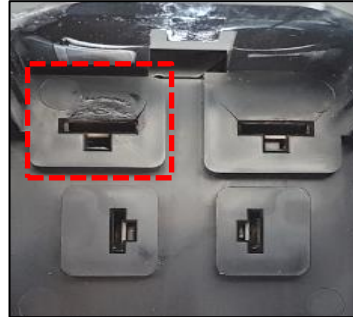
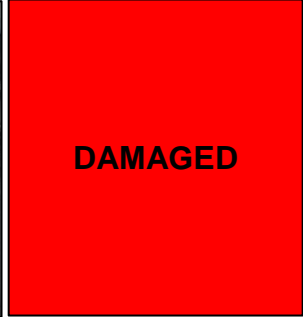
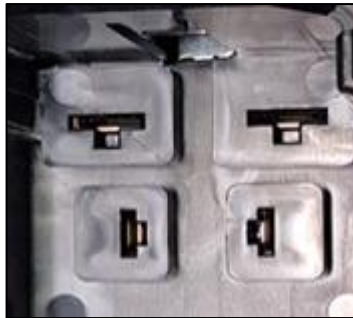
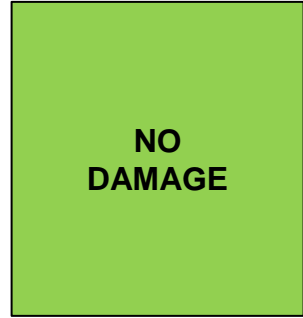
6. Inspect the PRA and main relays.

The specific location(s) and extent of damage can vary. If any damage is present, replace the PRA.

If either the PRA OR main relays are damaged: Replace the PRA according to the Shop Manual. The new PRA comes with new main relays preinstalled. Use **Labor Op Code: 90C058R1**

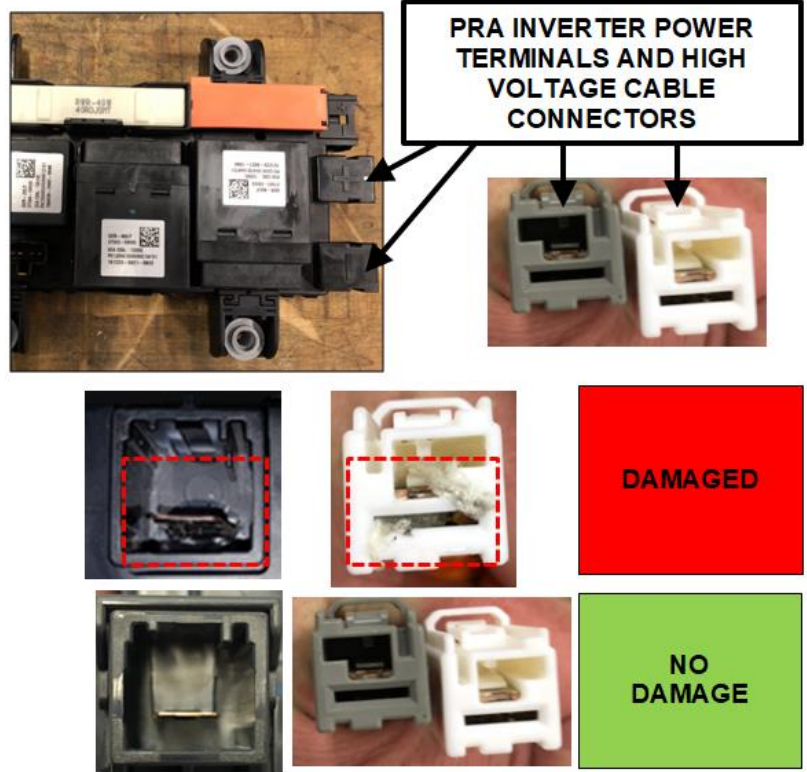
7. Inspect the PRA Inverter Power Terminals and High Voltage Cable connectors.

The specific location(s) and extent of damage can vary. If any damage is present, replace the High Voltage Cable and the PRA.

If either the terminals or connectors are damaged, replace the High Voltage Cable and the PRA if it was not replaced in step 6. Use **Labor Op Code: 90C058R2**
