# QUALITY ACTION

# CAMPAIGN BULLETIN

## Inside Rearview Mirror Dealer Inventory

Reference: PM937

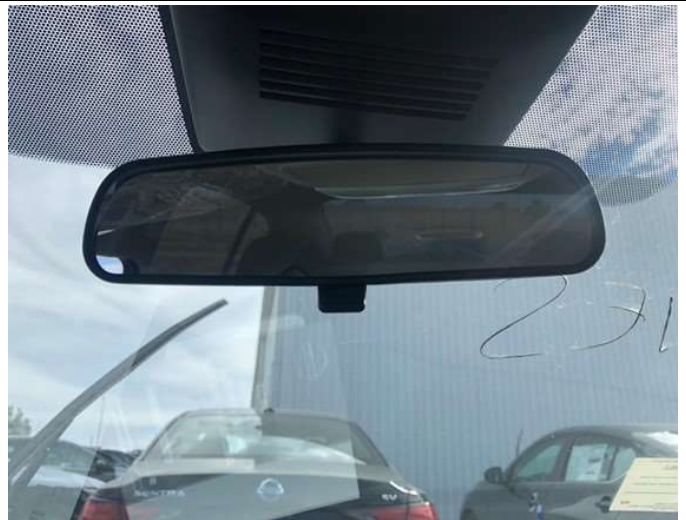
Figure 1

1. Locate the rear view mirror mounted to the windshield. (Figure 1)

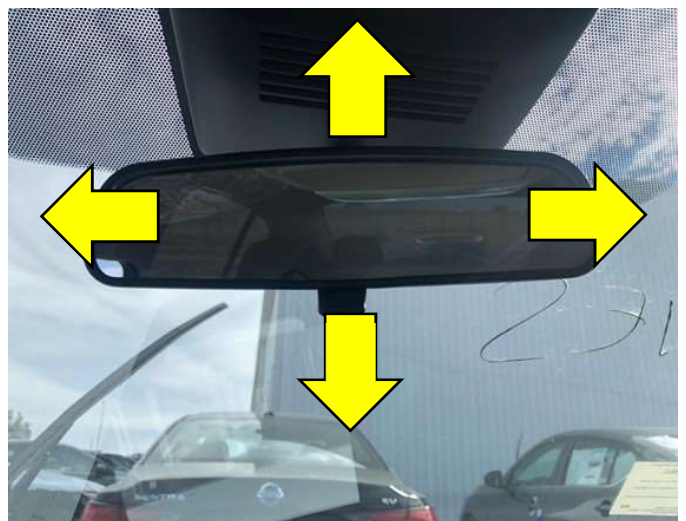
Figure 2

2. Confirm the rear view mirror is properly adhered to the windshield. (Figure 2)

**NOTE:** Do not use excessive force when performing this inspection procedure.

- a) Move the rear view mirror up until it reaches the stop.
- b) Move the rear view mirror down until it reaches the stop.
- c) Move the rear view mirror to the left until it reaches the stop.
- d) Move the rear view mirror to the right until it reaches the stop.
- e) Repeat the sub-steps a-d (10) additional times.

3. Did the rear view mirror and mounting plate become loose or detached from the windshield?
- **NO** - Inspection is complete, no further action is required
  - **YES** - Replace the windshield and aim the front camera unit using the procedure outlined in the ESM (***CRUISE CONTROL & DRIVER ASSISTANCE - DRIVER ASSISTANCE SYSTEM - DRIVER ASSISTANCE SYSTEM - BASIC INSPECTION - ADDITIONAL SERVICE WHEN REPLACING FRONT CAMERA UNIT***)
