REFERENCE:	Nova Bus Manuals
SECTION:	03: Windows
RS N°:	MQR 7621-1893
EFFECTIVE IN PROD.:	LC40 (2020FE)

SUBJECT:	Driver window
JUSTIFICATION:	The driver stationary and sliding glass can brake or crack

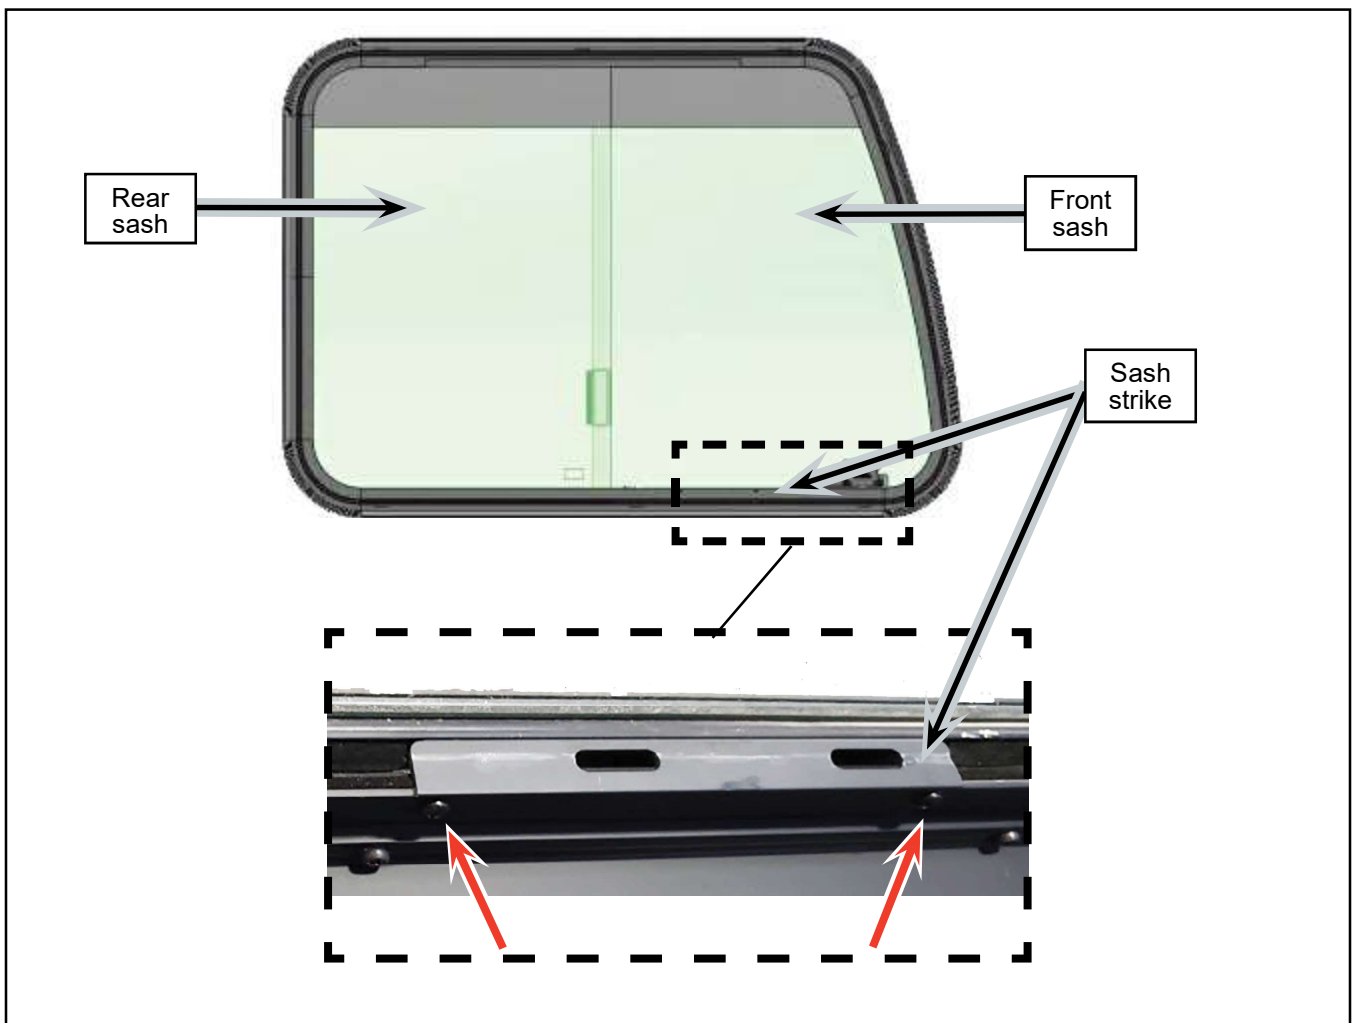
Figure 1 - Remove the Screws to Remove the Sash Strike (Your Configuration May Differ)

- 1.1. Remove the screws that secure the sash strike.

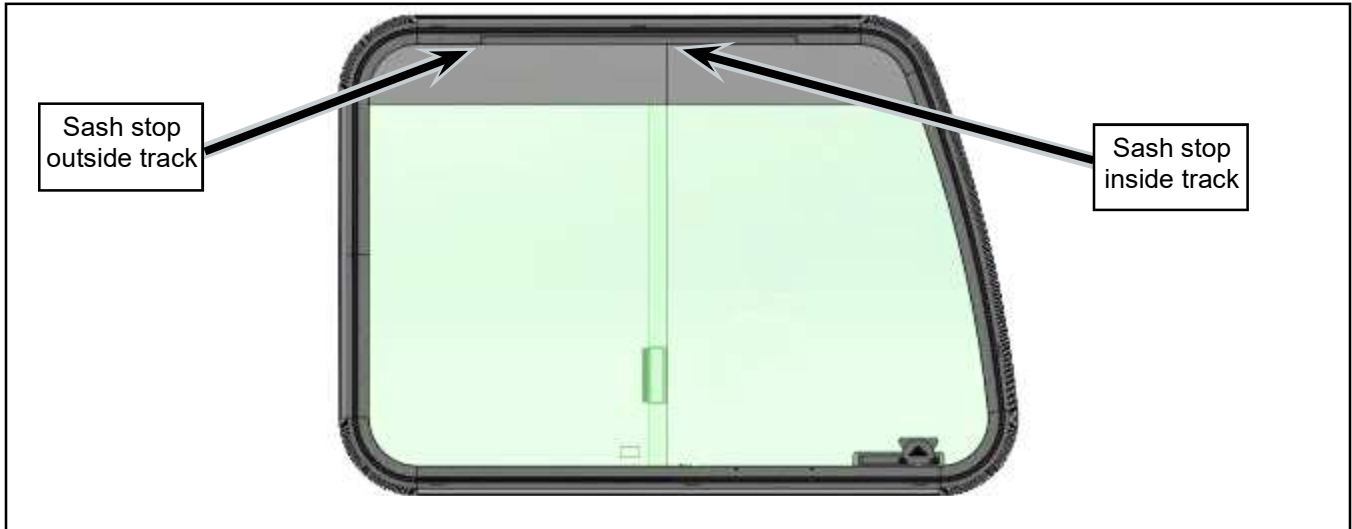
Figure 2 - Sash Stops Location

1.2. Remove and discard the two sash stops located on the inside and outside upper tracks.

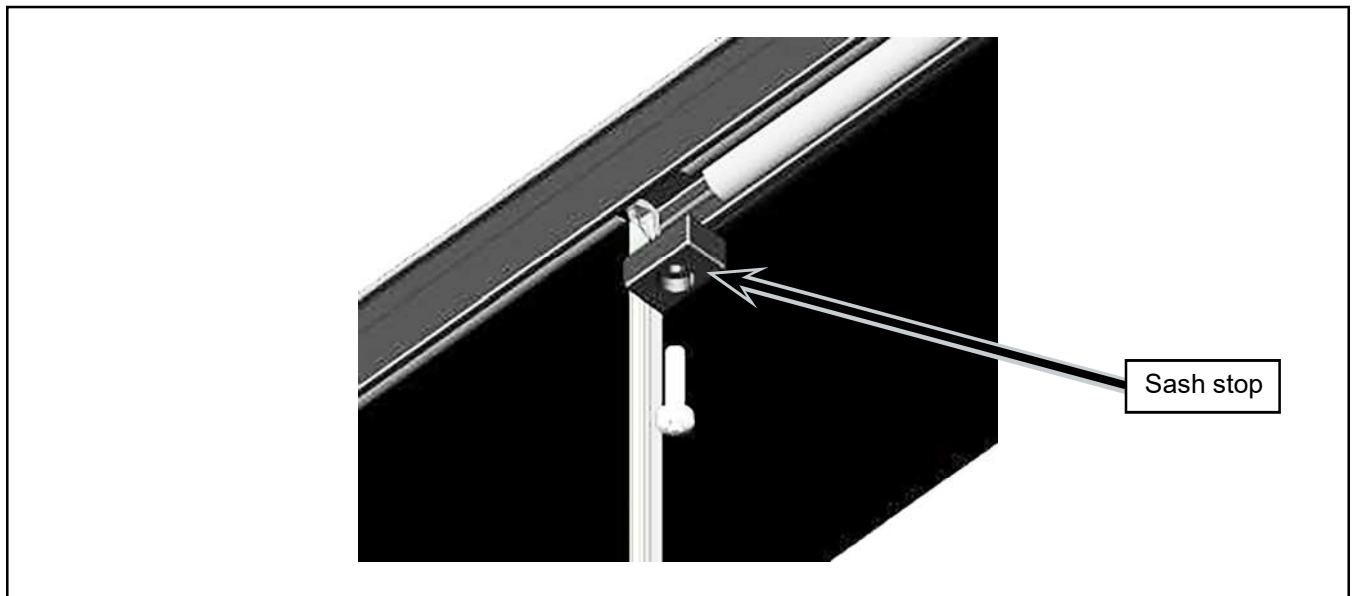
Figure 3 - Remove and Discard the Two Sash Stops (Only One Stop is Shown)

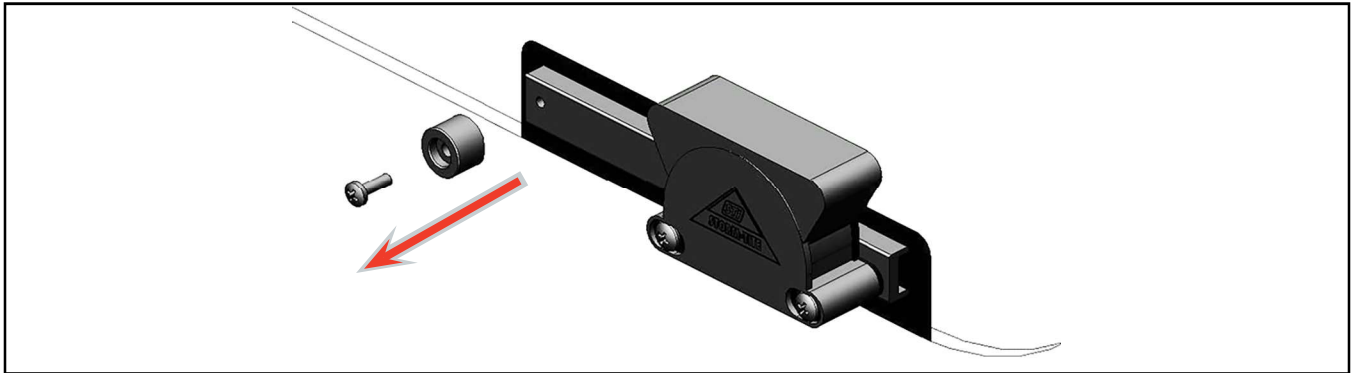
Figure 4 - Remove Round Sash Stop

1.3. Remove the round sash stop.

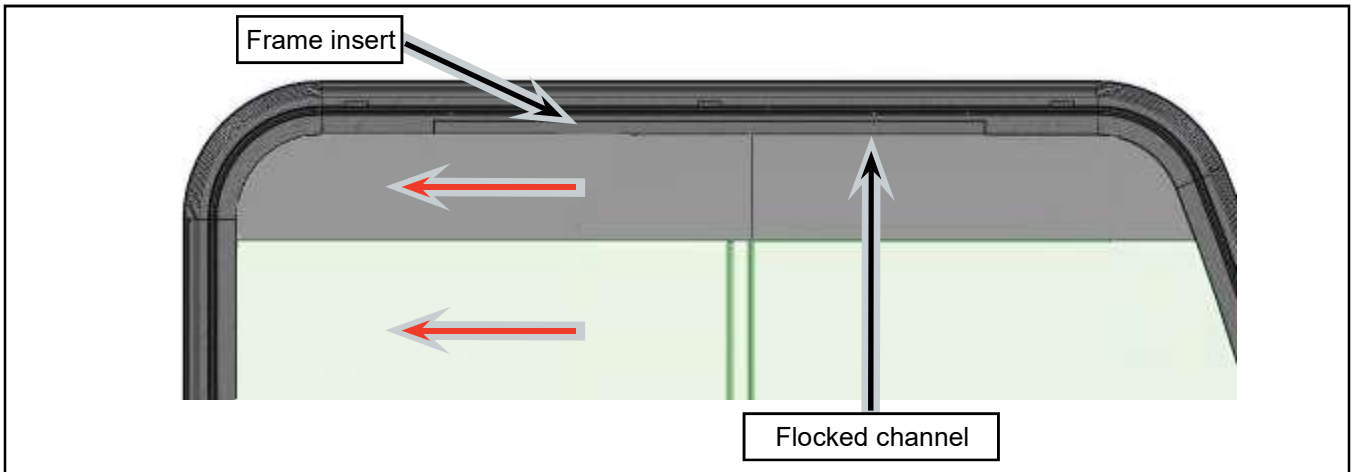
Figure 5 - Slide Back Rear Sash

1.4. Being inside the bus, slide back the rear sash. Locate the frame insert and the flocked channel.

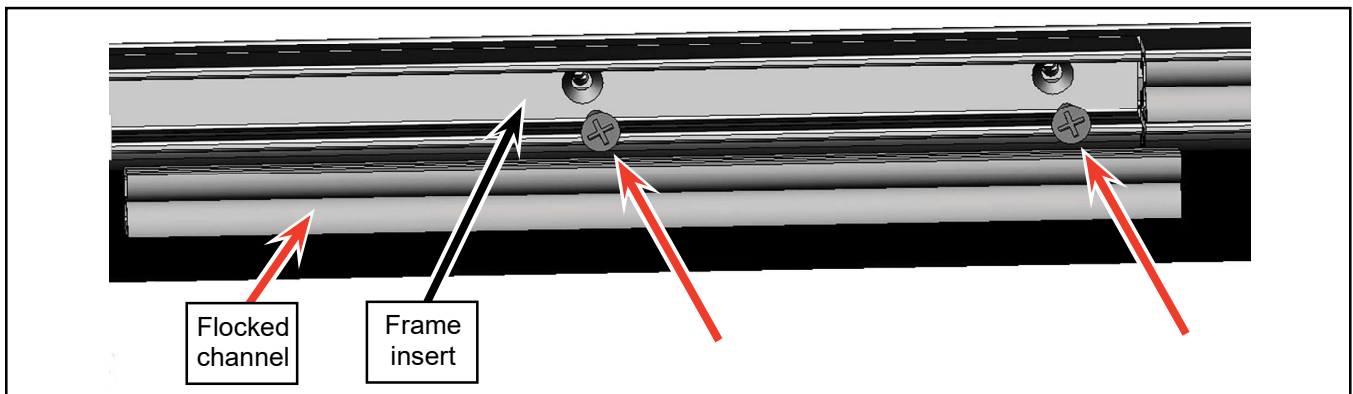
Figure 6 - Remove Flocked Channel and Screws

1.5. Remove the flocked channel to access the screws of the frame insert and remove them.

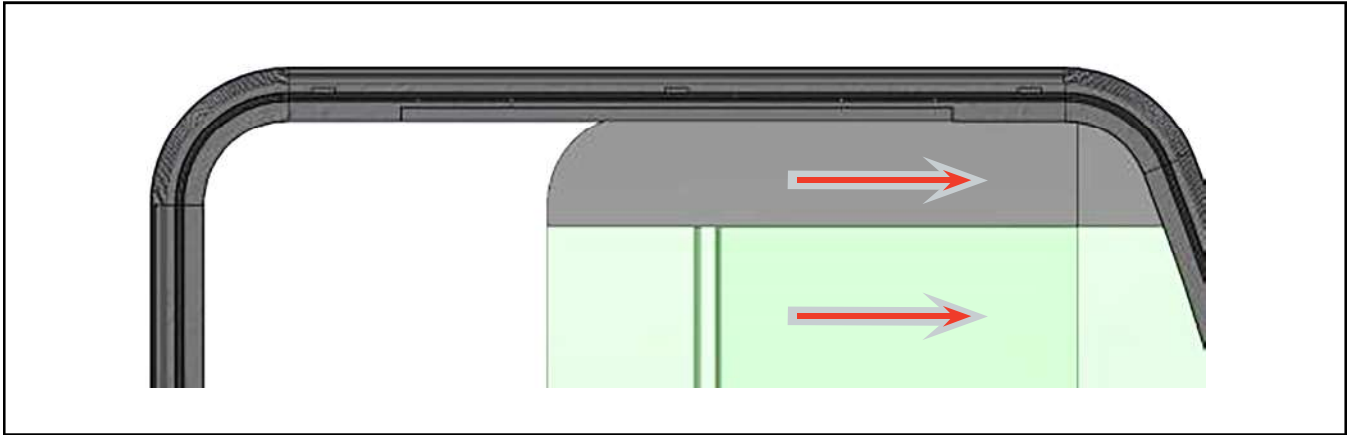
Figure 7 - Slide the Rear Sash Forward

1.6. Slide the rear sash forward.

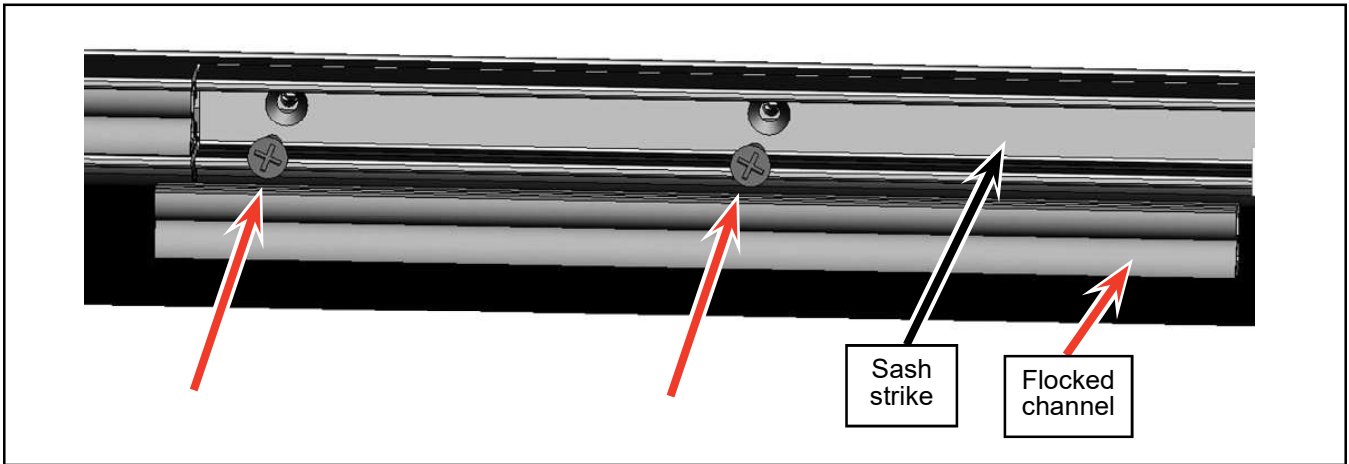
Figure 8 - Remove Flocked Channel and Screws

1.7. Remove the flocked channel to access the other half section of the frame insert. Remove the two screws.

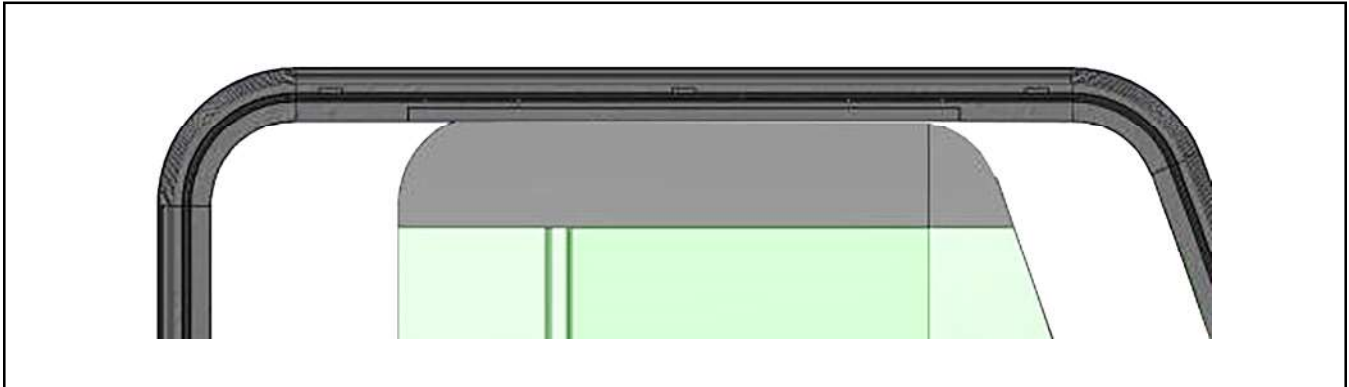
Figure 9 - Slide Sashes in the Middle of the Frame Insert

- 1.8. Slide the both sashes to position them in the middle of the frame insert.

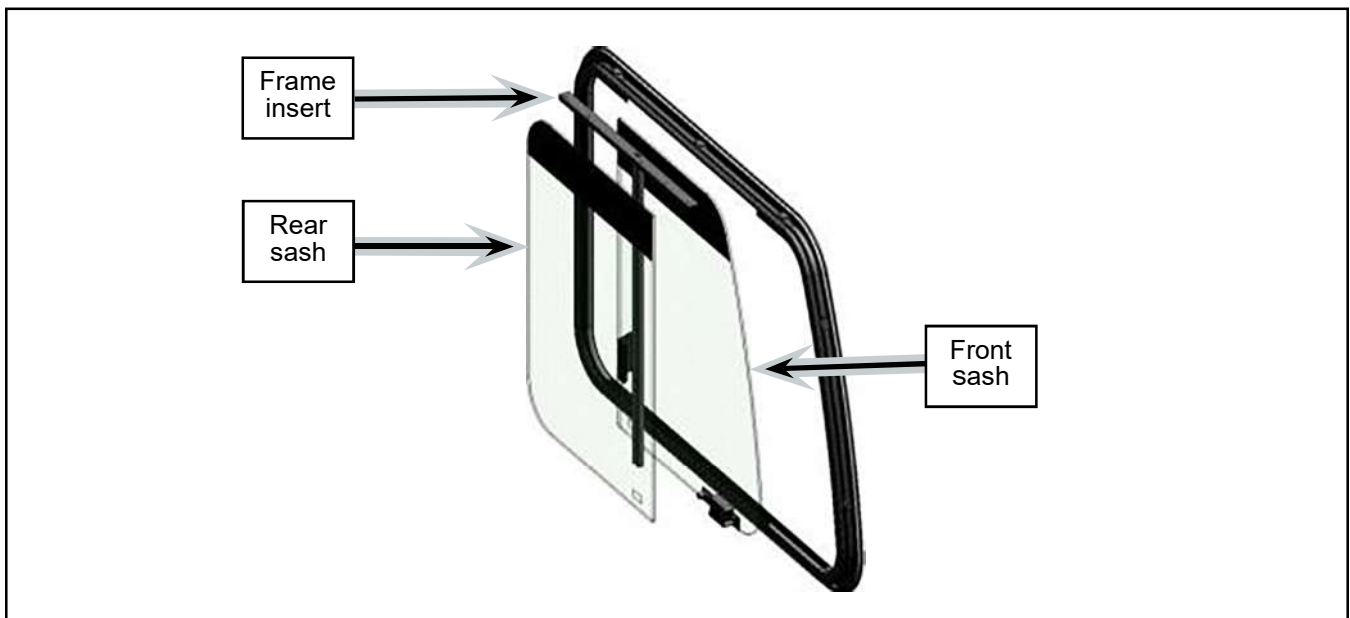
Figure 10 - Remove Rear Sash with Frame Insert, then Front Sash

- 1.9. Carefully remove the rear sash and frame insert as one unit by grasping the edges as close to the top as possible and gently pulling towards the interior of the bus. Then remove the front sash to secure it.

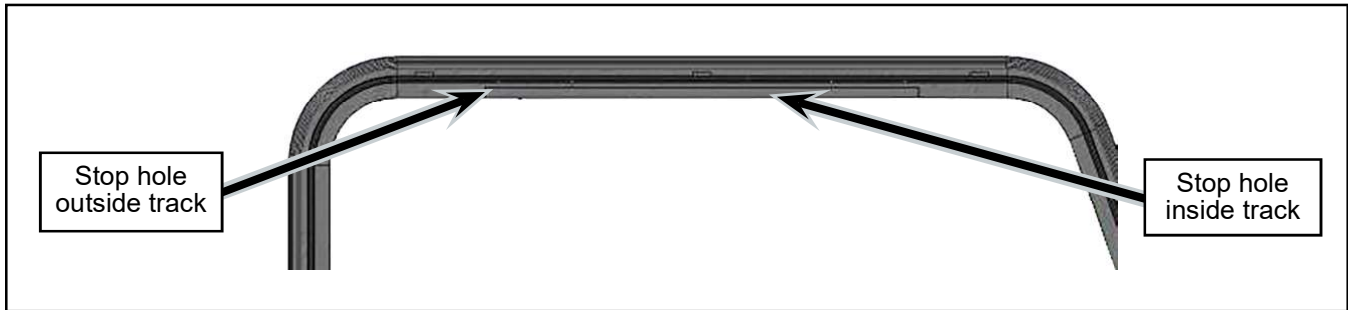
Figure 11 - Seal two Holes

1.10. Seal the two holes created by removing the sash stops at step 1.2 with Butyl 757 (N32989) or equivalent.

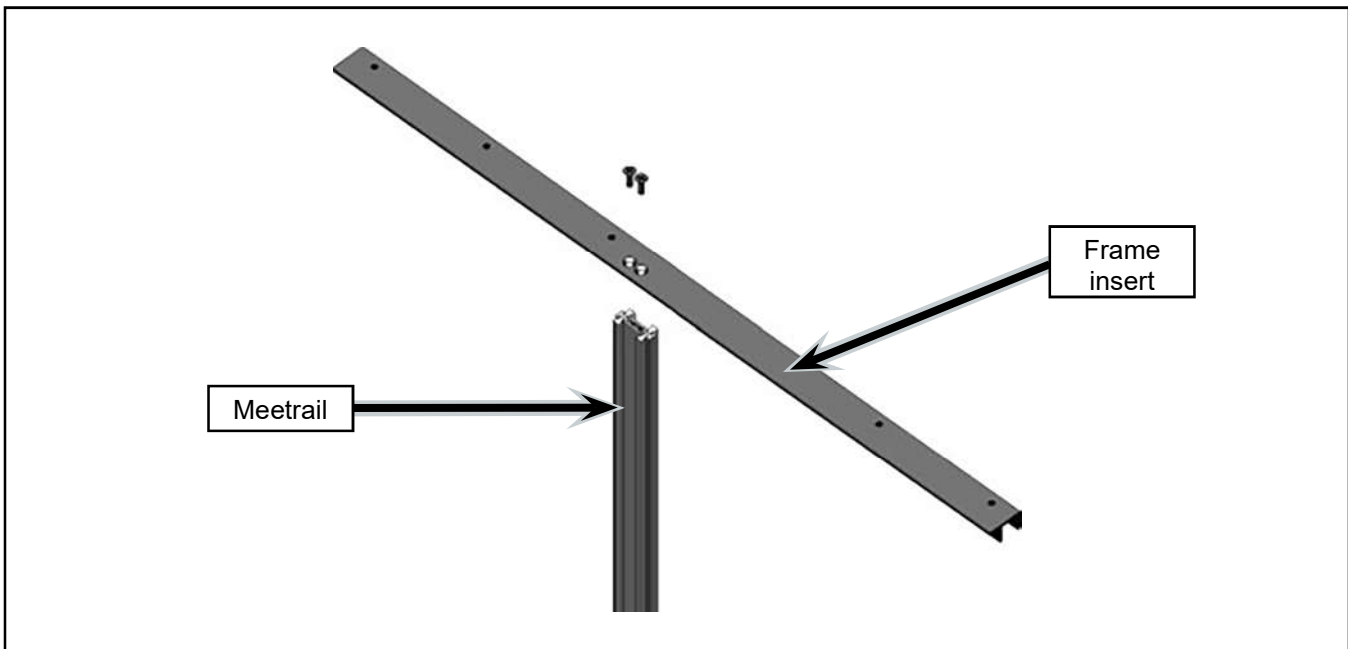
Figure 12 - Remove and Discard meetrail and Fasteners

1.11. Remove the two fasteners holding the current meetrail to the frame insert. Discard meetrail and fasteners.

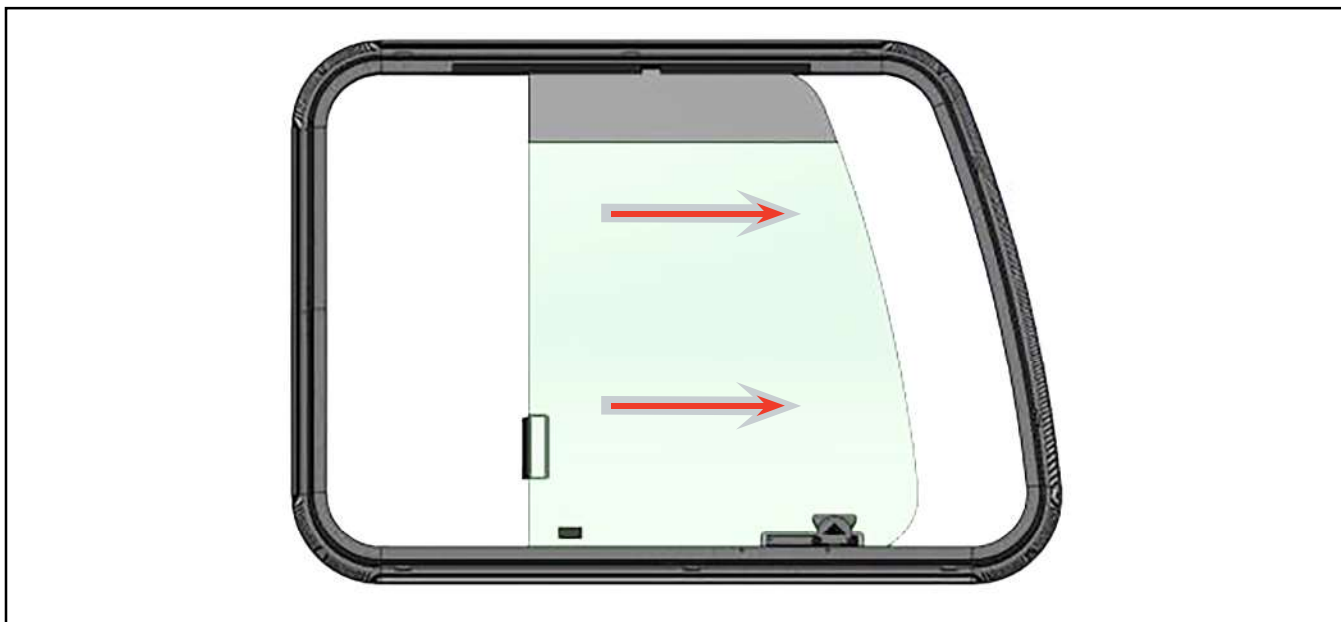
Figure 13 - Install Front Sash and Slide in Close Position

- 1.12. Reinstall the front sash by inserting the sash in the bottom outside track. Tilt the sash into the correct position within the frame insert opening. Then slide the sash forward the bus in close position.

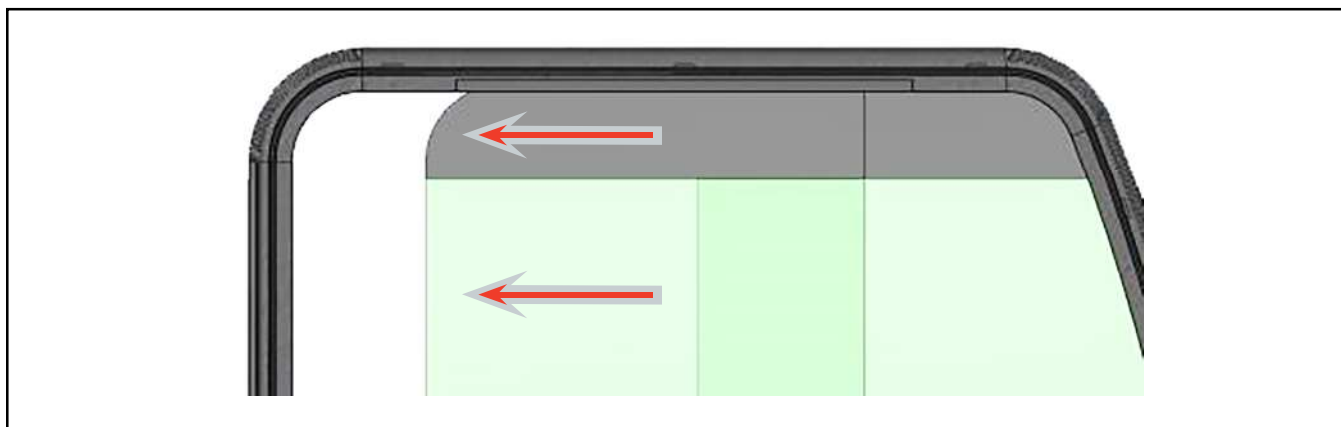
Figure 14 - Install Rear Sash and Slide in Close Position

- 1.13. Place the frame insert on top of the rear sash.
1.14. Insert the sash in the bottom inside track. Tilt the sash into the correct position within the frame insert opening. Then slide the rear sash backward the bus in close position.

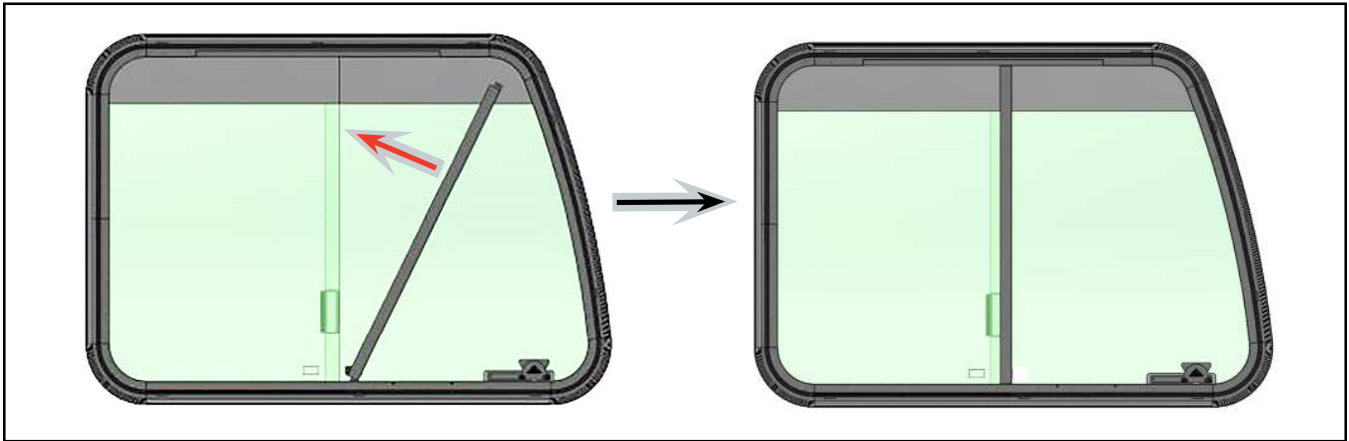
Figure 15 - Install Mullion

- 1.16. Install the mullion on the rear sash by inserting the milled end of the mullion into the lower track and rotation the top so it lines up the upper track.

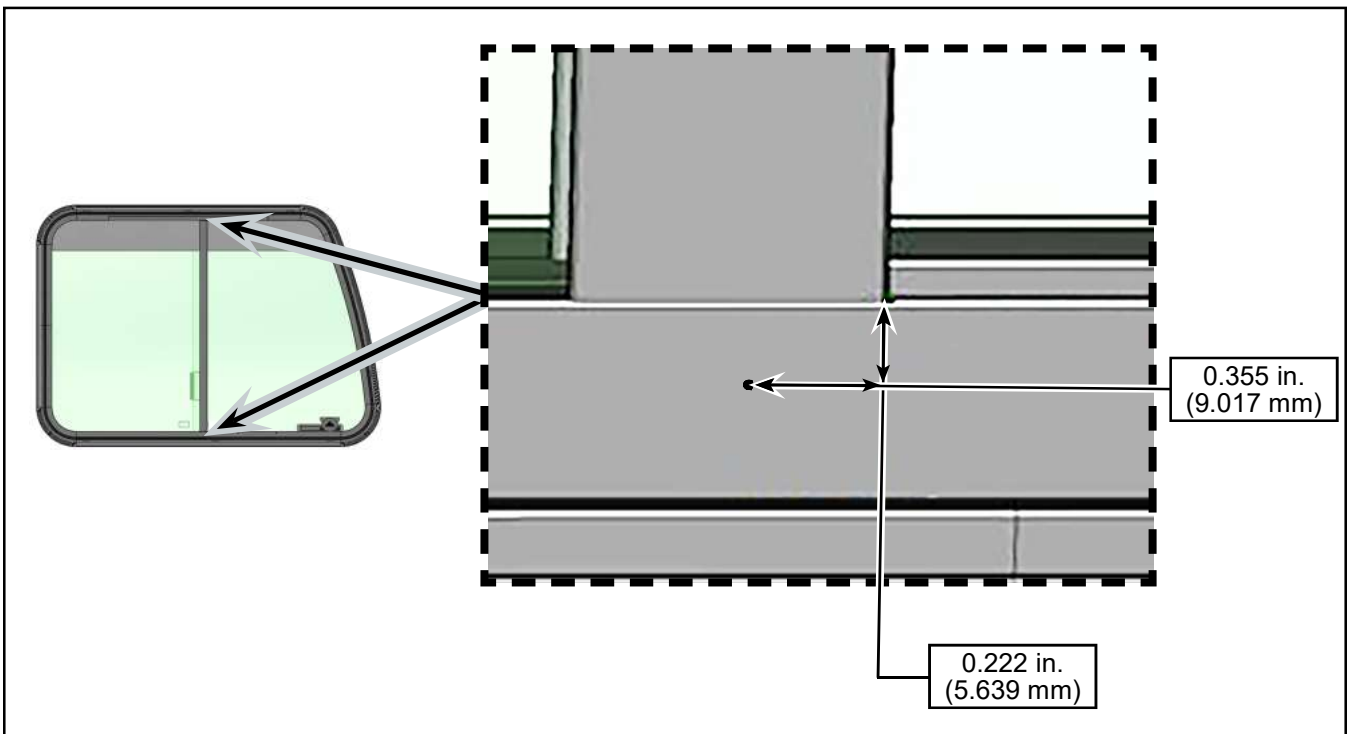
Figure 16 - Mark Clearance Hole Locations (Only Bottom One is Shown)

- 1.17. With the mullion well seated on the rear sash, mark the top and bottom clearance hole locations. Use the dimensions show in Figure 16 for both holes.

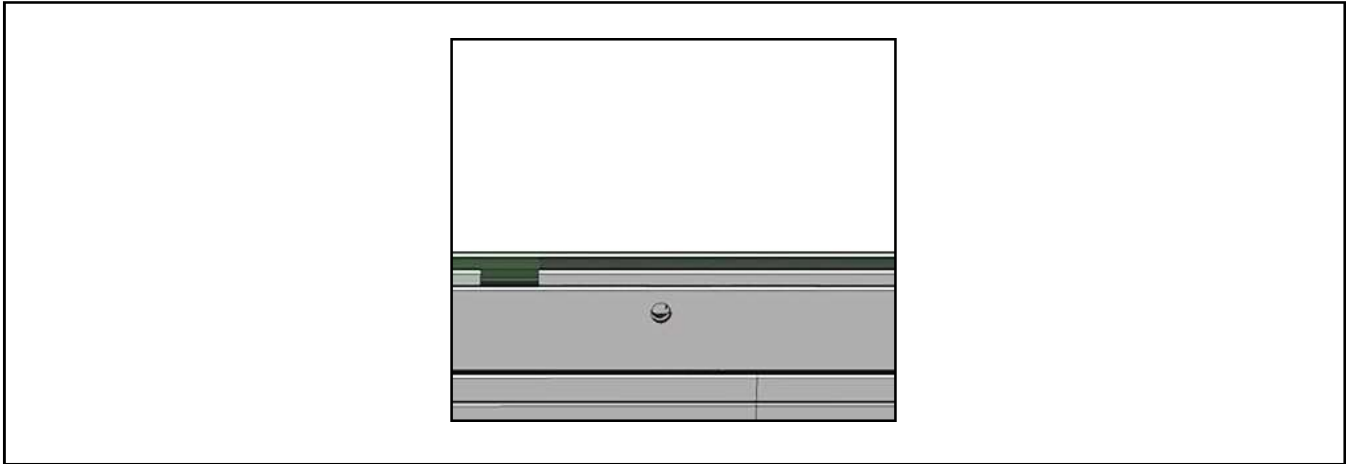
Figure 17 - Drill Clearance Hole thru First Wall (Only Bottom Hole is Shown)

- 1.18. Remove the mullion the same way that it was installed.
- 1.19. Drill the two marked locations with a #18 drill bit by taking care to drill only thru the first leg (wall) extrusion.

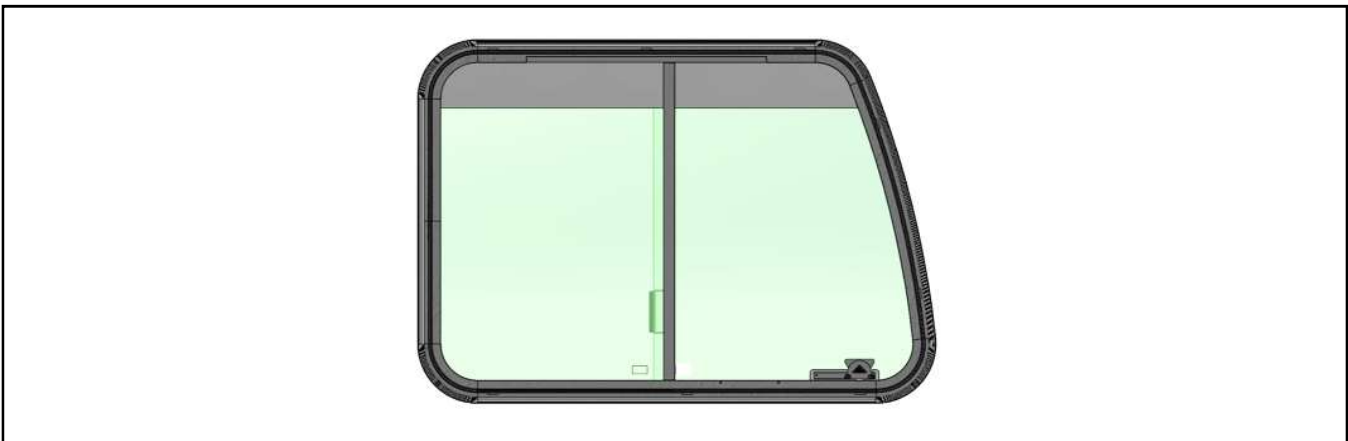
Figure 18 - Final Result

- 1.20. Reinstall the mullion and secure with the screws (N8907815) in the holes drilled in step 1.19.
- 1.21. Reinstall the round sash stop removed in step 1.3.
- 1.22. Reinstall the sash strike removed in step 1.1.
- 1.23. The vehicle can return in service. ❖
