BULLETIN NUMBER:
SB20-H-001

DTC P0027 AIR DRYER LINE REROUTING

AFFECTED VEHICLES

- 2018-2019 MY Isuzu FTR vehicles
Produced prior to January 2, 2019

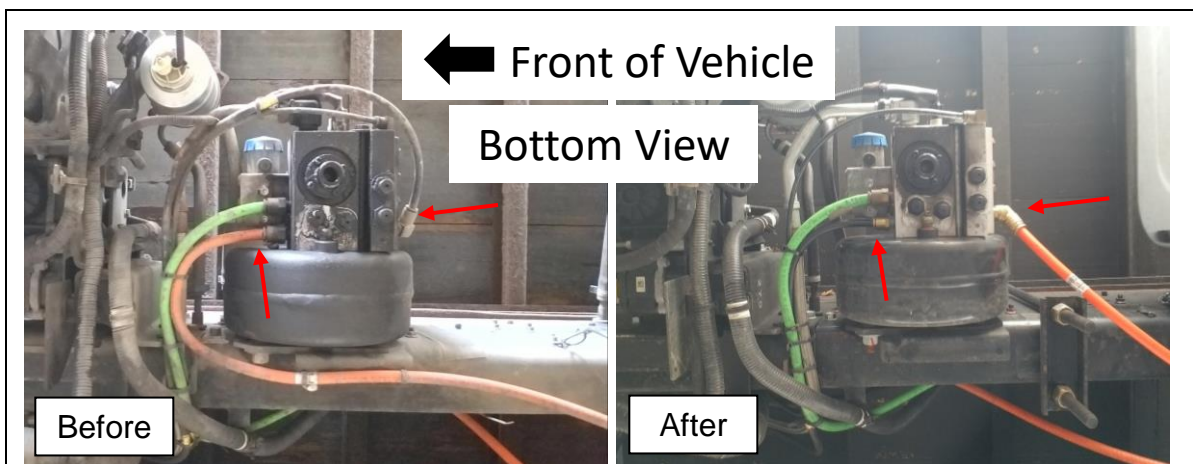
Figure 1 – Before and After Rerouting Air Dryer Lines

If DTC P0027 continues to set even though there are no air system leaks that may be quickly depleting the air supply or causing delays in the buildup of air pressure and the exhaust brake is functioning properly, follow the service procedure in this bulletin to reroute air dryer lines for improved air support to the exhaust brake.

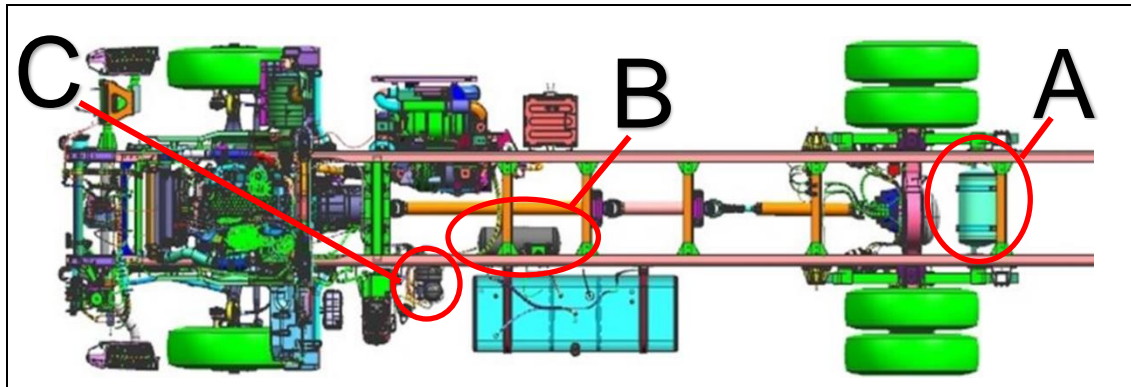
Figure 2

- A. Primary reservoir
- B. Secondary reservoir
- C. Air Dryer

2. Drain air from the air brake system (see Figure 2) by pulling the lanyards, as shown in Figure 3, on the primary and secondary air reservoirs until system is completely empty.

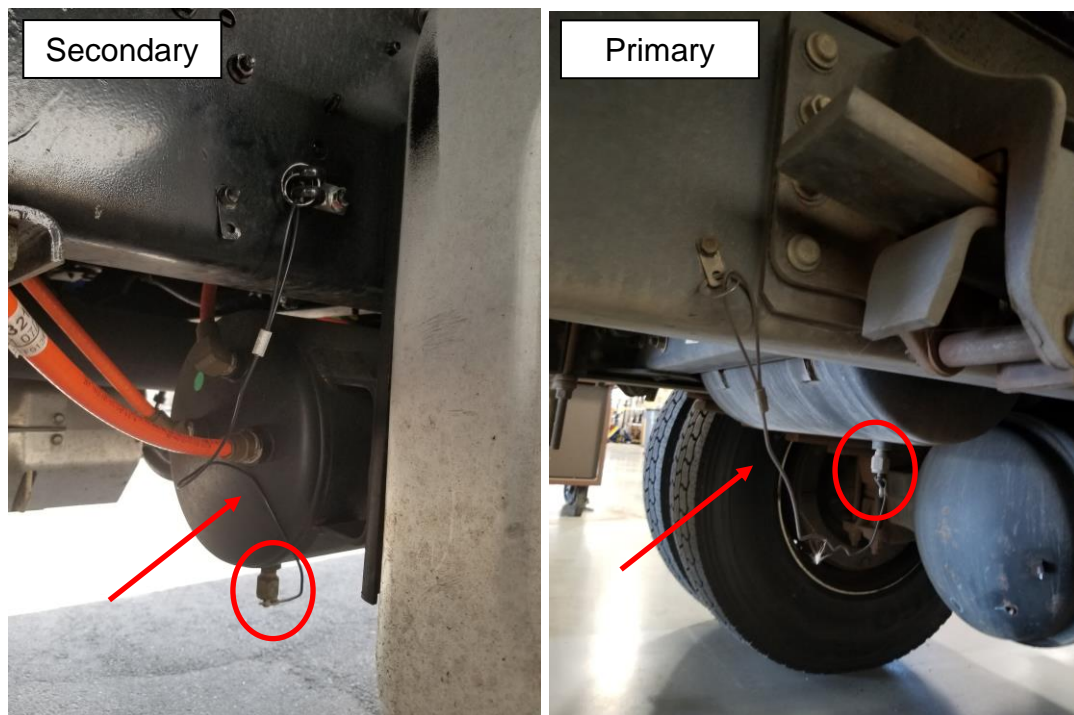
Figure 3

- A. Arrow points to lanyard.
- B. Circle shows reservoir drain valve.

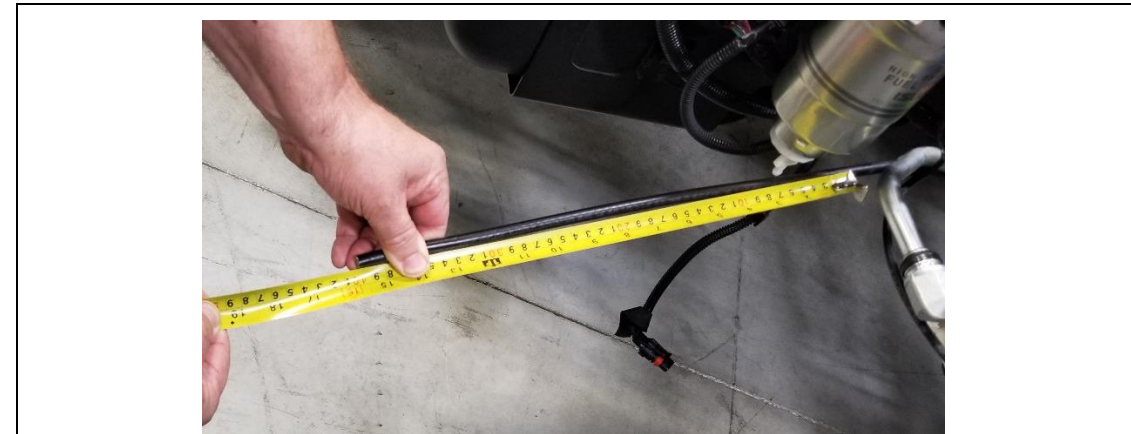
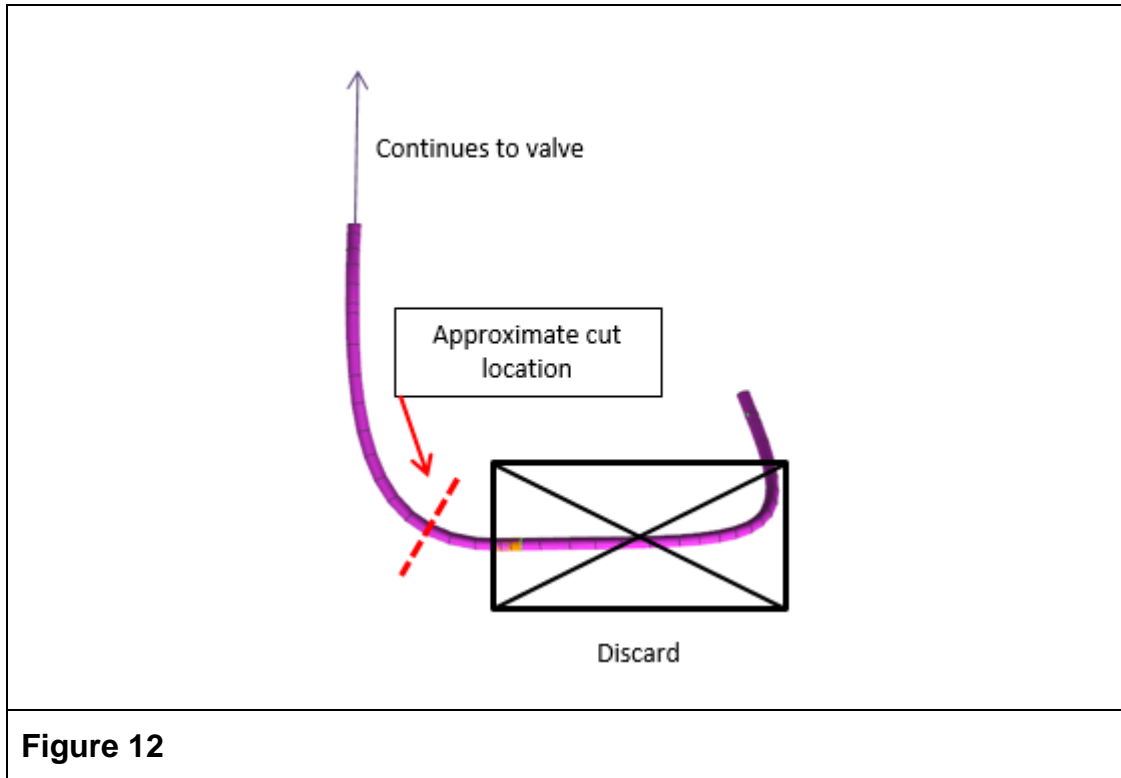
Figure 11 – Dryer harness disconnected solely for purposes of this photo

11. With a marker, mark and cut the 3/8 inch line to 400mm as measured from end that connects to the dryer. (See Figures 11 and 12.)

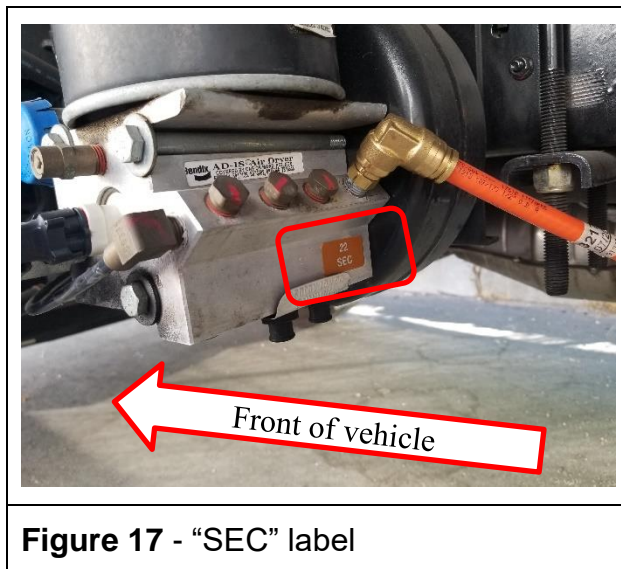
Figure 17 - “SEC” label

18. Using brake cleaner, clean the locations where new identification labels will be mounted, as shown by red rectangles in Figures 17 and 18.

19. Affix new labels to air dryer. Place “SEC” label over “AUX2” marking. (See Figure 17.) Place “AUX2” label over “SEC” marking. (See Figure 18.)

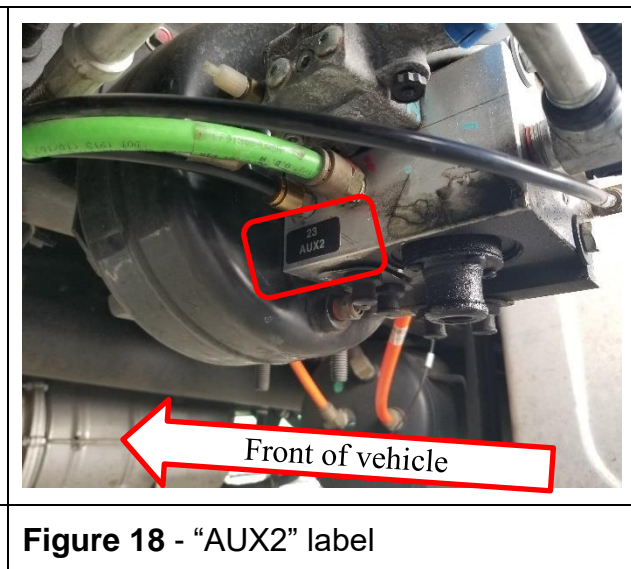
Figure 18 - “AUX2” label
