## REMOVAL - PULLOUT COUNTER TOP EXTENSION

<b>Bulletin Type:</b>	INC	<b>Publication Date:</b>	March 2020
<b>Bulletin #(s):</b>	20-007	<b>Make(s):</b>	EMBARK, REATTA, ENTEGR A COACH
<b>Job Code(s):</b>	N/A	<b>Model(s):</b>	VARIOUS
<b>Flat Rate(s):</b>	N/A	<b>Model Year(s):</b>	MY2009 TO 2021

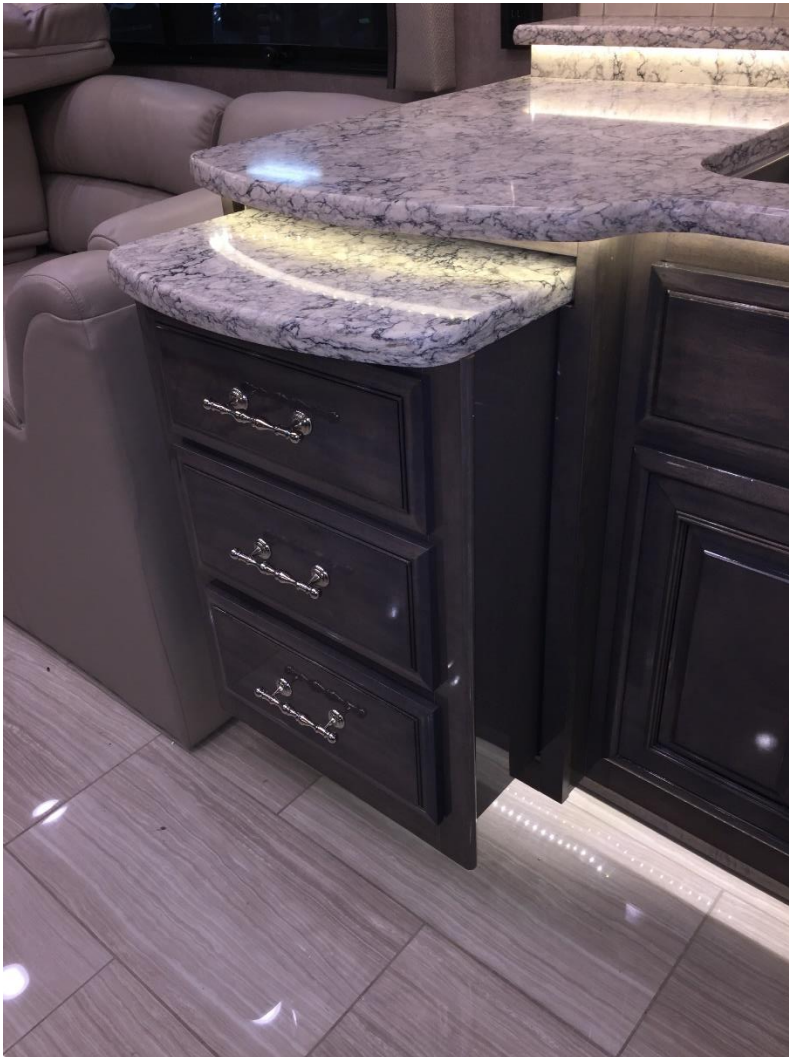
1. The pullout counter top extension can be removed by accessing the screws under the bottom third drawer.
2. Remove as many of the pullout drawers as necessary to remove the screws inside the bottom of the cabinet securing the cabinet to the metal sliding plate.

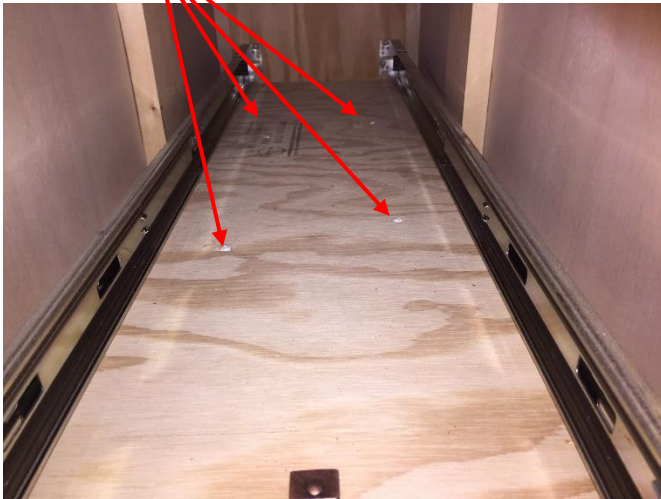
3. Remove the screws at the bottom of the cabinet securing the cabinet to the metal sliding plate.

View from inside the cabinet with drawer removed.

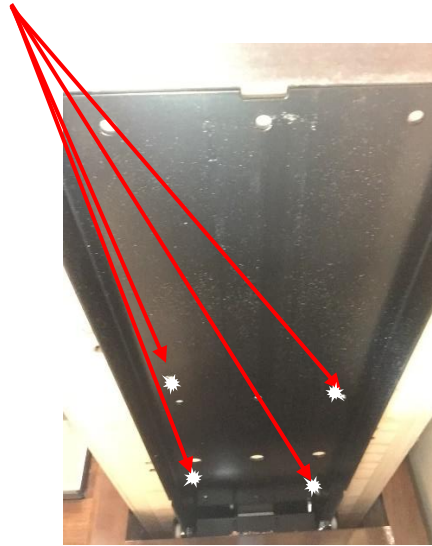
View from under the cabinet.
