Service Bulletin

Bulletin No.: 17-NA-233

Subject: Malfunction Indicator Lamp (MIL) Illuminated - DTC P0446 Set

Brand:	Model:	Model Year:		VIN:		Engine:	Transmission:
		from	to	from	to		
Chevrolet	Cruze	2016	2019			1.4L (LE2)

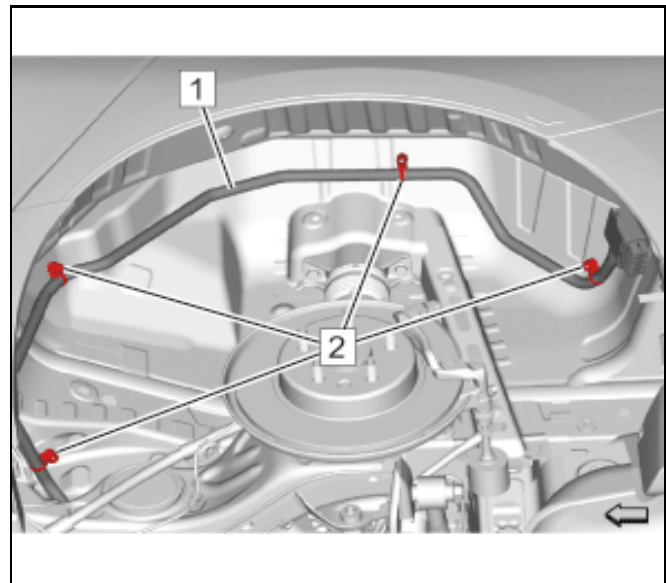
4224572

3. Using care, separate the evaporative emission canister filter pipe assembly retainers (2) from the vehicle and remove the assembly.

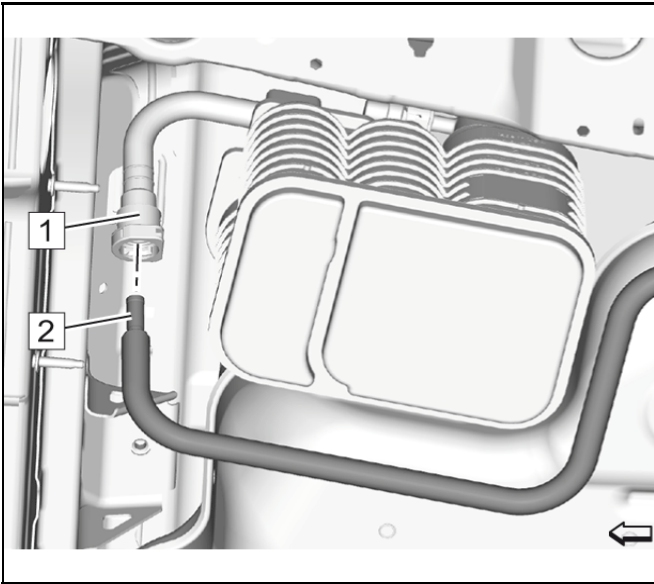
4553983

4. Disconnect the evaporative emission canister filter pipe (2) from the evaporative emission canister (1). Refer to *Plastic Collar Quick Connect Fitting Service* in SI.

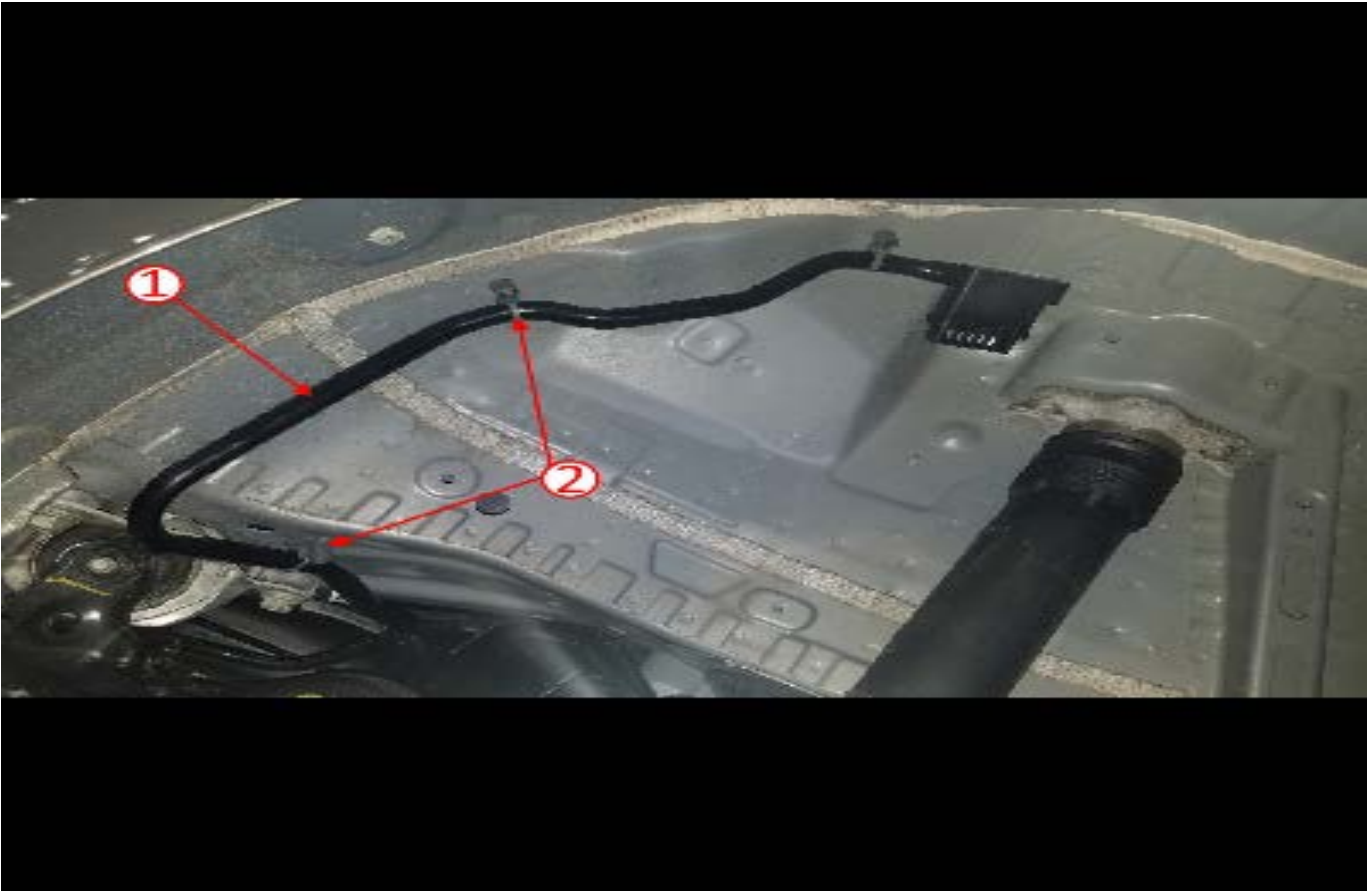
5443181

5. Install the new evaporative emission canister filter pipe (1), attaching the two lower clips to the existing studs (2).
6. Connect the evaporative emission canister filter pipe to the evaporative emission canister.

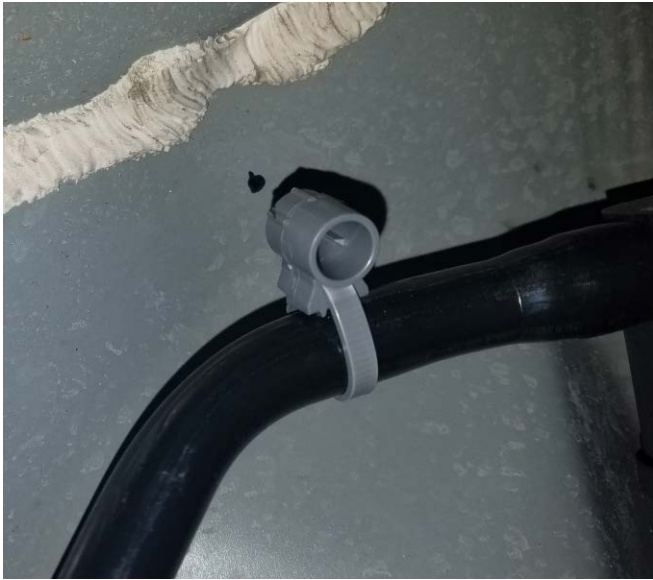
5253461

7. With the evaporative emission canister filter pipe lower clips connected and the vent assembly in its relaxed position, make a mark on the panel for a new stud location for the upper clip.

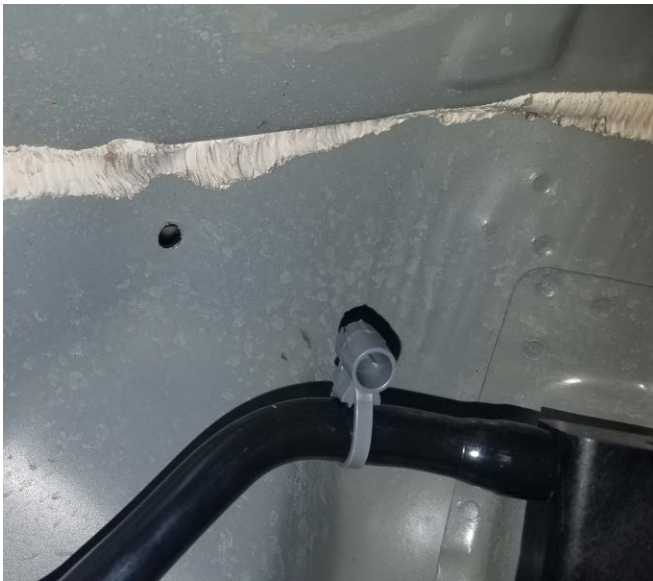
5253466

8. Using a 9/32 inch drill bit, drill a hole at the mark previously made.

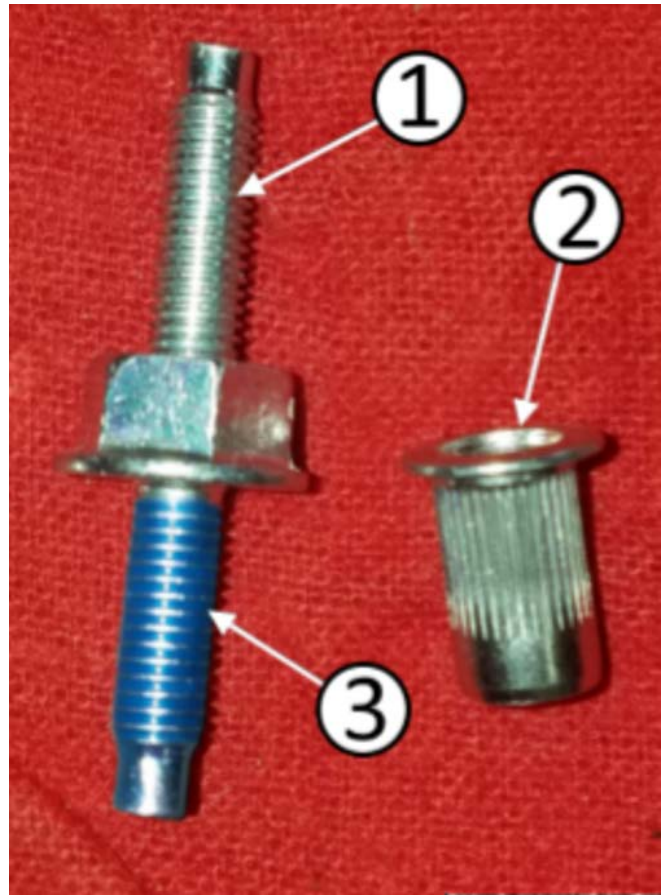
5279333

9. Add blue Loc-Tite® (3), or equivalent, to the threads of the stud (1) as shown above.
10. Using care, install the 5 mm retaining rivet (2) into the wheelhouse panel with a rivet nut installation tool.

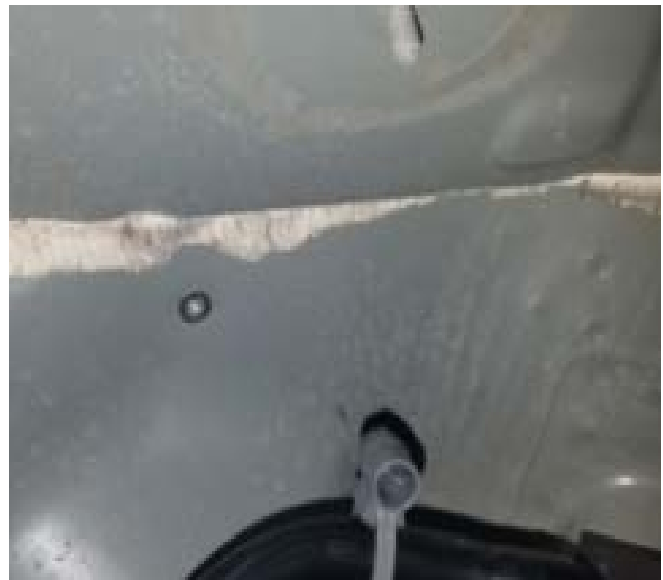
5278656

11. Crimp the Riv-nut until secure.

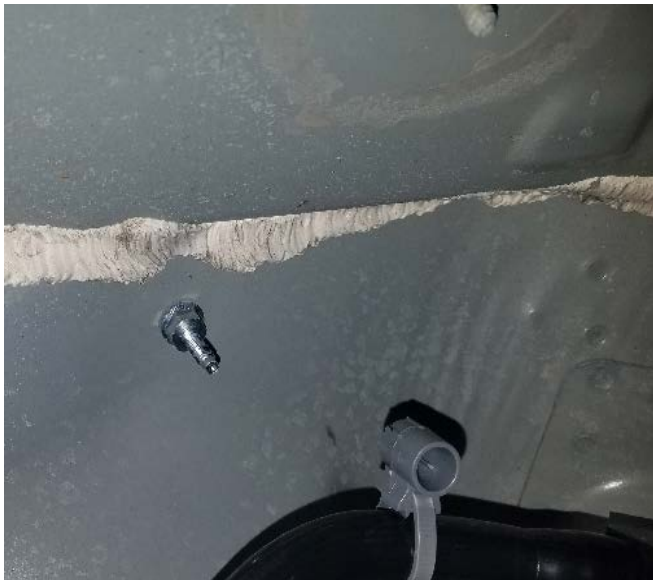
5280638

12. Install the stud into the nut.

Tighten the nut to 10 lb in.

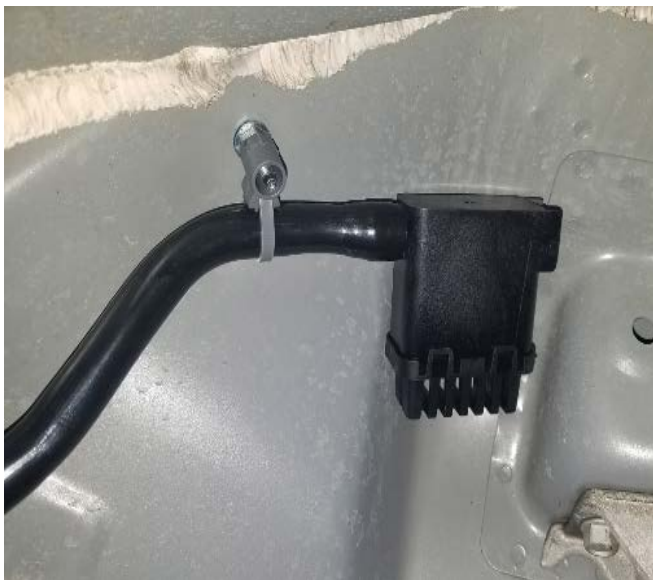
5279451

13. Install the filter pipe clip to the stud.
