Tech Tip T-TT-0528-19

Clad Wheel Finish Peeling Off/Bubbling

2014-2020 Highlander/HV

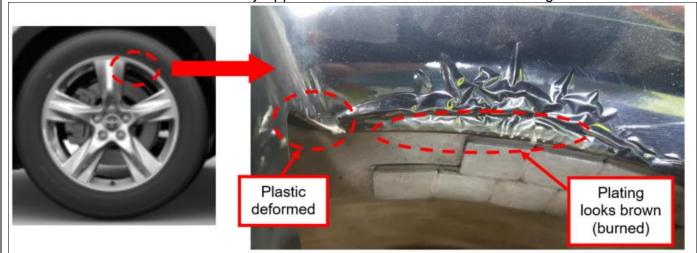
Some 2014-2020 model year Highlander and Highlander HV vehicles are equipped with alloy wheels that are clad with a plastic cover. Use of a heat gun to facilitate removal of stick-on wheel weights may damage the coating on the cladding and cause it bubble and/or peel off (see picture below).

Do not utilize any heat tool to remove stick-on wheel weights with part numbers listed in the table above.
