## STAR ONLINE PUBLICATION

**Case Number:** S1823000053

**Symptom/Vehicle Issue:** Water Leak On Floor Near A Pillar

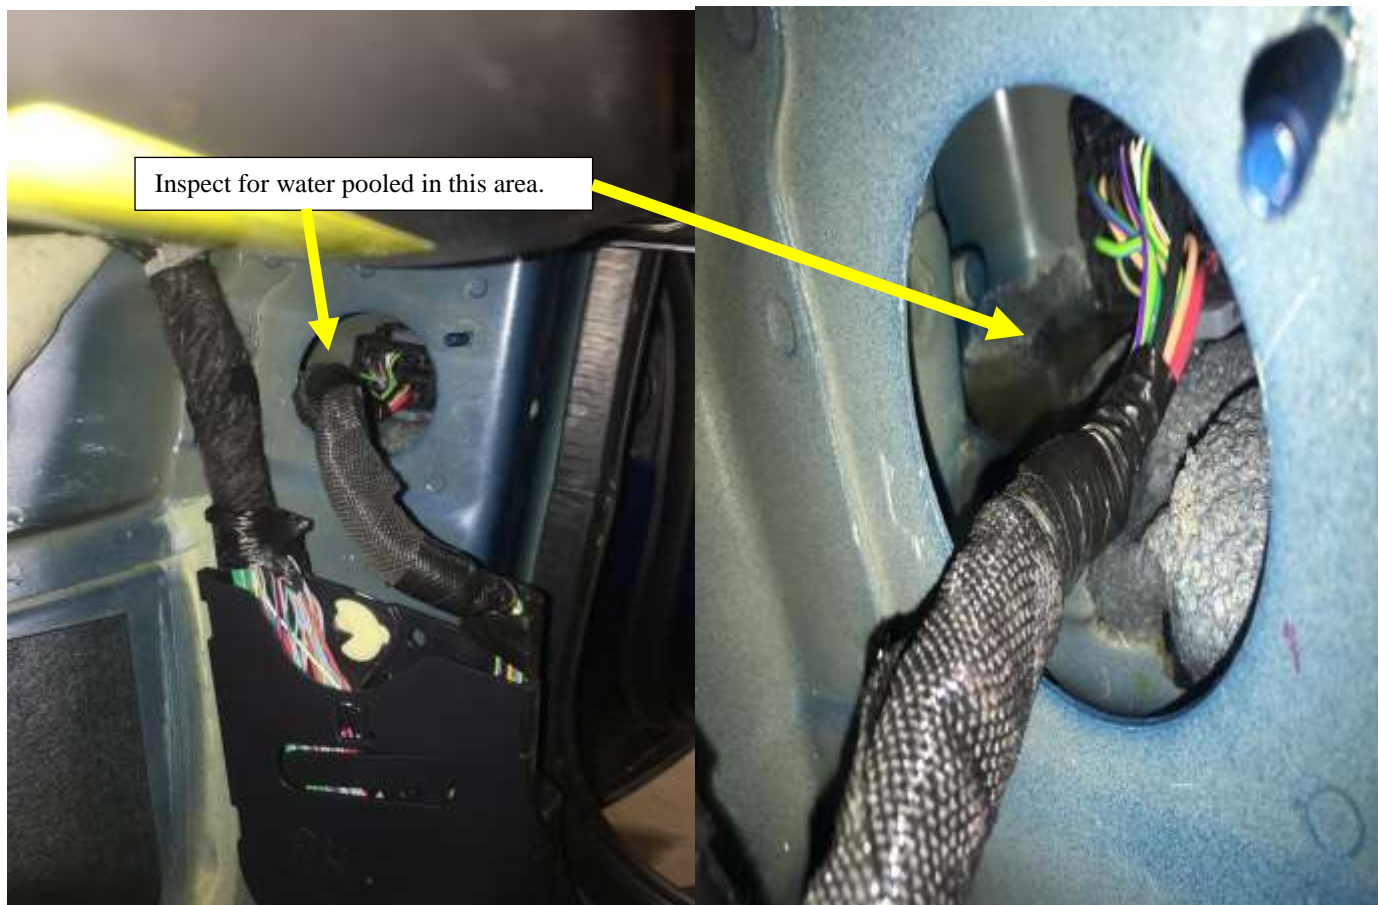
Fig 1

View of a pillar from inside the vehicle with trim kick panel removed. Inspect in the wire pass through for water pooling. If water is found, continue to next step.

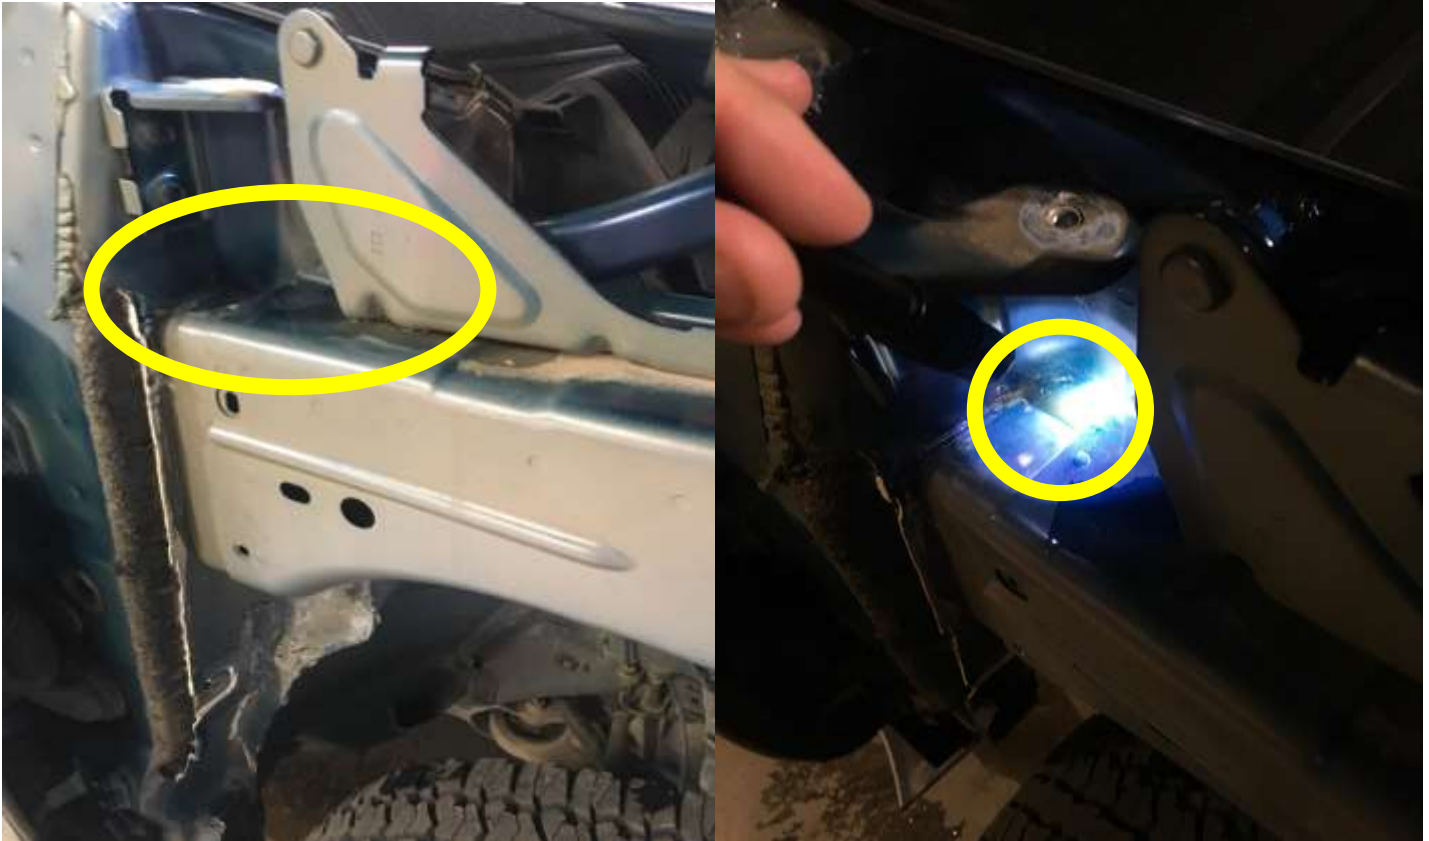
Fig 2

**Area of possible leak. Right A Pillar with fender removed for accessibility**

Fig 2- Hole in sealer allowing water to enter body. Reseal the area using a seam sealer such as Kent Products High-tech clear seam sealer p10200 or equivalent. Follow sealer manufacture's application and cure instructions.

**Verification:** Water leak test by using a garden hose with open flow (no nozzle) applied to the upper windshield/roof. Allow the water to cascade down and shed off the vehicle. Monitor the interior using a bright flashlight and inspect the pillar area (de trim as needed).
