# Technical Service Bulletin

## 69 Front seat belt is twisted

69 20 49 2058455/2 April 1, 2020. Supersedes Technical Service Bulletin Group 69 number 20-47 dated February 6, 2020 for reasons listed below.

Model(s)	Year	VIN Range	Vehicle-Specific Equipment
A6, A7, A8, Q8, and Audi e-tron quattro	2019 - 2020	All	Not Applicable

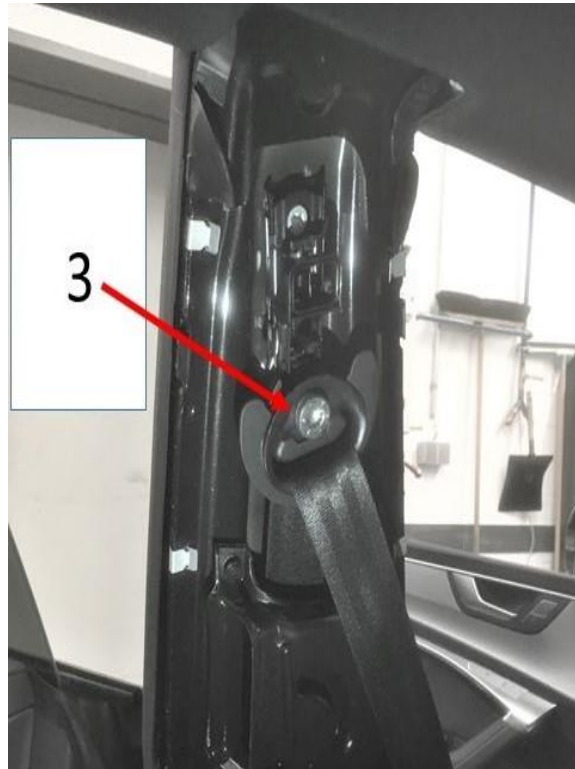
**Figure 1.** Seat belt deflector at height adjuster with B-Pillar trim removed.

1. Remove the upper B-Pillar trim on the affected side according to the repair manual.
2. Remove the bolt of the seat belt deflector (Figure 1, Pos. 3).

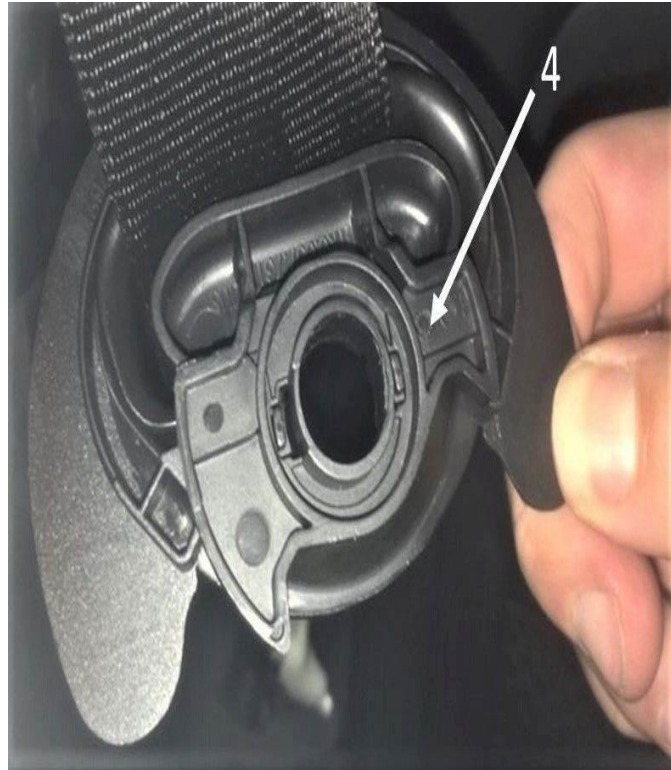
**Figure 2.** Backside of seat belt deflector. Deflector trim tabs engaged in old belt guide.

3. Use your thumb to remove the old belt guide (plastic part) from the steel deflector. Start by detaching the guide from the bolt hole, then press out the lower section covering the metal tab (Figures 2 and 3).

5. Install the modified belt guide 4K8 857 799 on the front driver side and 4K8 857 800 on the front passenger side (Figure 2, Pos. 4).

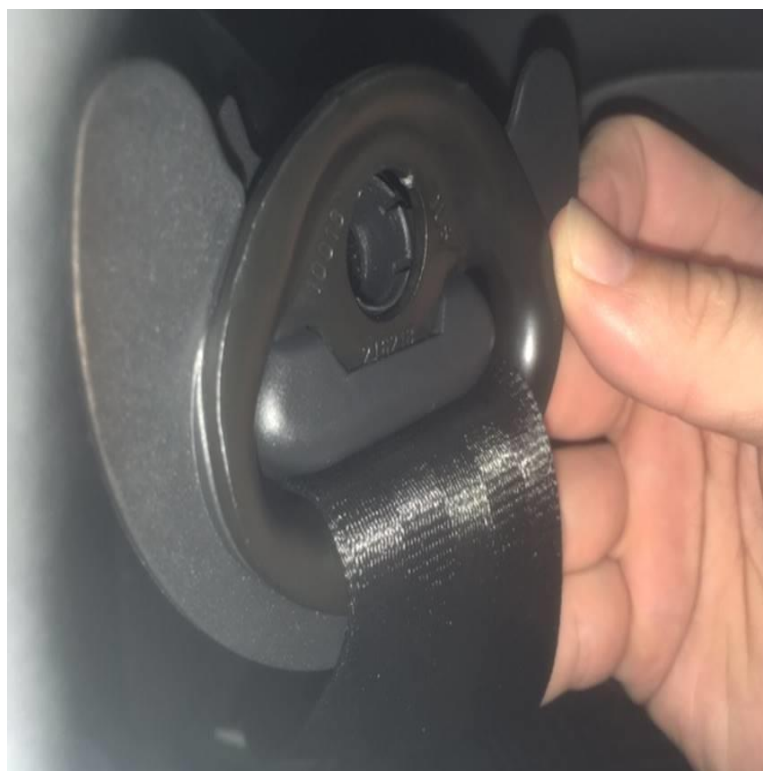
*Figure 3. Removing old seat belt guide starting at the bolt hole.*

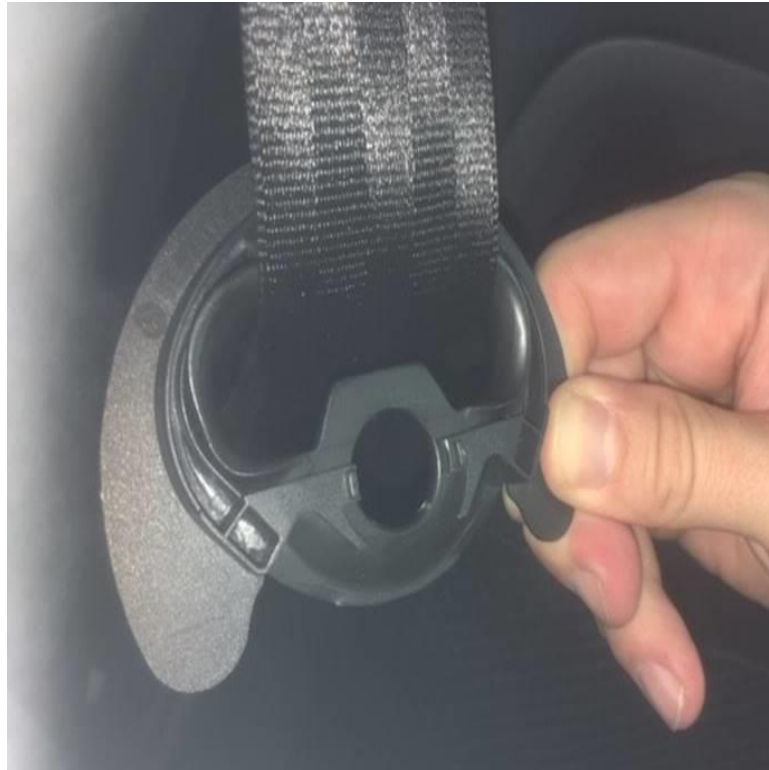
**Figure 4.** Old seat belt guide removed. Seat belt twist corrected.

4. With the old belt guide removed, turn the seat belt webbing to remove the twist (Figure 4).

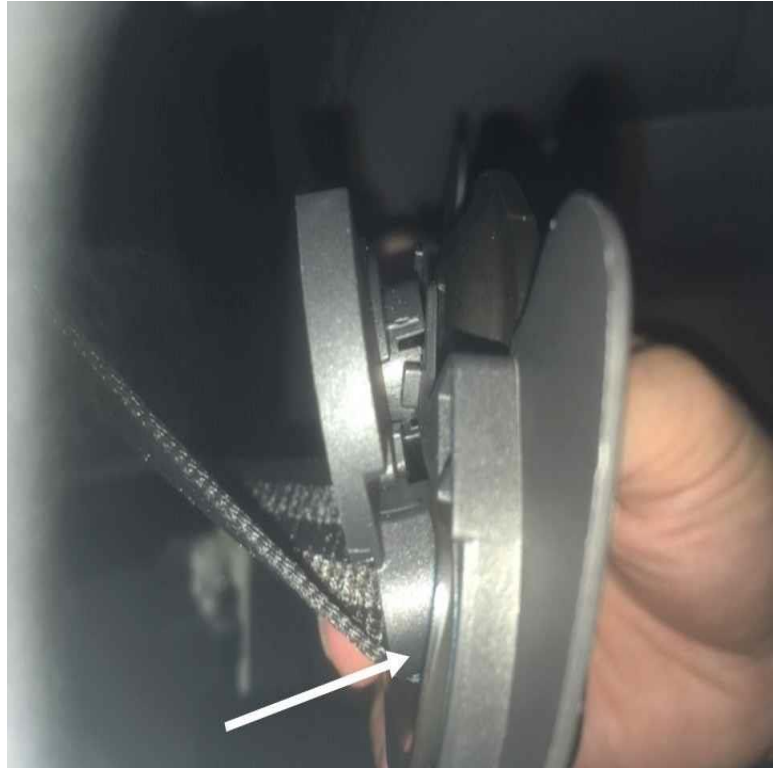
**Figure 5.** Installing modified seat belt guide starting with the metal tab on the bottom.

6. Start installing the modified seat belt guide at the deflector metal tab (Figure 5).

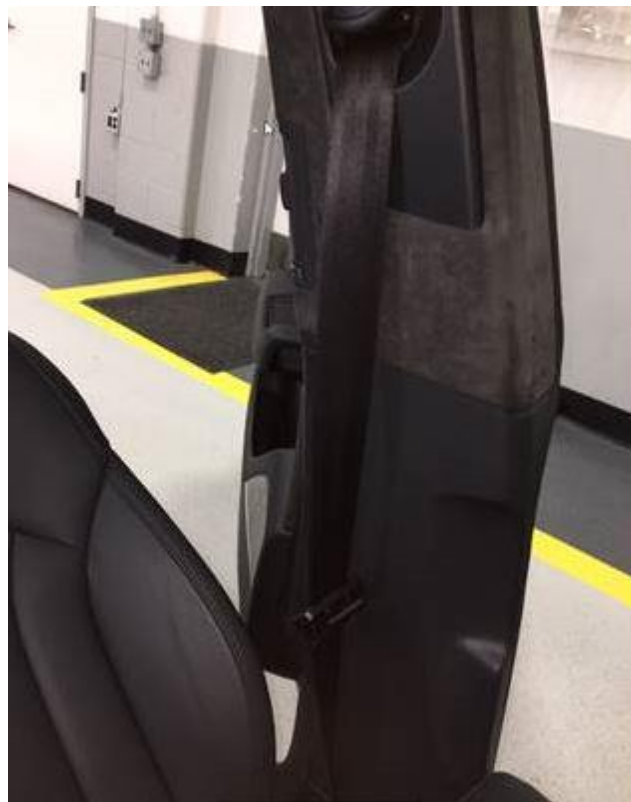
1. The twist that is within the seat belt assembly can be removed without any disassembly of the B pillar trim on either side of the vehicle. The pictures below show the twist and how it could look (Figure 9 and 10).

*Figure 9. Example of a twisted seat belt.*

2. To remove the twist from the seat belt assembly, all you need to do is feed a twist in the opposite direction that the seat belt is currently twisted. Please review the audio/video example below:

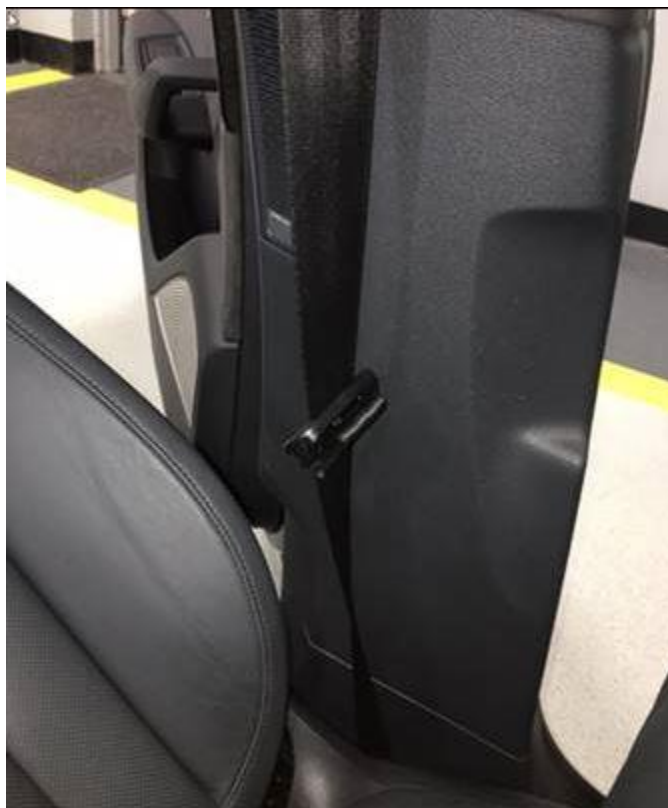
**Figure 10.** Example of a twisted seat belt.
