Technical Service Bulletin

15 Oil leak from cylinder head - 2.9 and 3.0TFSI only

15 20 34 2053278/3 April 28, 2020. Supersedes Technical Service Bulletin Group 15 number 19-33 dated February 5, 2019 for reasons listed below.

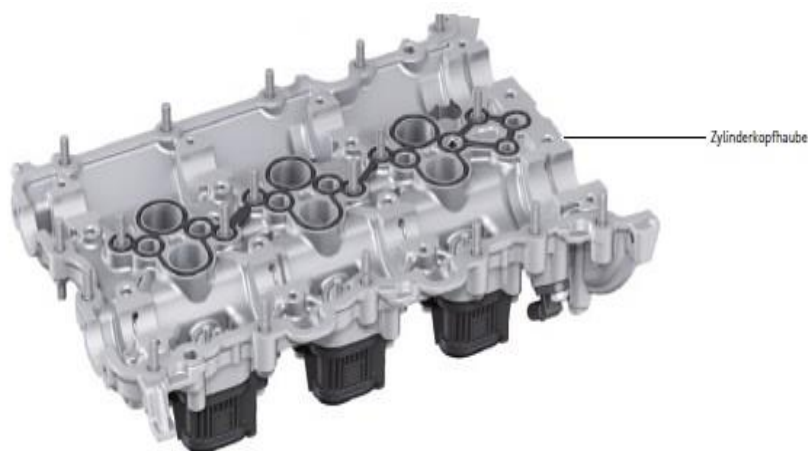
6. Remove the cylinder head cover and the seal (Figure 4).

Figure 4. Remove the cylinder head cover.

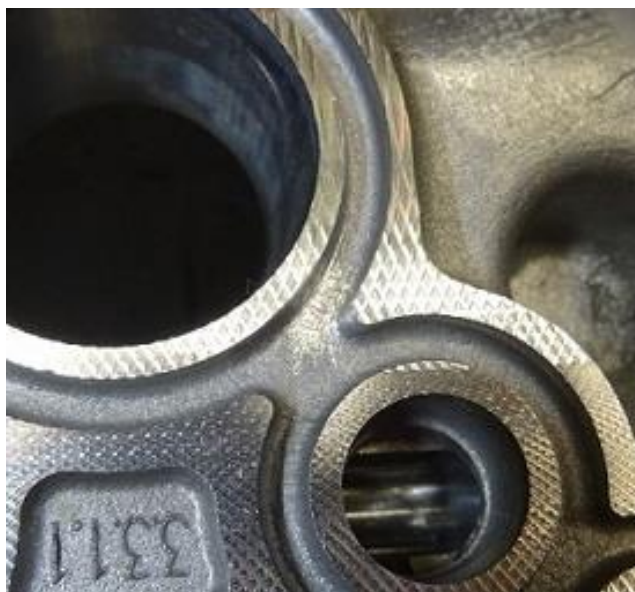
7. Inspect the seal groove in the cylinder head cover and remove any cast metal debris (Figure 5). The debris can be removed with a small flat screwdriver (Figure 6).

Figure 6. After the repair.

8. Install a new seal, re-assemble camshaft cover, clean the engine compartment, and if necessary replace the noise insulation (if it is full of oil).
