Title	Automated Manual Transmission (AMT) Oil Filter Cap Leak After Service
-------	---

AMT oil filter housing corrosion

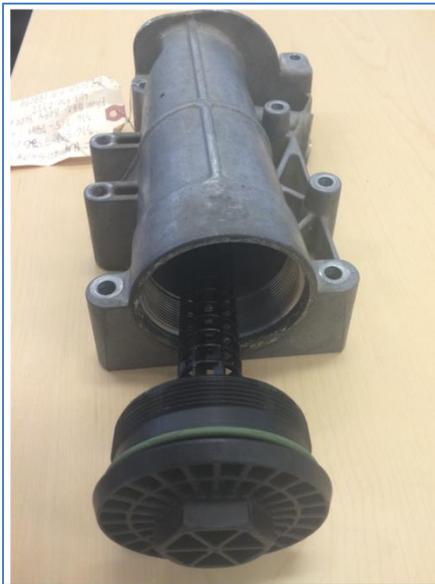
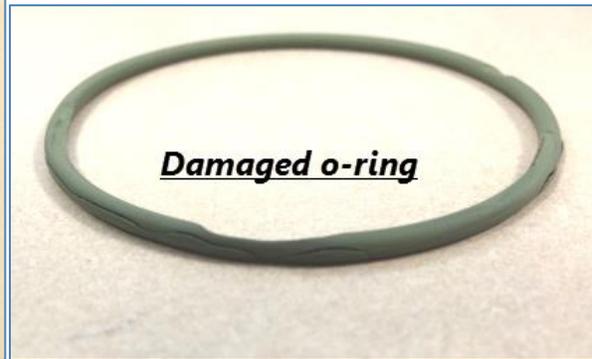
The AMT gearbox oil filter housing has been found to develop debris buildup or corrosion on the filter cover flange.

If you detect corrosion on the location shown above do not attempt to clean or reuse this housing. The corrosion is harder than the aluminum. This housing must be replaced.

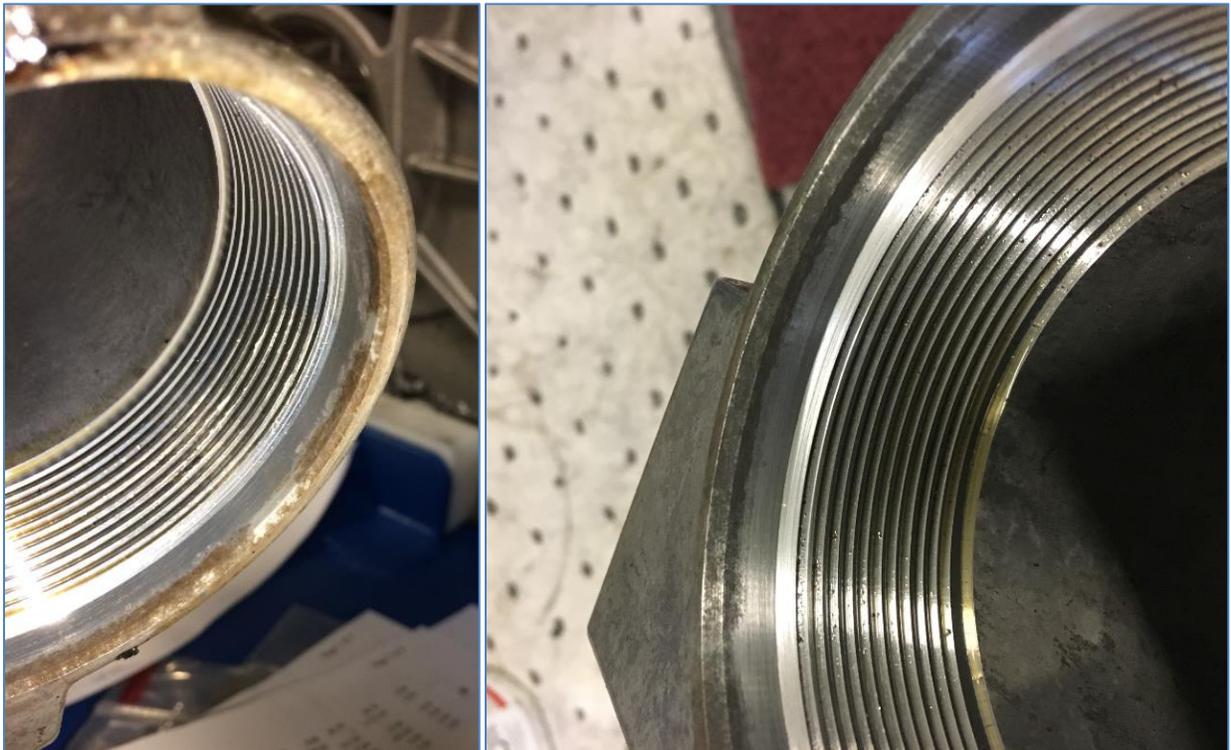
Filter housings that show normal dirt build up (left image) can be cleaned with a Scotchbrite pad or equal. Some residual staining of the aluminum housing (right image) may still be present after cleaning. Clean the threads and sealing surfaces before reassembly. Apply a small amount of silicone grease that meets the specification below on the o-ring, filter housing sealing area and the cap flange below the o-ring prior to assembly to help seal out moisture and dirt. There must be enough grease present to allow squeeze-out under the flange so the dirt and moisture is sealed out of the area of concern. Clean the filter cap of any excess grease squeeze-out after assembly to prevent giving false impression of a leak.

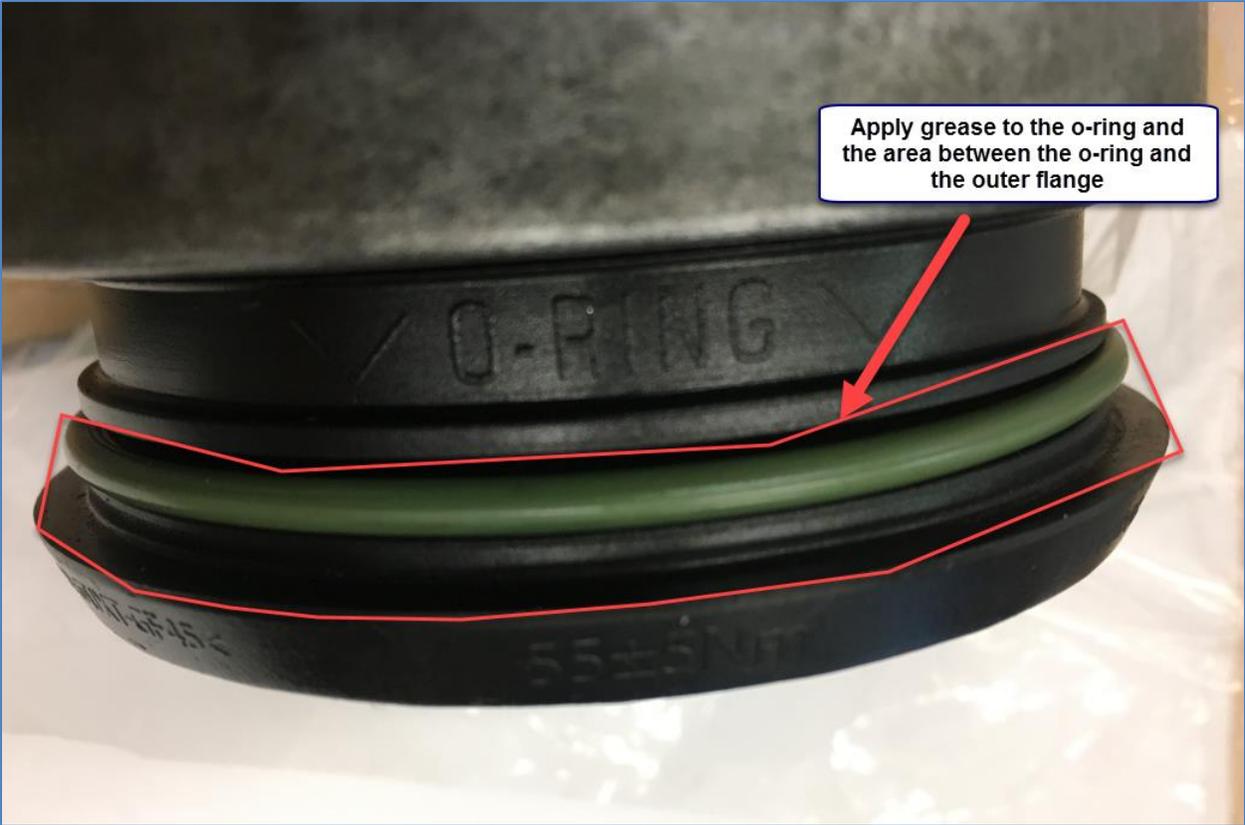
Silicone grease

Base	Silicone
Consistency	NLGI 2
Thickener	Lithium soap
Temperature range	-70°C to +160°C

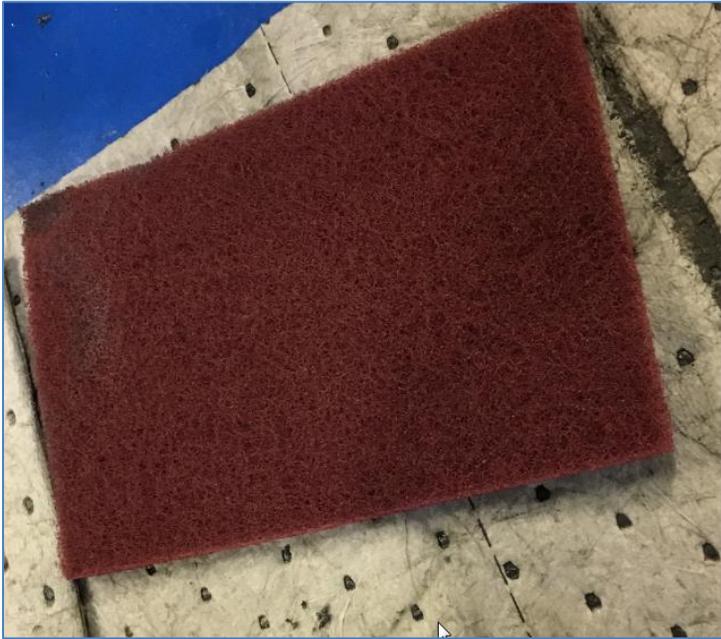
Approved cleaning pad red or green Scotchbrite pad or equal.
