HYUNDAI

Technical Service Bulletin

GROUP	NUMBER
AUTOMATIC TRANSMISSION	20-AT-015H
DATE	MODEL
APRIL 2020	ACCENT (HC) ELANTRA (AD/ADa) ELANTRA GT (PD) KONA (OS) SANTA FE SPORT (AN) TUCSON (TL) VELOSTER (JS)

SUBJECT: AUTOMATIC TRANSAXLE OIL TEMPERATURE SENSOR
DTC P071100, P071200 & P071300

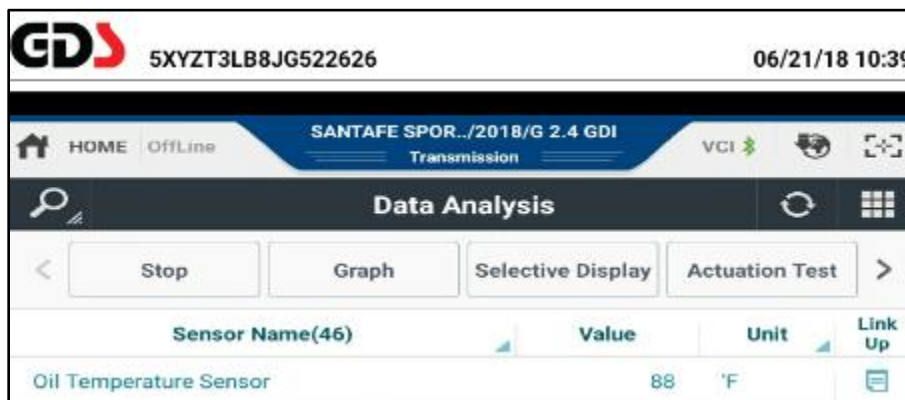
1. Attach a GDS and select **DTC Analysis** and **A/T** menu. Record the DTC and description. Delete the DTC.
2. From the GDS home screen, select **Data Analysis** and **A/T** menu and the parameters shown below. If the solenoids show:
 - Continuous and changing output while driving, the wiring **currently** has no open/short circuits. Go to Step 4.
 - No continuous and changing output, go to Step 3.

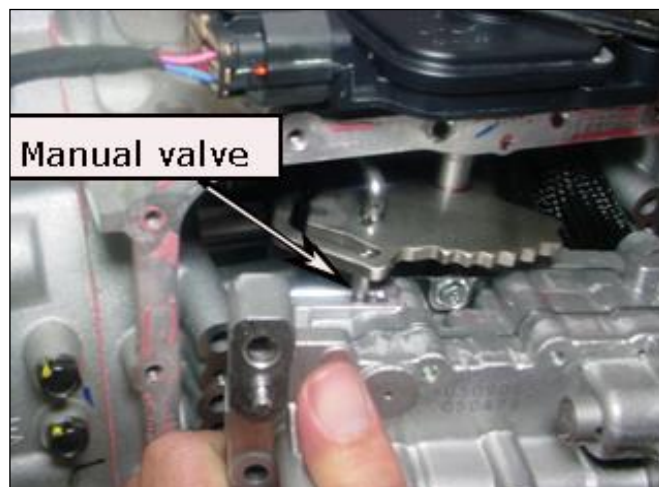
16. Align the manual shaft to the shift lever and install the valve body.

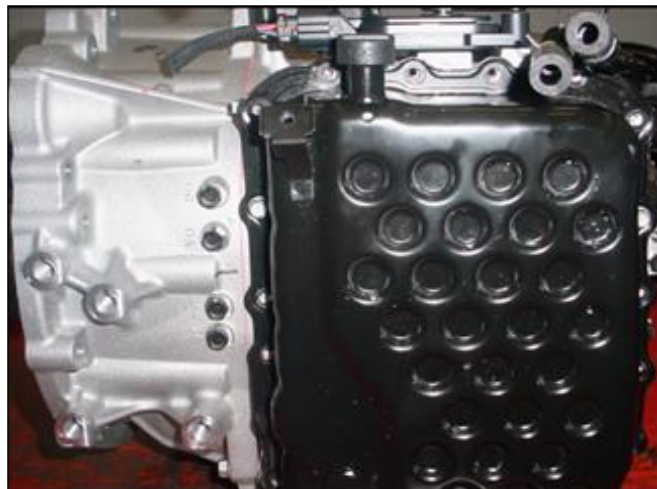
19. Reinstall the pan and tighten the bolts to specification.

Torque: 9~10 lb.ft (1.2~1.4 kgf.m/12~14 N.m)
