Technical Service Bulletin

42 Rattle noise from the rear suspension

42 20 44 2038689/4 May 13, 2020. Supersedes Technical Service Bulletin Group 42 number 18-38 dated June 20, 2018 for reasons listed below.

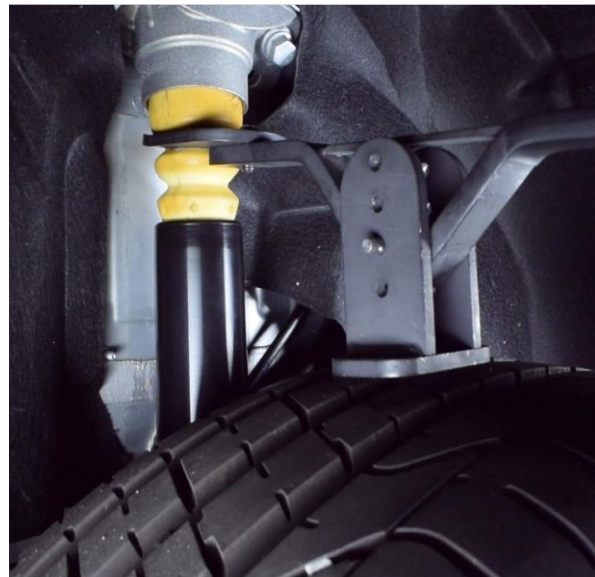
Figure 2. The SET900 tool being used to install a rear bump stop.

1. Clean the top of the rear bump stops and coat with tire mounting paste.
 2. Use the SET900 special tool to fully press the rear bump stops into the upper shock mounts (Figure 2).
- The purpose of the tool is to properly seat the rear bump stops in the rear shock mounts (Figure 3), which will prevent them from dropping out of the rear upper shock mounts and causing the noise.

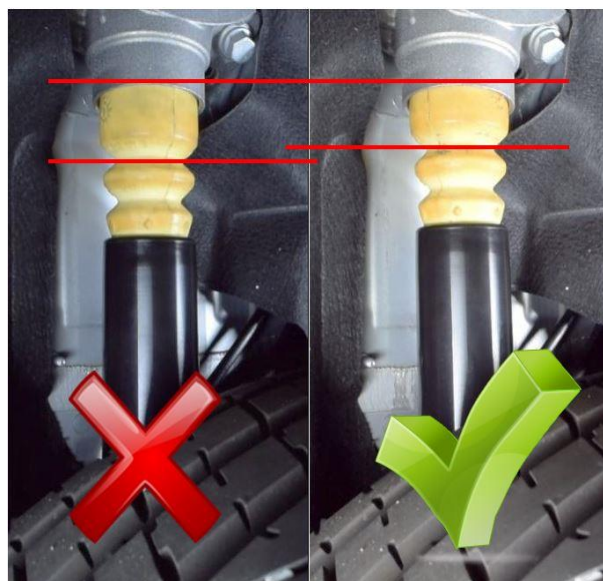
Figure 3. Comparison between rear bump stop installation without and with the SET900 tool.

Always ensure that the dust boot does not get caught on the top of the shock once the vehicle is lowered.
