Loose trim moulding rear door

REF NO: TJ 35197.1.1	ISSUING DEPARTMENT: Technical Service	CAR MARKET: United States and Canada	
PARTNER: 3 US 7510 Volvo Car USA		ISSUE DATE: 2020-03-30	STATUS DATE: 2020-04-07
FUNC GROUP: 8414	FUNC DESC: Trim moulding at window	Page 1 of 6

TJ Instruction VCC-405787-2

Title	Weatherstrip, door window, rear	Page	1 (4)
Action	Product fix	Operation number:	99922-2

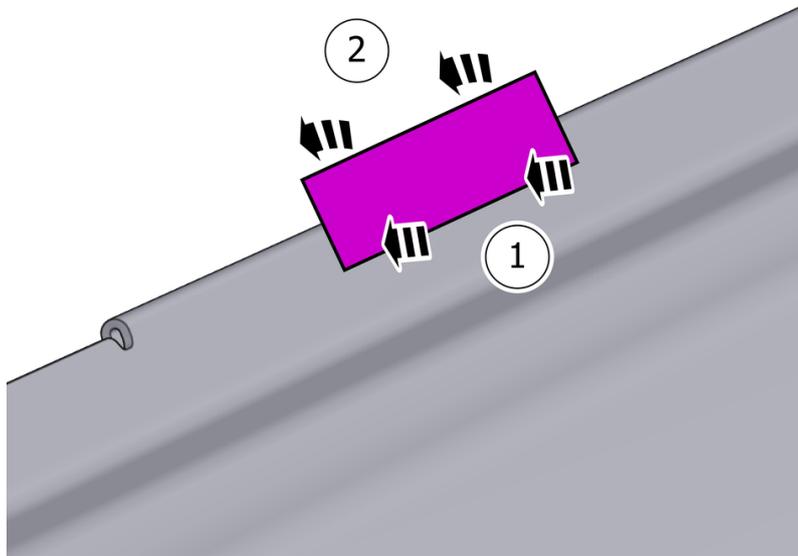
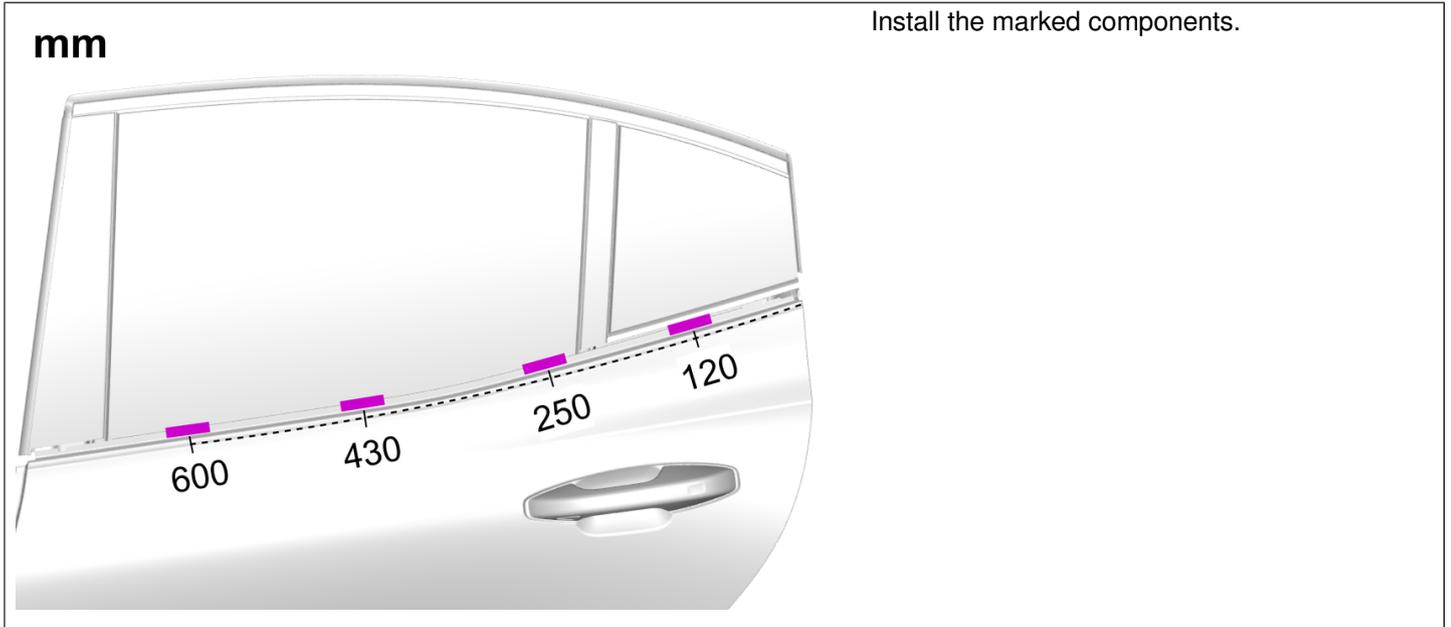
mm

Use: Tape , 894910

Note! Orientation view

Perform the repair according to attached method.

Use WURTH tape PN 894910 (Canada)

Use WURTH tape PN 189412 (US)
