Technical Service Bulletin

60 Water entry into cabin from the sunroof area

60 20 43 2056944/3 May 28, 2020. Supersedes Technical Service Bulletin Group 60 number 20-39 dated February 5, 2020 for reasons listed below.

Model(s)	Year	VIN Range	Vehicle-Specific Equipment
Q3, Q8, and Audi e-tron quattro	2019 - 2021	All	Not Applicable

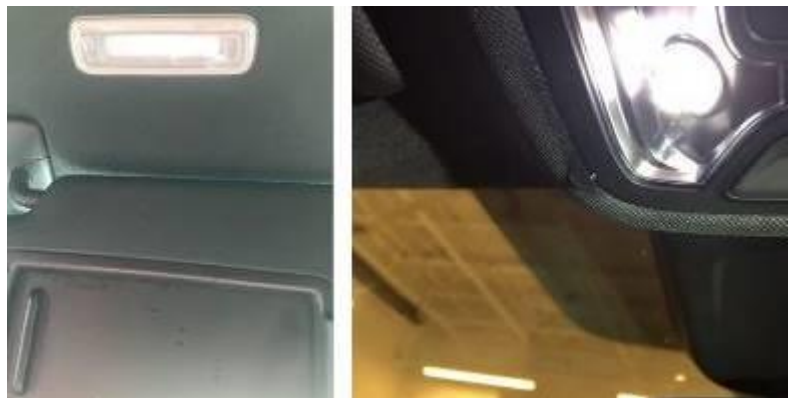
- They see a water drip from the headliner area (Figure 1).

Figure 1. Water intrusion near the headliner.

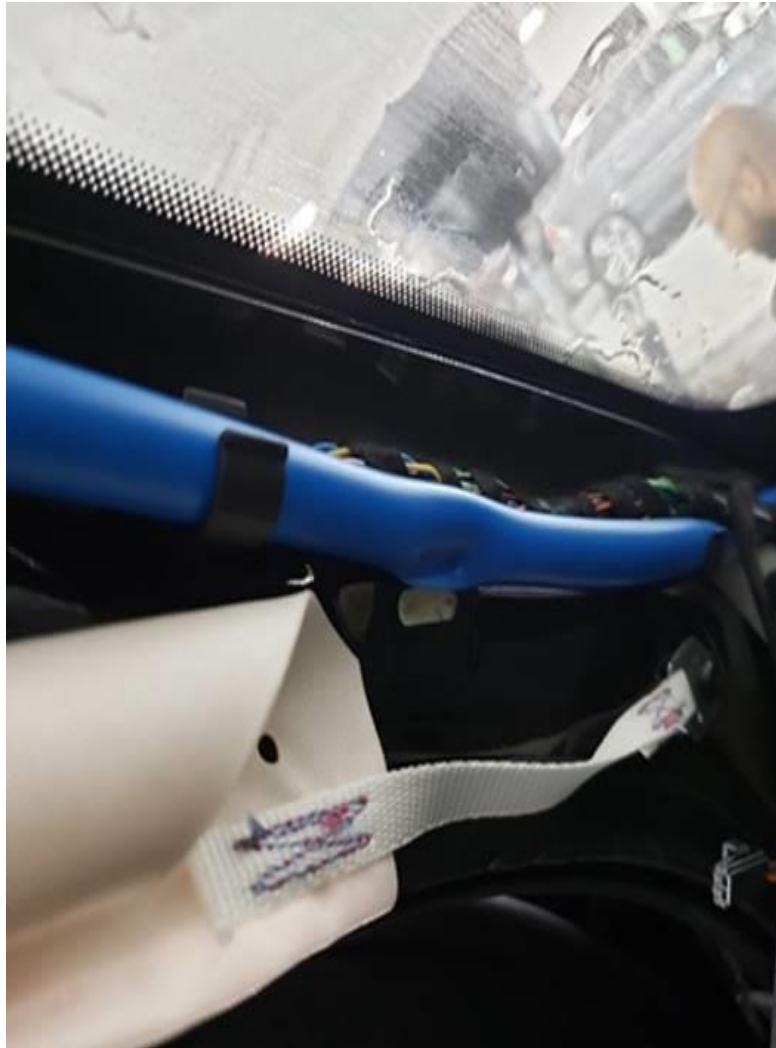
1. Sunroof drain hose or outlet valve:
Visually inspect all 4 sunroof drain hoses and valves for any damage or obstruction (Figure 2).

Figure 2. Sunroof drain hose pinched by pillar trim.

1. Sunroof drain hose or outlet valve:
Ensure that any water in the sunroof frame drainage areas flows freely. Replace any pinched or otherwise obstructed drain hose(s) or valve(s).

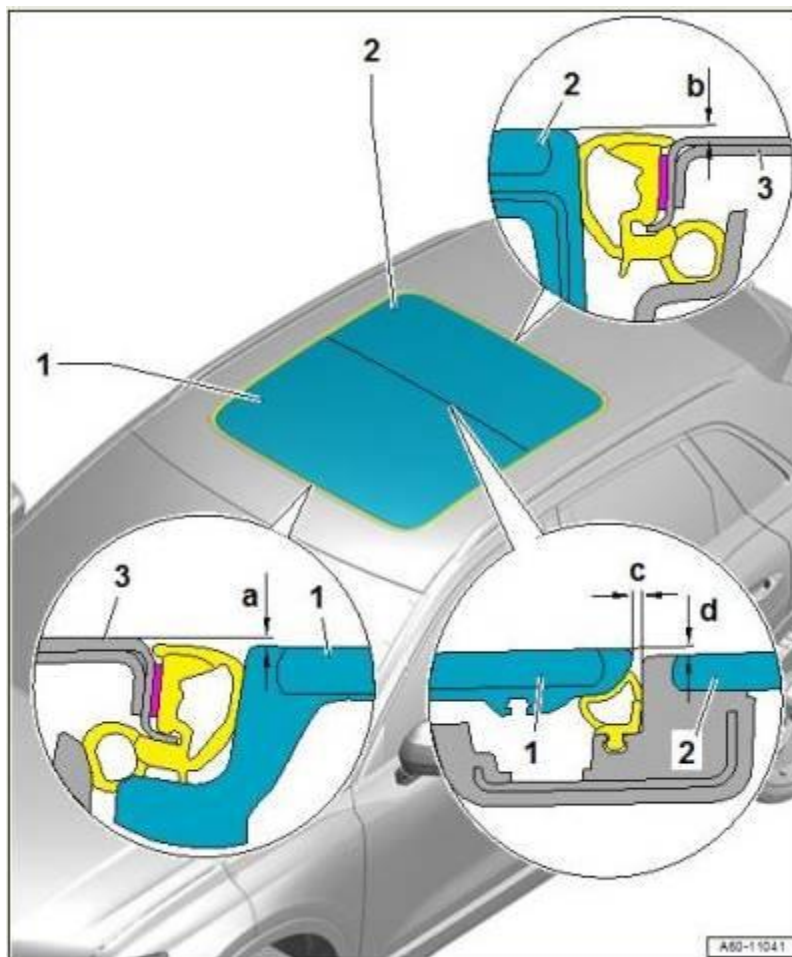
Check all adjustment axes of the sunroof glass panels for poor adjustment (Figure 4).

Figure 4. Front and rear glass panel adjustment.

2. Roof opening seal:
If after inspecting the roof opening seal any detachment, malformation or damage is discovered, replace the sunroof opening seal.
3. Glass sunroof panels:
If after all dimensional measurements are made on the sunroof glass panels a problem is found make the necessary adjustments to the sunroof glass panels.

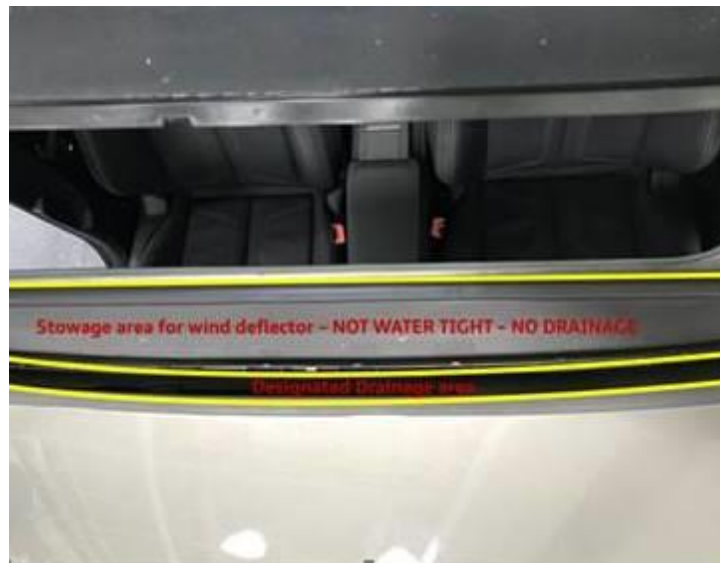
Figure 6. Areas of sunroof opening water elimination capabilities.

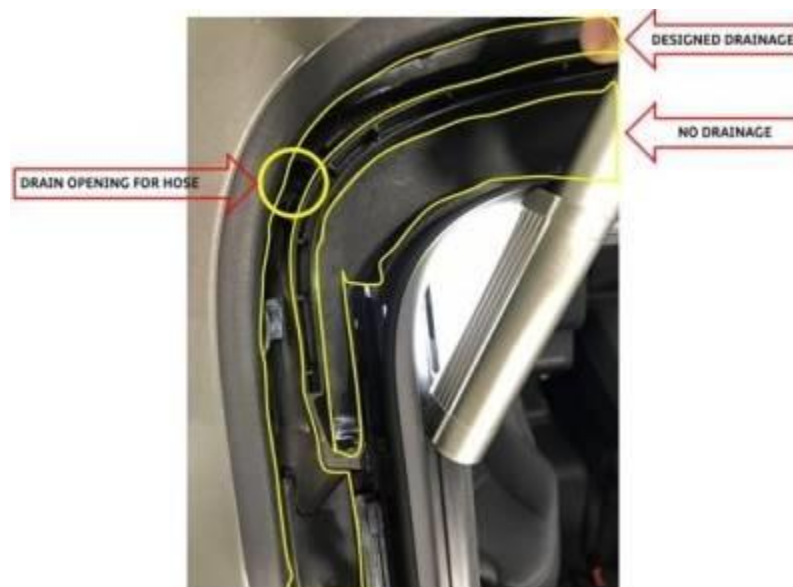
Figure 7. Sunroof water channeling diagram.

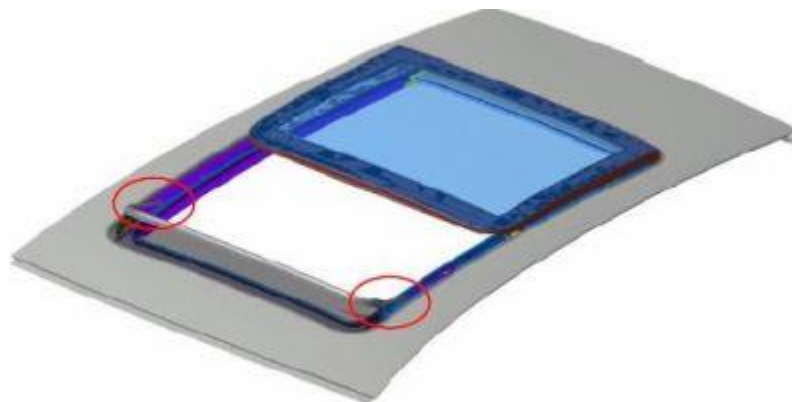
Figure 8. Locating points for the sunroof wind deflector.

5. Open the front sunroof panel completely and locate the mounting points for the sunroof wind deflector (Figure 8).

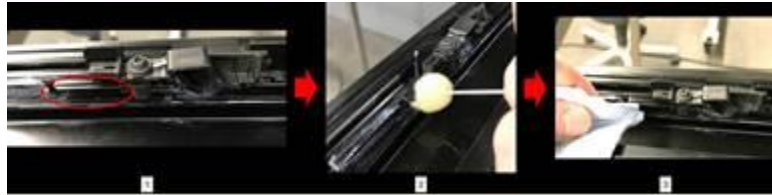
Figure 9. Area of sunroof frame to be cleaned.

- Using a primer applicator D 009 500 25 (or equivalent) and D 009 401 04 all purpose cleaner thoroughly clean the area shown in Figure 9. It should be free of any lubricant or contaminants and completely dry.

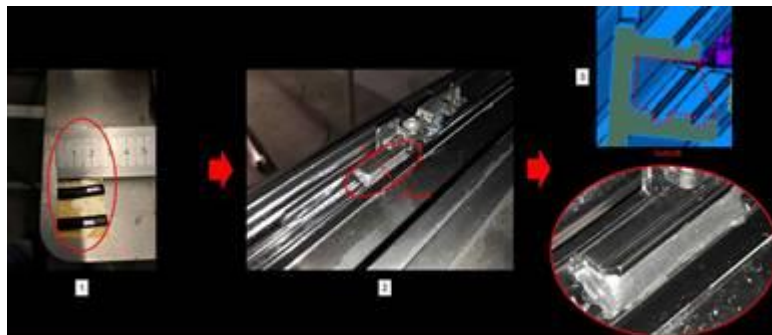
Figure 10. Preparation and application of butyl cord.

- Cut two 25mm strips of AKL 450 005 05 Butyl adhesive/sealing cord. Firmly press each strip into the groove shown in Figure 10. Both channels shown in the cut away must be completely filled with the butyl cord.

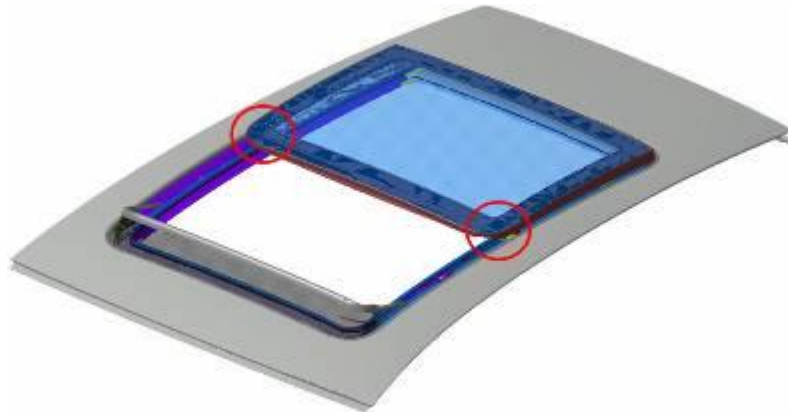
Figure 11. Area of sunroof glass panel to be modified.

- Next, a small modification will be made to the sunroof glass panel shown in Figure 11.

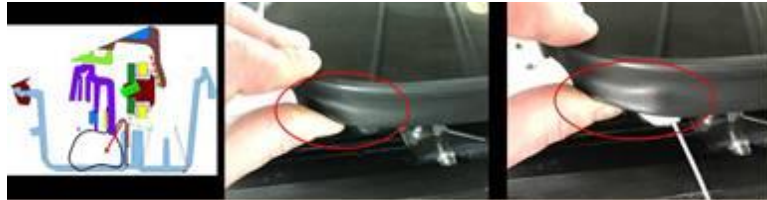
Figure 13. Area of glass panel 'skirt' where bonding agent is to be applied.

10. Apply D 355 205 A2 Bonding Agent using a primer applicator D 009 500 25 (or equivalent). Allow bonding agent to thoroughly dry.

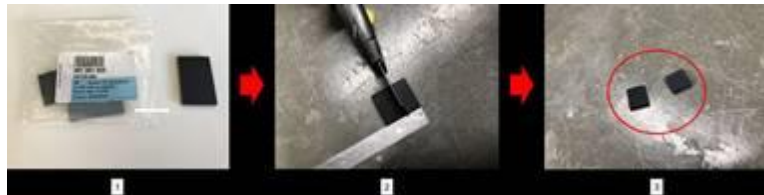
Figure 14. Preparing 2 – 10mm x 10mm pads of 251 201 525 packing.

11. Using 251 201 525 packing cut 2 x 10mm x 10mm pads.

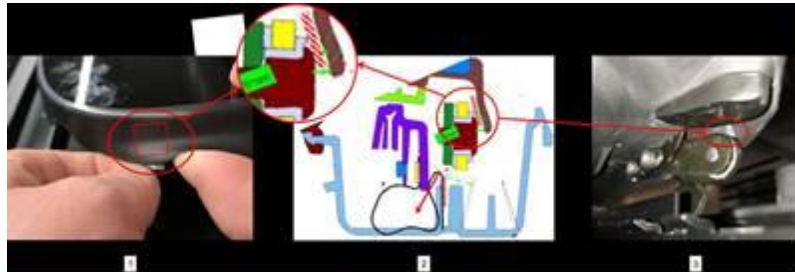
Figure 15. Positioning and application of the 10mm x 10mm pads.

12. Bond each pad to the front areas of the sunroof glass panel 'skirt' as shown in figure 15. A cut away drawing is included to illustrate the precise positioning of each pad from the inside.

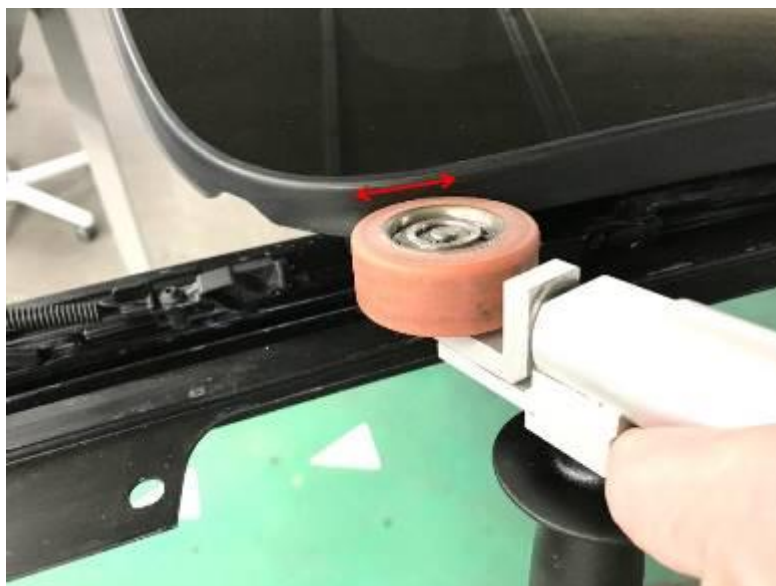
Figure 16. Applying pressure to bonded area with 3356 roller (or equivalent).

13. Using a 3356 roller tool (or equivalent), apply firm pressure to the newly adhered pads to enhance the strength of adhesion.
