Technical Service Bulletin

69 Front seat belt is twisted

69 20 51 2058455/3 May 11, 2020. Supersedes Technical Service Bulletin Group 69 number 20-49 dated April 1, 2020 for reasons listed below.

Model(s)	Year	VIN Range	Vehicle-Specific Equipment
A6, A7, A8, Q8, and Audi e-tron quattro	2019 - 2020	All	Not Applicable

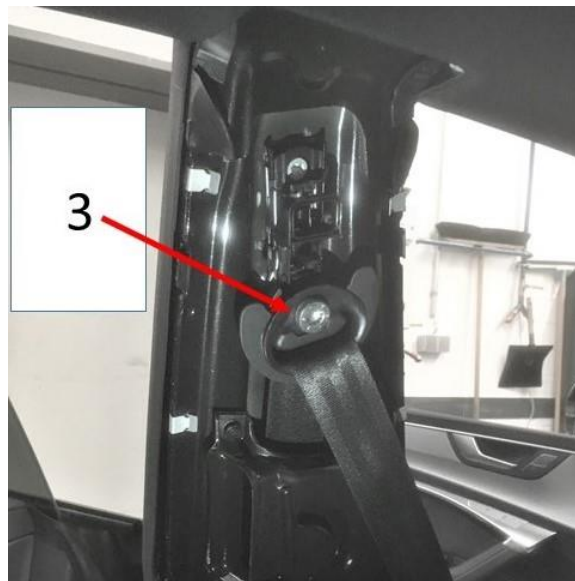
Figure 1. Seat belt deflector at height adjuster with B-Pillar trim removed.

1. Remove the upper B-Pillar trim on the affected side according to the repair manual.
2. Remove the bolt of the seat belt deflector (Figure 1, Pos. 3).

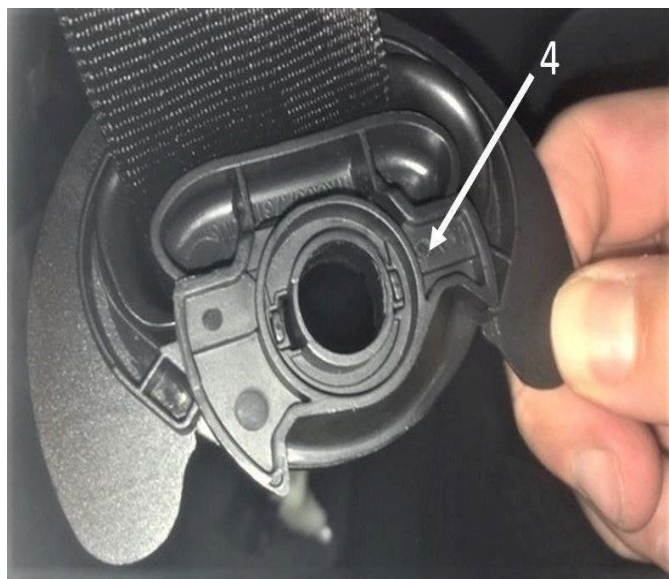
Figure 2. Backside of seat belt deflector. Deflector trim tabs engaged in old belt guide.

3. Use your thumb to remove the old belt guide (plastic part) from the steel deflector. Start by detaching the guide from the bolt hole, then press out the lower section covering the metal tab (Figures 2 and 3).

5. Install the modified belt guide 4K8 857 799 on the front driver side and 4K8 857 800 on the front passenger side (Figure 2, Pos. 4).
6. Start installing the modified seat belt guide at the deflector metal tab (Figure 5).

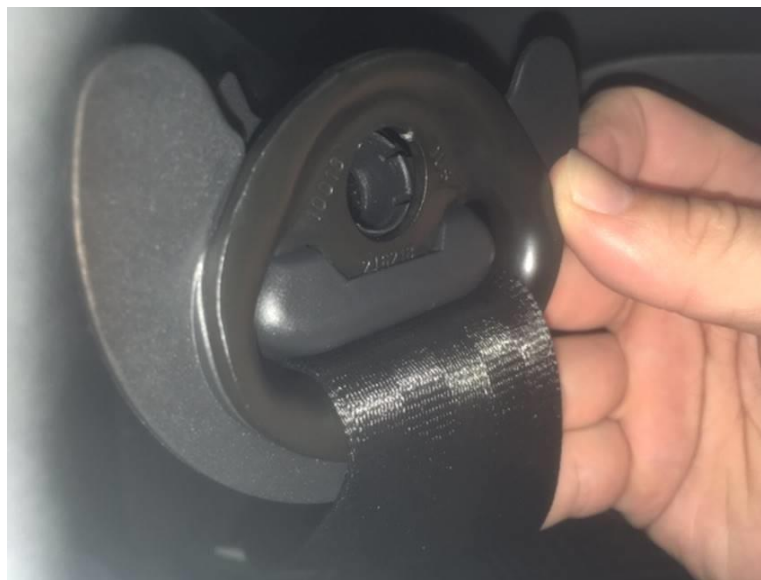
Figure 3. Removing old seat belt guide starting at the bolt hole.

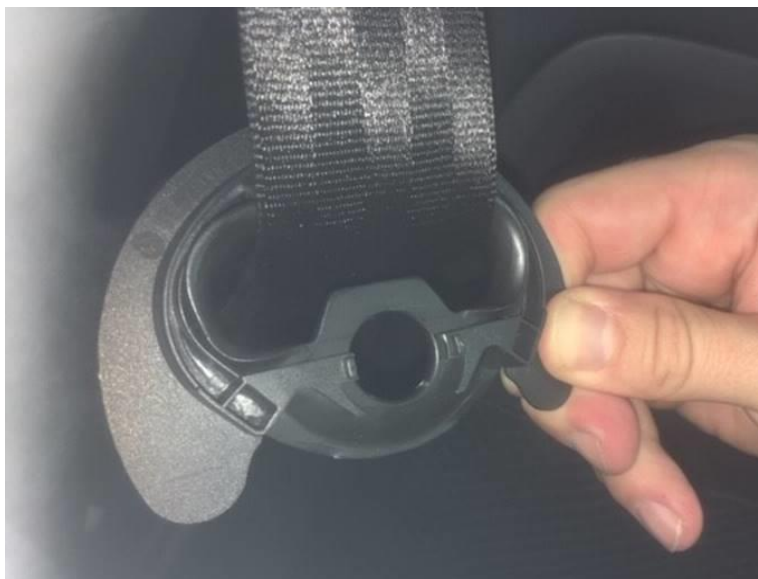
Figure 4. Old seat belt guide removed. Seat belt twist corrected.

4. With the old belt guide removed, turn the seat belt webbing to remove the twist (Figure 4).

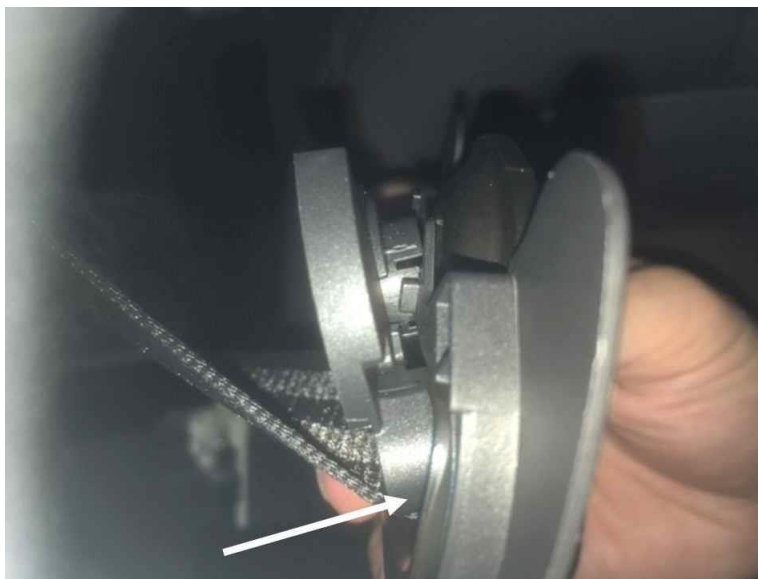
Figure 5. Installing modified seat belt guide starting with the metal tab on the bottom.

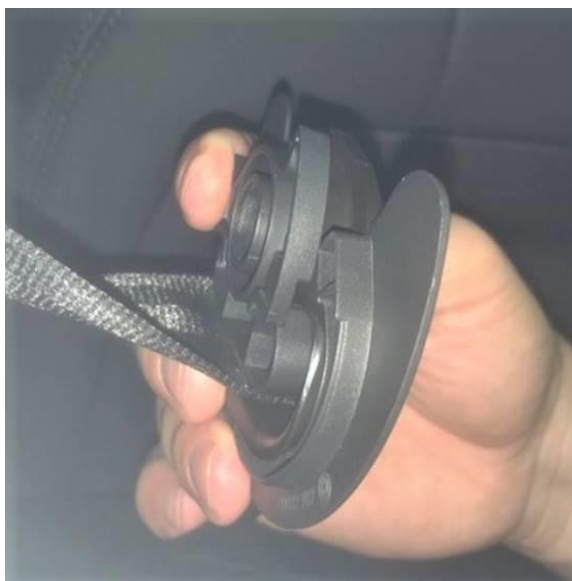
Figure 6. Seat belt deflector with new guide installed.

7. Push the new guide into the bolt hole until you can hear the plastic retainers snap into place (Figure 6).

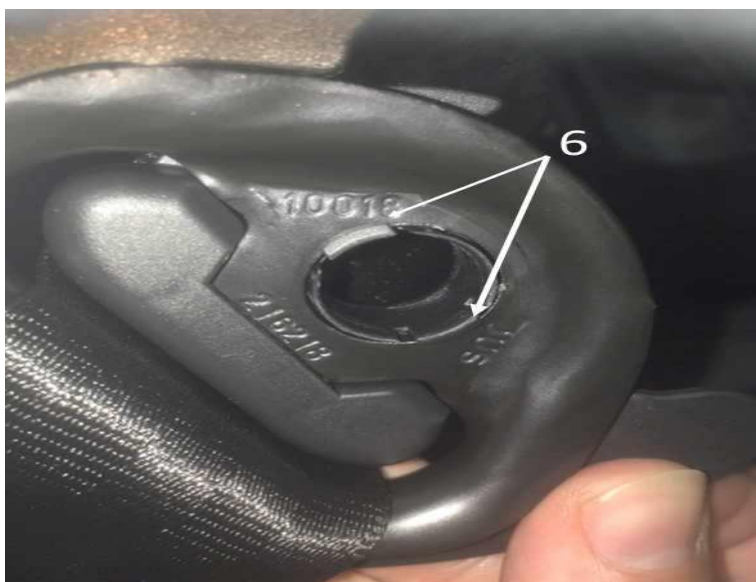
Figure 7. Belt guide locking tabs correctly secured at bolt hole.

8. Inspect the front of the deflector for proper installation of the guide locking tabs at the bolt hole (Figure 7, Pos. 6)

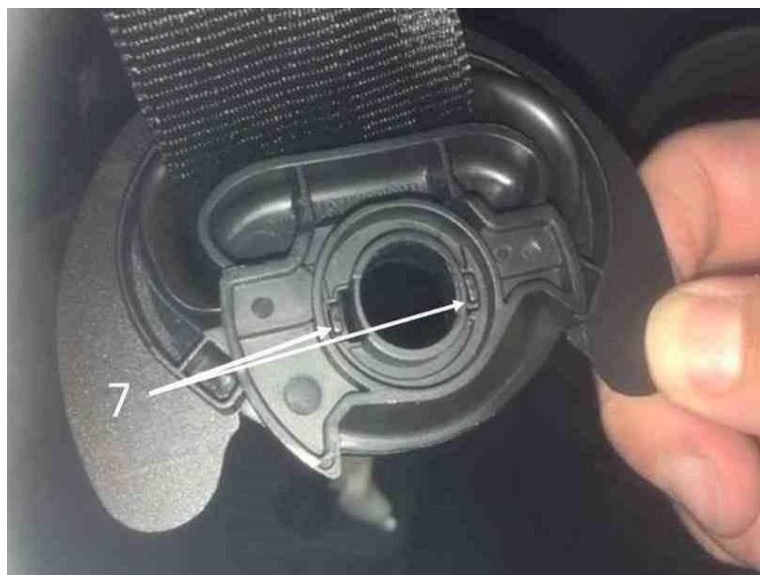
Figure 8. Seat belt deflector trim locking tabs properly secured to seat belt guide.

9. Inspect the back of the deflector for proper installation of the deflector trim locking tabs to seat belt guide (Figure 8, Pos. 7)
