Title	Turbo Compound (TC) Hot Side Noise Diagnostic Information
<b>Mack Models</b>	
<b>Mack Model</b>	AN - Anthem , GR - Granite , PI - Pinnacle
<b>Volvo Models</b>	
<b>Volvo Model</b>	VN , VNL , VNR , VNX , VAH , VHD
<b>Emission Standard</b>	
Emission Standard	US17+OBD16 , US17+OBD18 , US17+OBD19
<b>Engine family</b>	
Engine family	13L Engine , MP8

<b>Cause</b>	Information to use when diagnosing a report of noise from the hot side of the turbocharger on turbo-compound engines.
--------------	---

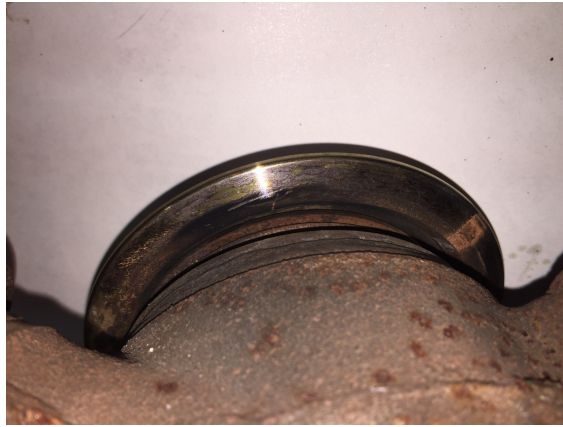
Flange weld at EGR cooler inlet

**If the noise goes away or gets quieter:** Focus on the EGR Hot pipe.

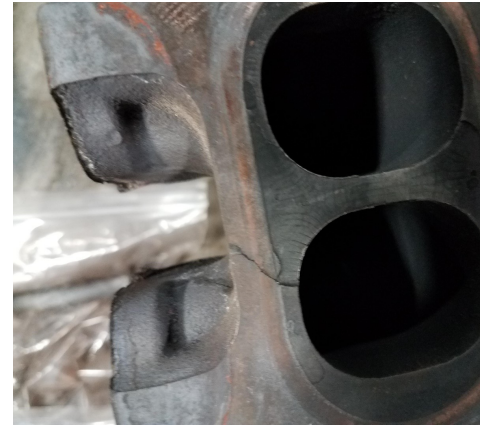
Cracks in Manifold or warped face causing leaks at gasket

**If the noise gets louder or worse:** Focus on the manifold.

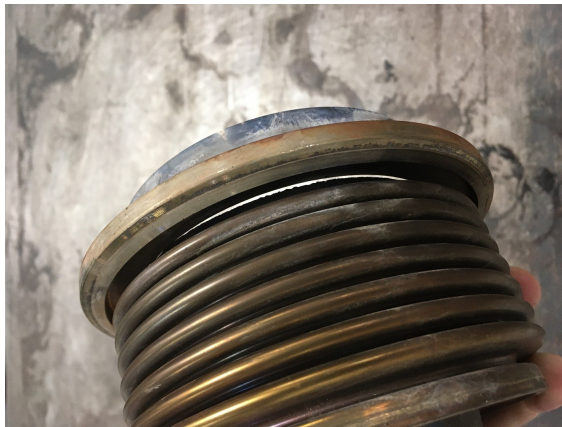
**If the noise gets louder or worse:** Focus on the diffuser pipe (between TC unit and turbo)

2. Perform a Soot Regen.
