# Service Information Bulletin Group 11 Engine

Bulletin Number: 20-004 Models: FE/FG Issue Date: June 11, 2020 Page 1 of 3

Destruction and scrapping of engine assemblies replaced under warranty

FEC52, FEC72, FEC92, FGB72, FEC7T, FECZT, FEC9T

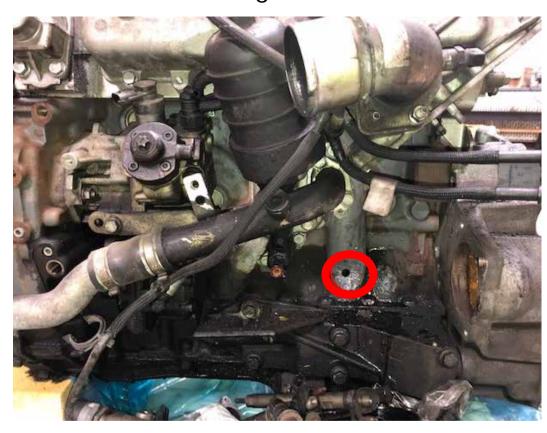
• Driver Side of Engine

# Damage Point for the 4P10 Diesel Engine Block

- Fully drain all fluids from the engine.
- There is a weak spot on the middle of the cylinder block on the driver's side of the engine.
- Use an air hammer to puncture a hole in the side of the block. (Fluids will leak out if not drained)

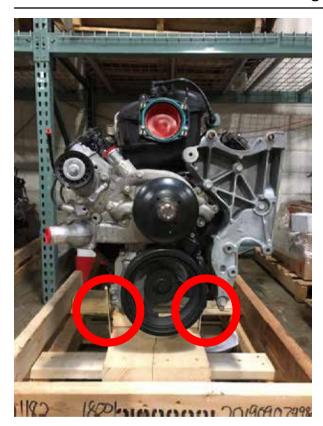
### Front of Engine

# Damage Points for the 6.0L Gas Engine Block

- Fully drain all fluids from the engine.
- Where engines mount to the crate are weak spots in the front of the engine that will damage the block beyond repair.
- Use a sledgehammer (or equivalent) to strike the block and break the areas around mounting tabs (Fluids will leak out if not drained)

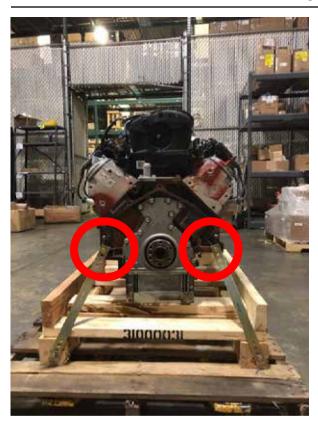
### Back of Engine

- Fully drain all fluids from the engine.
- The transmission mounting tabs are the best spot to destroy the engine by damaging the block.
- Use a sledgehammer (or equivalent) to strike the block and break the areas around mounting tabs (Fluids will leak out if not drained)
