# **Service Campaign Bulletin**

Campaign No. 2020040015, May 2020

SUBJECT: Model 907 Model Year 2019

**Retrofit Adapter on Spare Wheel**

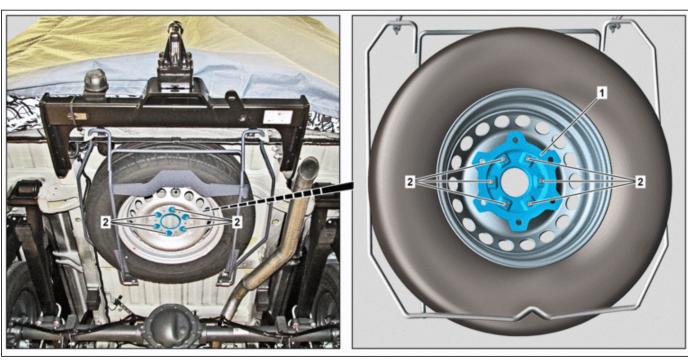
D40.10-A004-79

#### 1 Disk wheel adapter

## 2 Spherical collar bolts

<b>4</b>	Check		
1	Check, whether the vehicle is affected by the measure.	Only the entry in the "Extended VEGA Application" (EVA) system in the "Current" tab is decisive for authorized Mercedes-Benz service partners. An additional test of the affected vehicles in the workshop information system (WIS) or vehicle list is thereby not necessary.	
	Remove		
2	Raise vehicle.		
Topical note	Special instructions for lifting and supporting vehicle		AH00.60-N-0100-01TS
<b>⊯</b> AR			AR00.60-D-1000-04TS
3	Remove spare wheel holder with spare wheel.	Lower spare wheel holder with spare wheel far enough until the disk wheel adapter (1) can be inserted into the spare wheel.	
X	Install		
4	Retrofit disk wheel adapter (1).	Fasten disk wheel adapter (1) to spare wheel using spherical collar bolts (2).	
5	Install spare wheel holder with spare wheel.		
6	Lower vehicle.		
<b>⊯</b> AR			AR00.60-D-1000-04TS
