SERVICE BULLETIN

EM20-007

2015-2020 ROGUE; AIR DUCT REPLACEMENT

APPLIED VEHICLES: 2015-2020 Rogue (T32)

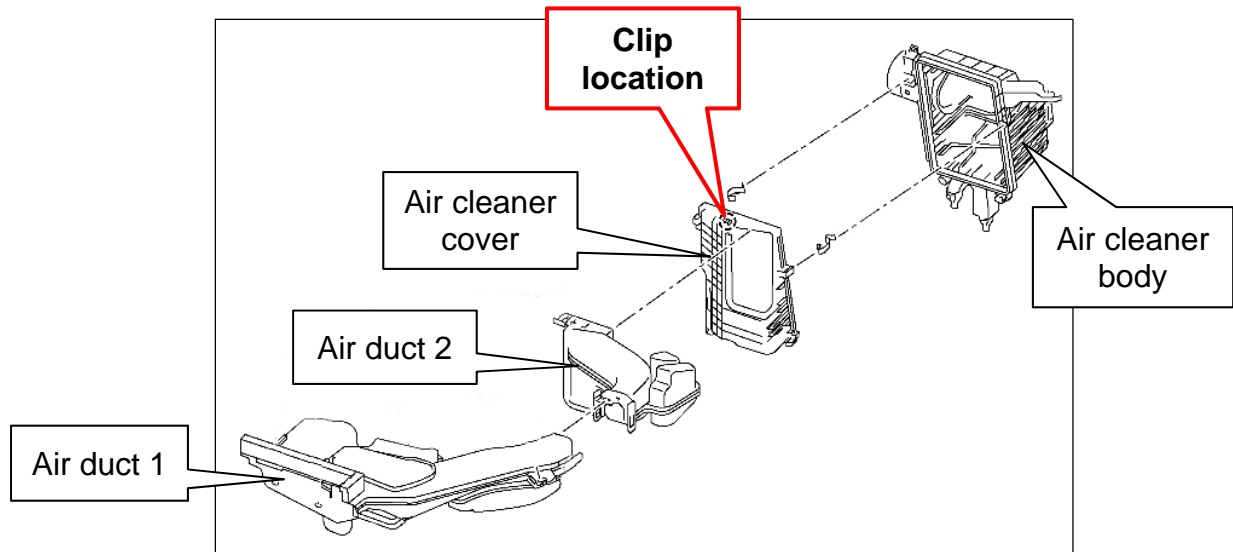
Air duct 1, air duct 2, or the air cleaner cover shown in Figure 1 needs to be replaced.

Inspect for a clip in the location shown in Figure 1 and Figure 2.

- If a clip is present, then the vehicle **IS** equipped with the updated parts; no further action is needed. Individual parts may be replaced as needed.
- If a clip is **NOT** present, then the vehicle is equipped with older parts. See **SERVICE PROCEDURE** on the next page.

1. Inspect the air cleaner body for a clip in the location shown in Figure 1 and Figure 2.
 - If a clip is present, then the vehicle is equipped with the updated parts; no further action is needed. Individual parts may be replaced as needed.
 - If a clip is **NOT** present, then the vehicle is equipped with older parts. All components listed in the **PARTS INFORMATION** section must be replaced.
 - For removal and installation, refer to the Electronic Service Manual (ESM) section **REPAIR > ENGINE > ENGINE MECHANICAL > REMOVAL AND INSTALLATION > AIR CLEANER AND AIR DUCT**.
2. Install the new clip into the location shown in Figure 2.
