Noises From Dynamic Seat

Topic number	LI91.25-P-071314
Version	1
Function group	91.25 Multicontour seat (MKS)
Date	06-15-2020
Validity	MODEL 213 with code 432 (Active Multicontour Seat Package) MODEL 257 with code 432 (Active Multicontour Seat Package) MODEL 290 with code 432 (Active Multicontour Seat Package)
Reason for change	
Reason for block

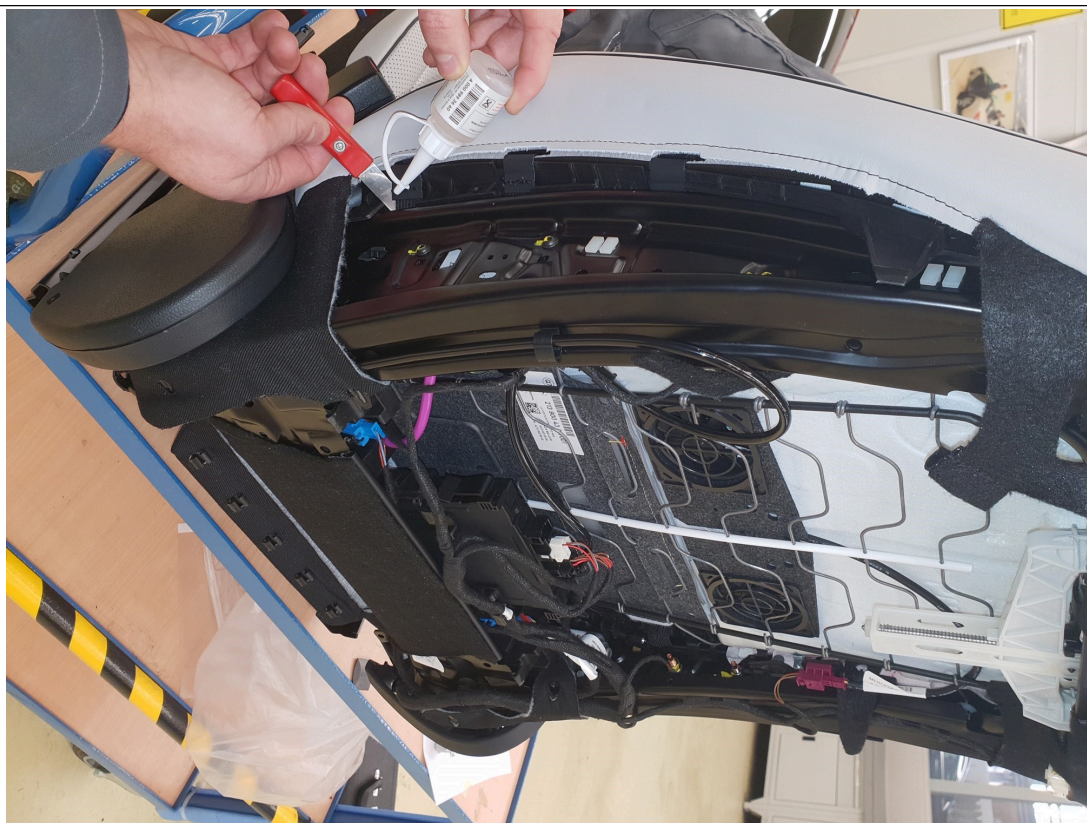
Bearbeitung Spannband
1.jpg:

When the dynamic seat is activated, the tensioning straps on the seat backrest frame may creak.

The tensioning straps are in contact with the seat backrest frame and as a result, a creaking noise may occur.

Apply lubricant (Krytox) between the tensioning strap and the seat backrest frame, see figures.
