Noise From Air Conditioner Housing (humming)

Topic number	LI83.40-P-071168
Version	2
Function group	83.40 Air conditioning (automatic)
Date	06-15-2020
Validity	BR167 with automatic air conditioning code 580/581
Reason for change	Replacement parts are now available.
Reason for block

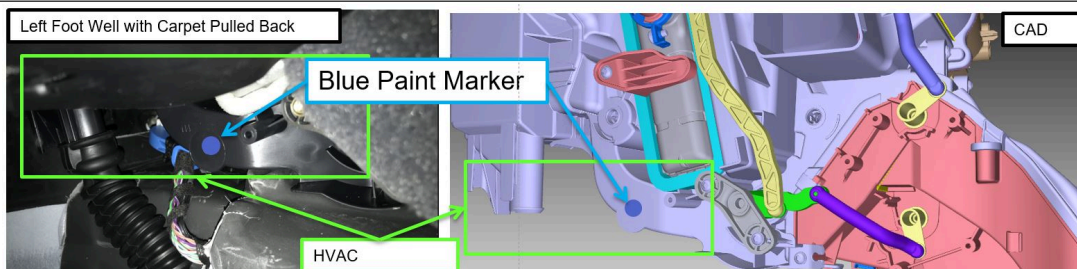
marking.jpg:

To clearly identify them, they have a blue mark on the left-hand side on the footwell vent, near to the condensation drain (see picture "marking.jpg"). All parts with the blue mark have a modified flap seal.

Attachments	
File	Description
marking.jpg	Position of blue marking
Analysis sheet for complaints about blower motor noise, form.pdf	OF83.10-P-3001-01A

The air distribution box must be replaced.

New air conditioner housings with modified flap seals are available. These have a manufacturing date of May 2020 or later.
