Oil In Control Housing Or TECU -- AMT-F 🖒 ූා

I-SHIFT OIL IN CONTROL HOUSING

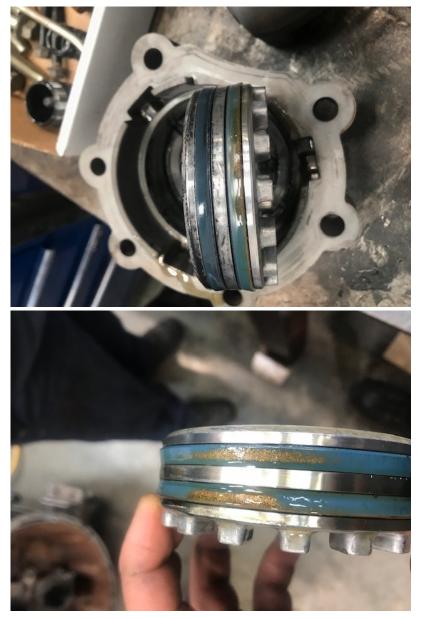
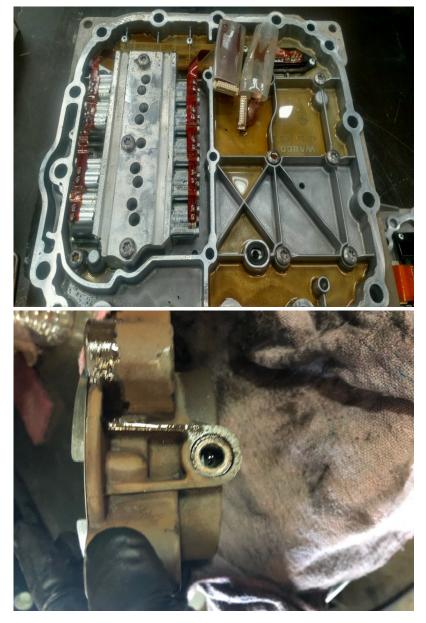
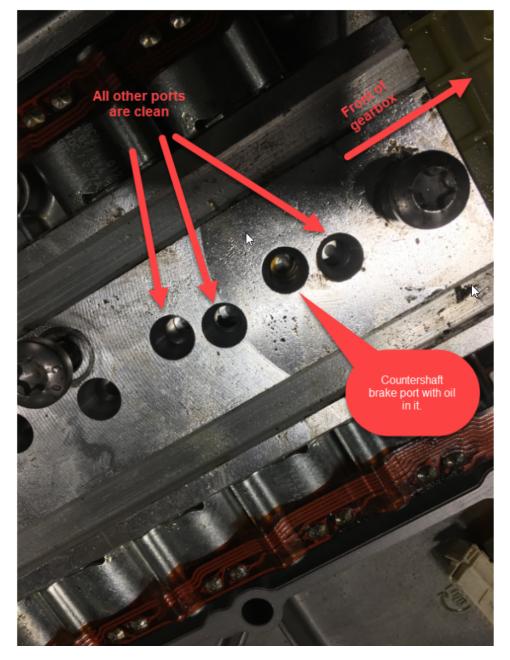
If there is no air leakage or only slight air leakage from vents during countershaft brake testing and oil is found in the control housing:

- **1.** Remove the gearbox from the vehicle.
- 2. Remove the countershaft brake air line.
- **3.** Check for the presence of oil in the air line or check the exhaust port on the solenoid block for the presensce of oil.

If oil is found in the countershaft brake airline or the solenoid block then repair or replace the countershaft brake as needed. Oil in the solenoid block does not affect the operation and can be cleaned and reused following the instructions below.

Clean the oil from the inside of the control housing and from the TECU with a clean cloth and blow it dry with compressed air. Cleaning sprays like brake cleaner are not recommended by WABCO for cleaning the electrical components like the solenoids harnesses and circuit boards. Unplug the connectors from the circuit board and clean the oil from inside the connections with compressed air and wipe off any residue. Clean all the air passages for the countershaft brake and reassemble the unit.

NOTE: Bench test assembly before reinstallation.
