Latest Vehicle Concern Fixes

Coolant Leak

18MY Onward F-PACE, XE, RR
Velar equipped with AJ20P4

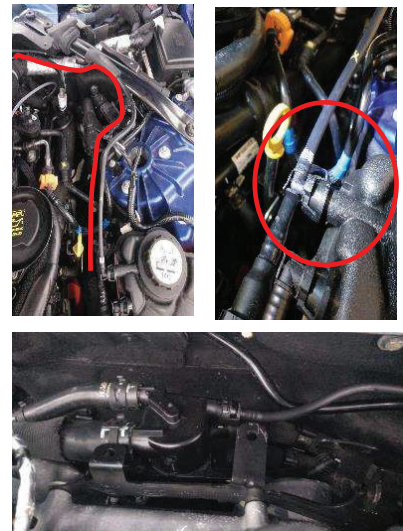
- The leak is identified from JX73 8C362 AC

- We are interested in gathering additional data from a vehicle **before** the hose is replaced.
- If a leak is identified from this hose or one of the connections complete the steps below with the original pipe installed:
 - Pressure test cooling system as per TOPIx when coolant temp cold.
 - Drive the vehicle for at least 20 minutes to allow the coolant to get to full operating temperature.
 - Pressure test cooling system as per TOPIx with coolant temp hot.
 - Collect pictures or videos of a leak from either side of the pipe referenced.
 - Remove hose and measure inner and outer diameter of pipe and mating surface at 90 degree intervals.
- Create an EPQR and include details of the findings from the steps provided.
