# SERVICE ADVISORY

**Article** TSA-18-01

2015-18 Slingshot – Muffler noise

Polaris has identified a quality issue affecting a small number of Slingshot mufflers, where insufficient penetration of muffler plug welds weakens the muffler wall, making it susceptible to fatigue failure. The first mode of failure is a loosening of the wall, distinguishable by a rattle during normal engine operation. If left unrepaired for an extended period of time, a hole may form in the muffler wall resulting in noticeably higher noise levels.

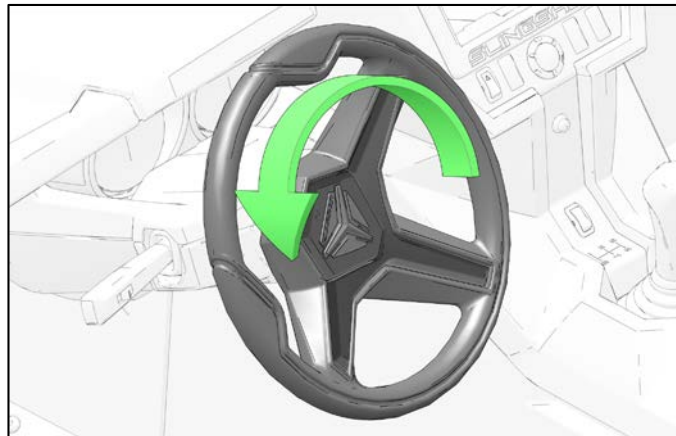
1. Park vehicle on flat and level surface. Apply parking brake. Chock rear tire and open vehicle hood.
2. Turn steering wheel to the left allowing access to passenger side rocker panel.

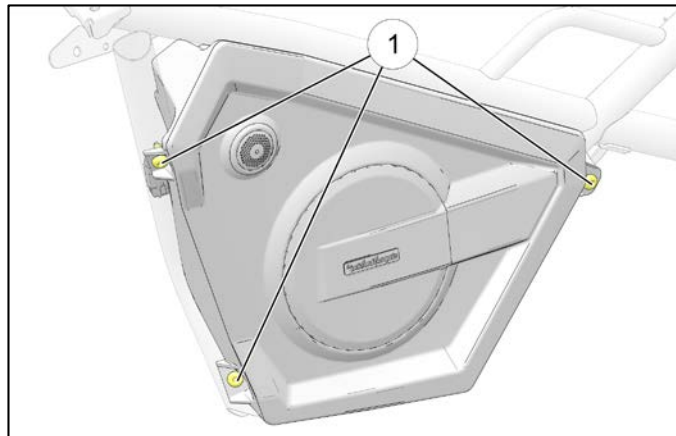
3. If applicable, remove three passenger side speaker fasteners ① and position enclosure out of the way.

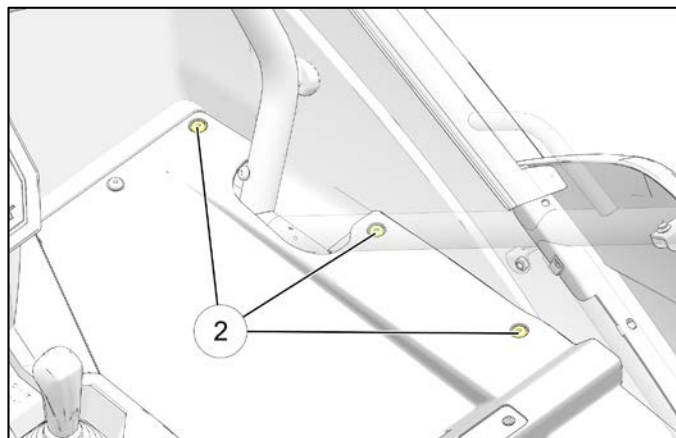
4. Remove three lower passenger rocker panel fasteners ②.

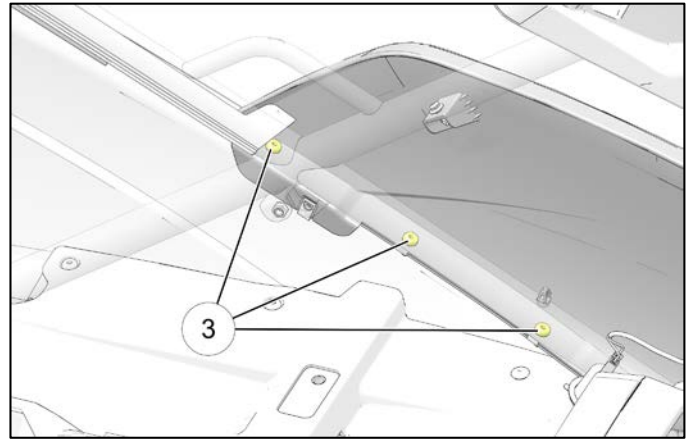
5. Remove three top passenger front rocker panel fasteners ③.

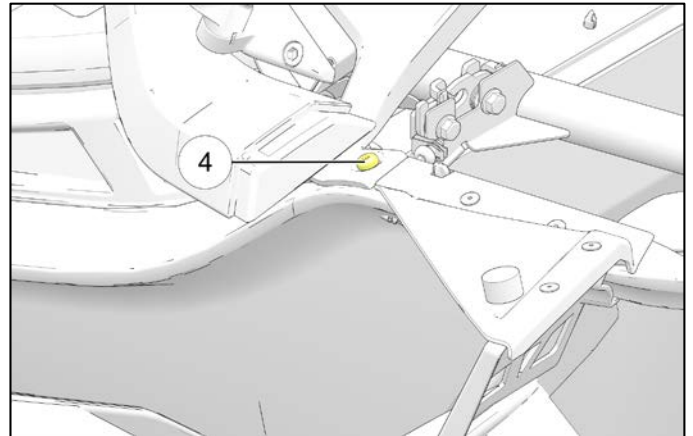
6. Remove fastener ④ from the top of the rocker panel.

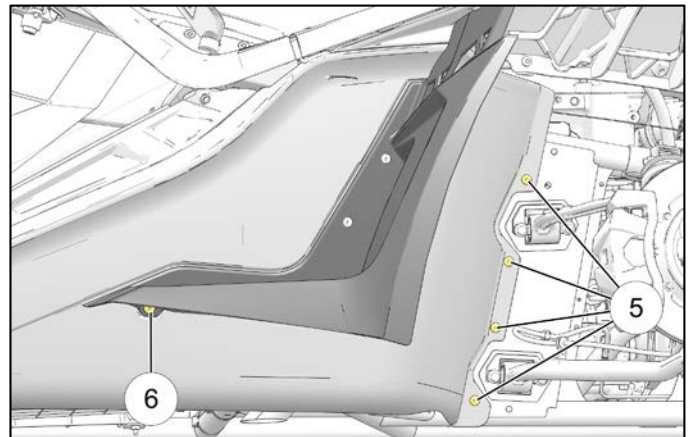
7. Remove four fasteners ⑤ securing the passenger front rocker panel horizontally to the chassis. If applicable, remove splash guard fastener ⑥.

The fastener ⑥ securing the splash guard is longer than the other four fasteners.

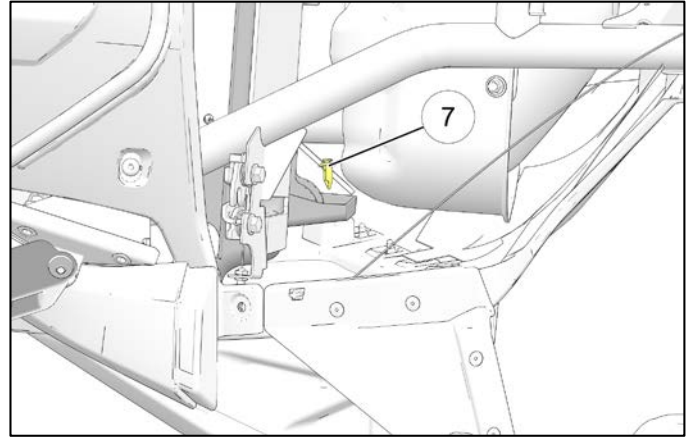
8. Remove push rivet fastener ⑦ from the inside of the rocker panel.

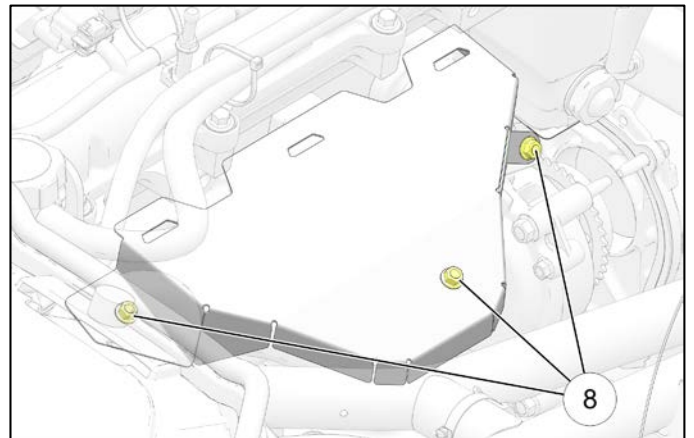
Remove three fasteners ⑧ securing the exhaust manifold heat shield to the exhaust manifold. Remove exhaust manifold heat shield.

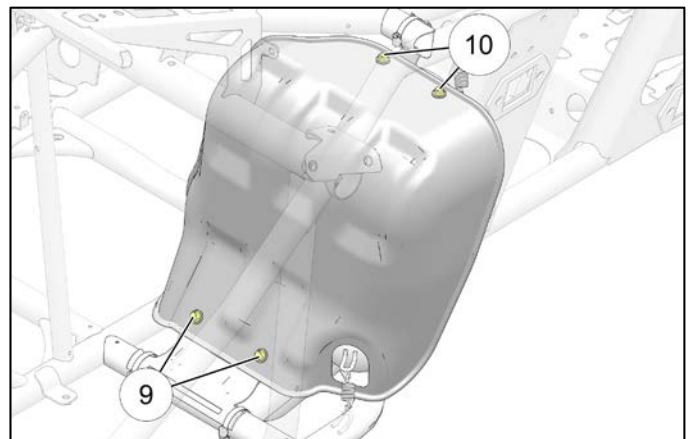
- A. Remove two fasteners ⑨ securing the lower heat shield bracket to the muffler heat shield.
- B. Remove two fasteners ⑩ securing the upper heat shield bracket to the muffler heat shield.

Loosening the top hose clamp and rotating the shield bracket makes muffler removal easier.

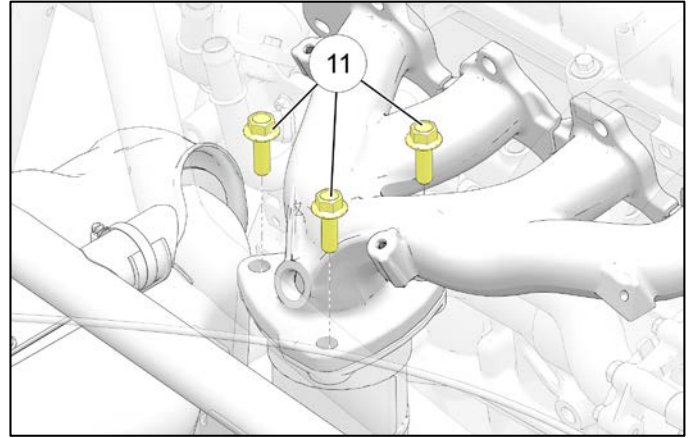
9. Remove three fasteners ⑪ securing the downpipe to the exhaust manifold.

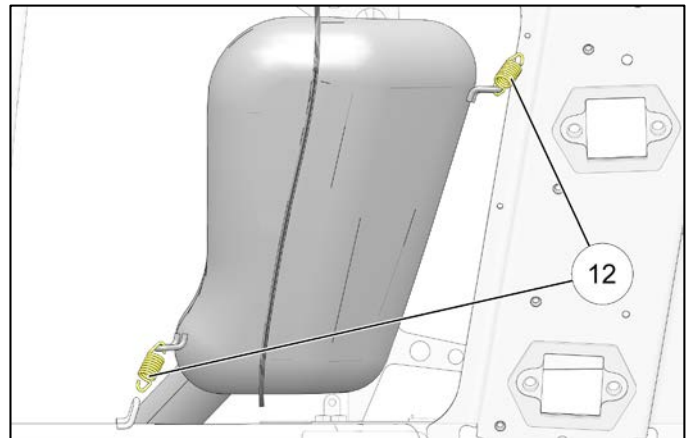
10. Remove two springs ⑫ attaching the muffler to the chassis and discard springs.

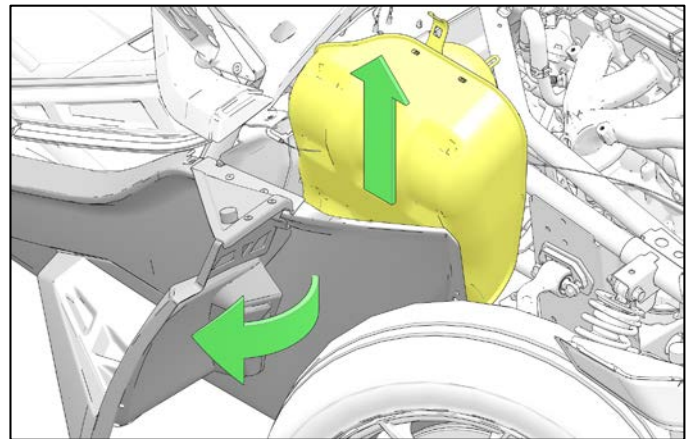
11. Gently pull outward on the rocker panel to expose an opening between the chassis and the rocker panel. Position the hood latch cable out of the way. Rotate and remove the muffler assembly (with muffler heat shield if applicable) together through the opening.

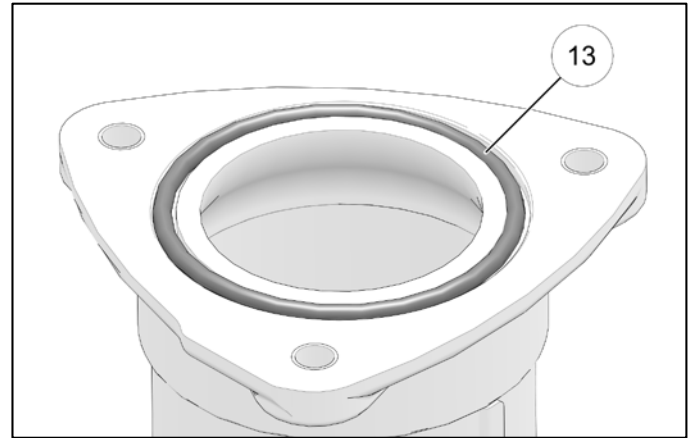
12. Carefully remove and discard exhaust manifold pipe gasket ⑬.

Using a pick, pry up on gasket until it releases from the manifold. Be careful not to damage manifold pipe.

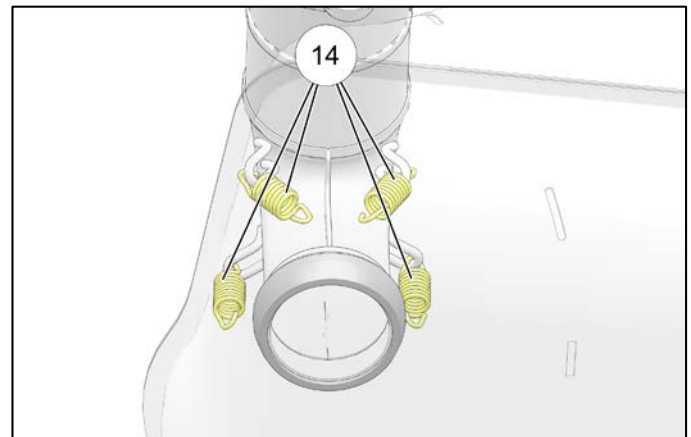
13. Remove four springs ⑭ securing the muffler to the exhaust catalyst. Discard the springs after disassembling.

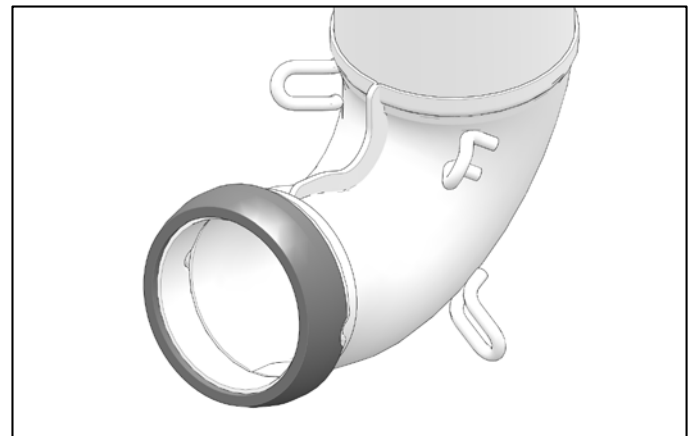
14. Separate the muffler from the exhaust catalyst assembly.

15. Remove the exhaust socket seal and discard.

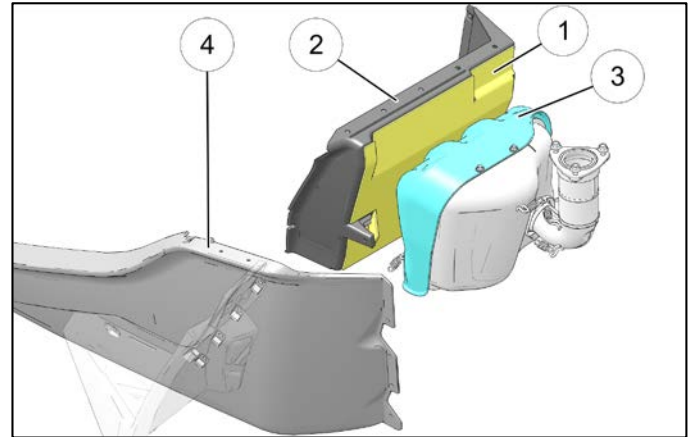
1. Inspect thermal shield ①, which is adhered to passenger footwell, for signs of damage.
2. Inspect the composite footwell ② for signs of damage looking from the cockpit side (opposite from the thermal shield).
3. Select vehicles include a muffler heat shield ③. If applicable, inspect shield for thermal damage.
4. Inspect rocker panel ④ for damage. If Damaged, submit an "Ask Polaris" case for component replacement approval.

This Service Advisory authorizes the replacement of the muffler heat shield ③ only if the heat shield is present and shows evidence of damage at the time of inspection.

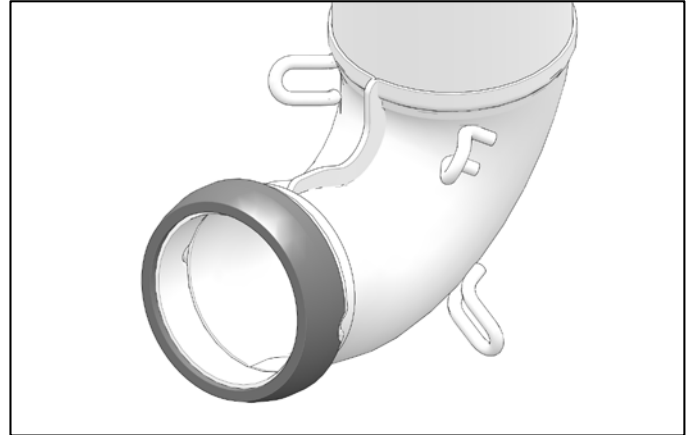
1. Install NEW exhaust socket seal (3610211) by assembling over exhaust catalyst assembly.

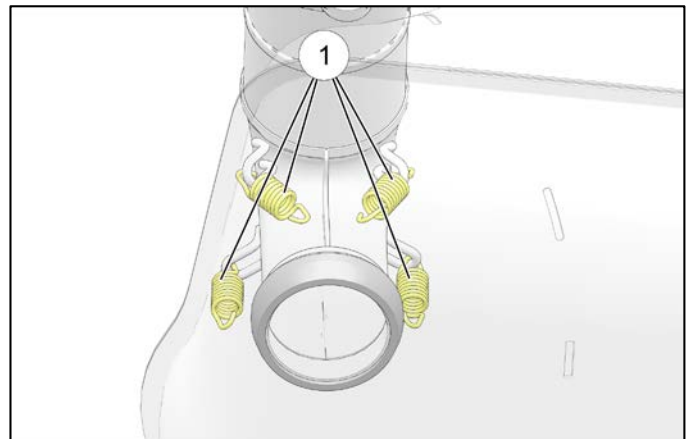
2. Assemble muffer downpipe to the new muffer assembly (1262781) by securing four NEW springs ① (7043726).

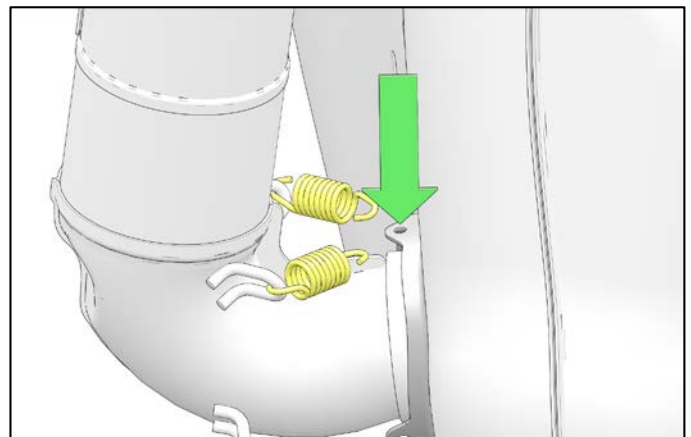
The top two springs share the same flange eyelet. Make sure the springs are secured to their proper eyelet locations during installation.

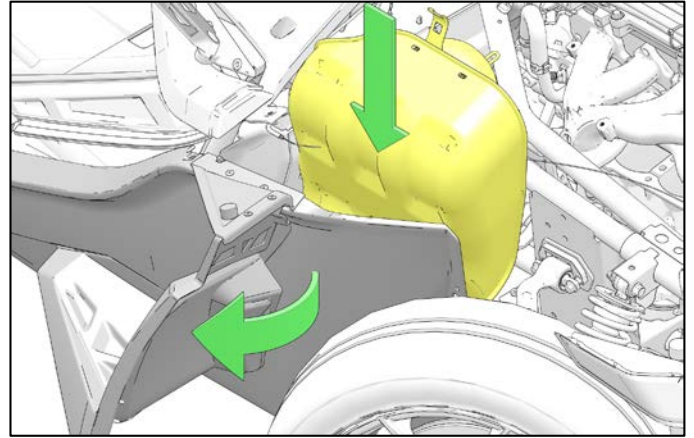
3. Gently pull outward on the rocker panel to expose an opening between the chassis and the rocker panel. Rotate and install the muffler assembly (with muffler heat shield if applicable) together through the opening.

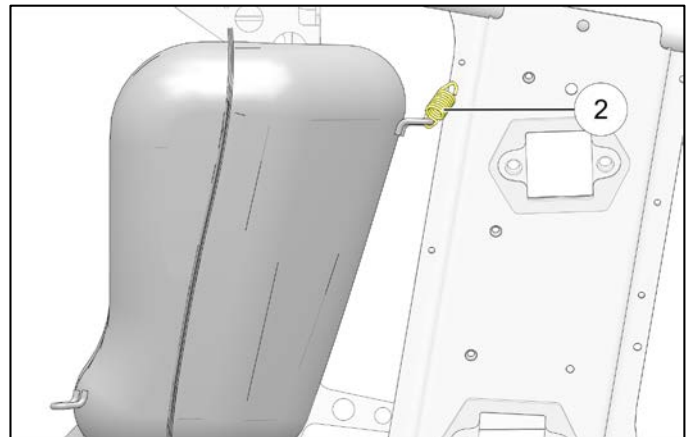
4. Install NEW upper spring (2) securing the muffler to the chassis.

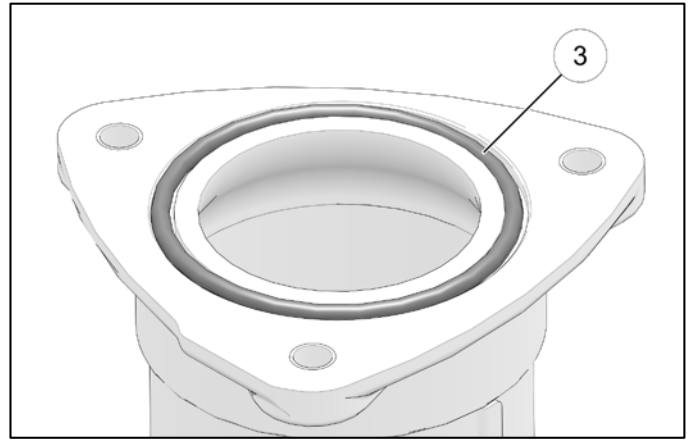
5. Verify downpipe is not damaged. Install NEW exhaust manifold pipe gasket (3) (24505057).

Verify exhaust manifold pipe gasket is properly installed in downpipe before installing fasteners.

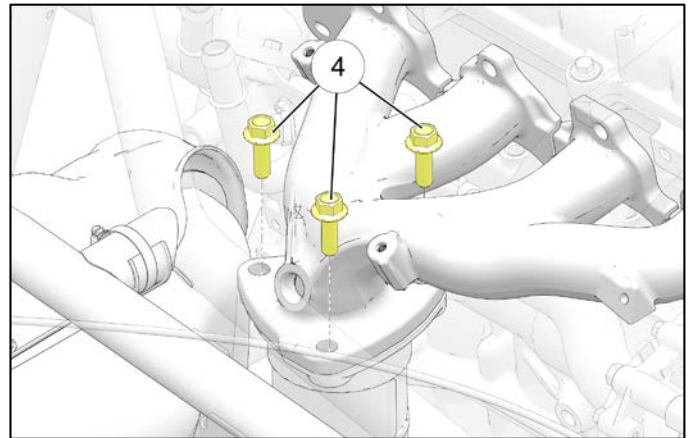
6. Install three fasteners (4) securing the exhaust downpipe to the exhaust manifold. Torque to specification.

Downpipe Fasteners:  
**37 ft-lbs (50 Nm)**

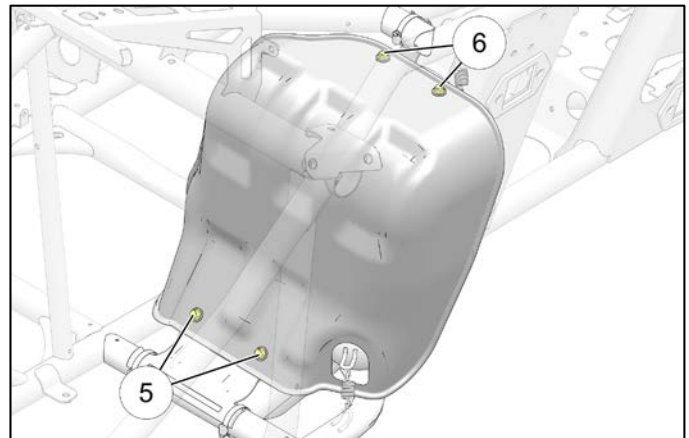
- A. Install two fasteners (5) securing the lower heat shield bracket to the muffler heat shield.
- B. Install two fasteners (6) securing the upper heat shield bracket to the muffler heat shield.
- C. Torque fasteners to specification.

Do not torque fasteners until all have been installed.

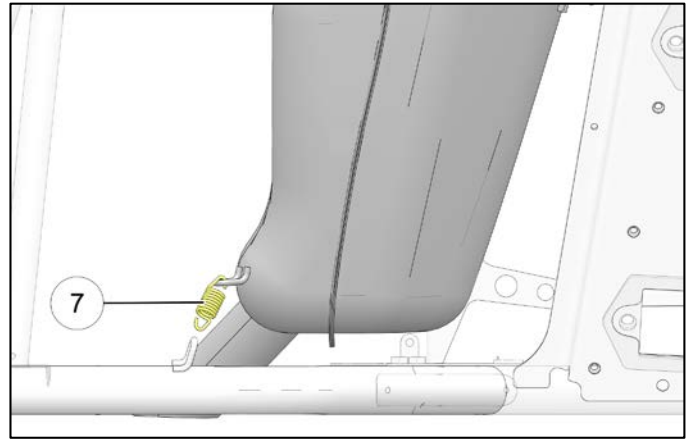
8. Install the NEW lower spring (7) securing the muffler to the chassis.

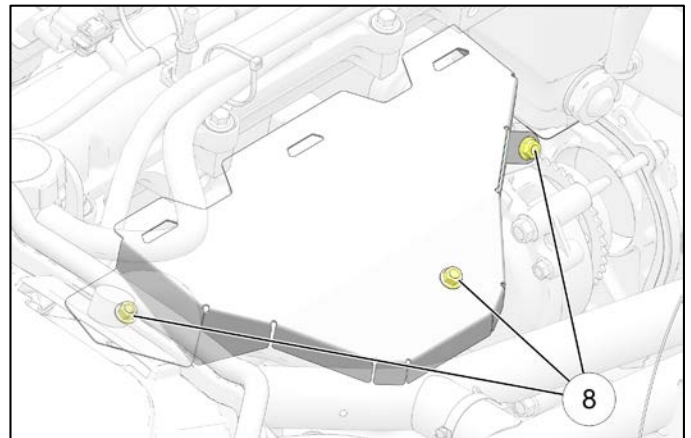
- A. Install exhaust manifold heat shield. Install three fasteners (8) securing the exhaust manifold heat shield to the exhaust manifold.
- B. Torque fasteners to specification.

Exhaust Manifold Heat Shield Fasteners:  
**84 in-lbs (9 Nm)**

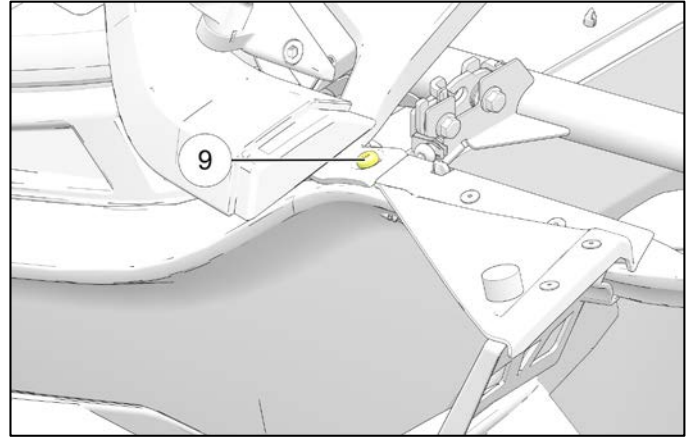
10. Install fastener ⑨ to the top of the rocker panel. Torque to specification.

Rocker Panel Fastener:  
**65 in-lbs (7 Nm)**

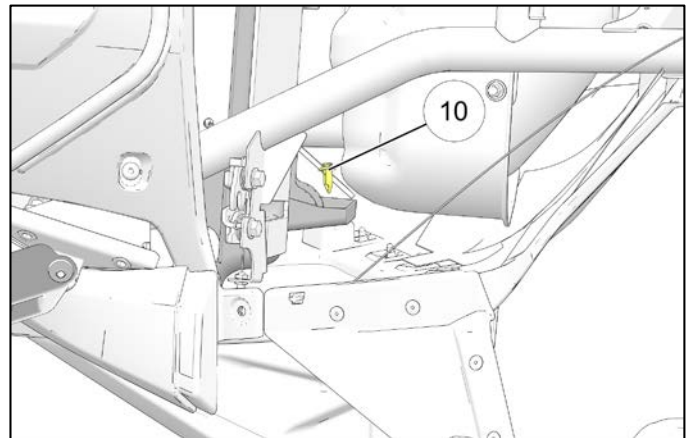
11. Install push rivet fastener ⑩.

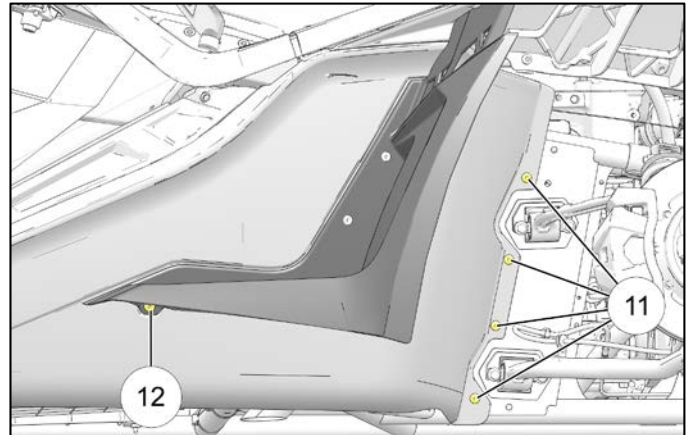
12. Install passenger front rocker panel. Loosely install fasteners ⑪ and ⑫. Torque fasteners to specification.

If applicable, make sure the long fastener ⑫ is used to secure the splash guard.

Long Rocker Panel Fastener ⑫:  
**50 in-lbs (6 Nm)**

Short Rocker Panel Fasteners ⑪:  
**65 in-lbs (7 Nm)**

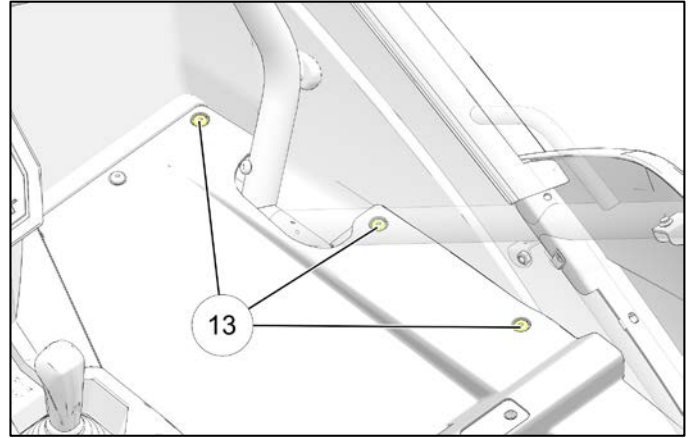
13. Install three lower passenger rocker panel fasteners ⑬. Torque fasteners to specification.

Rocker Panel Fasteners:  
**65 in-lbs (7 Nm)**

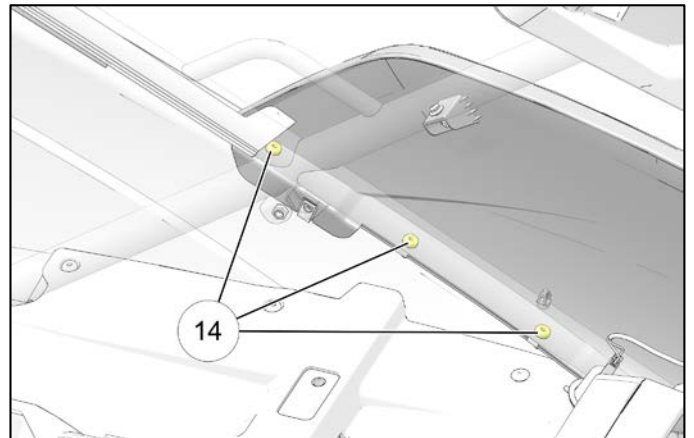
14. Install three top passenger front rocker panel fasteners ⑭.

Rocker Panel Fasteners:  
**65 in-lbs (7 Nm)**

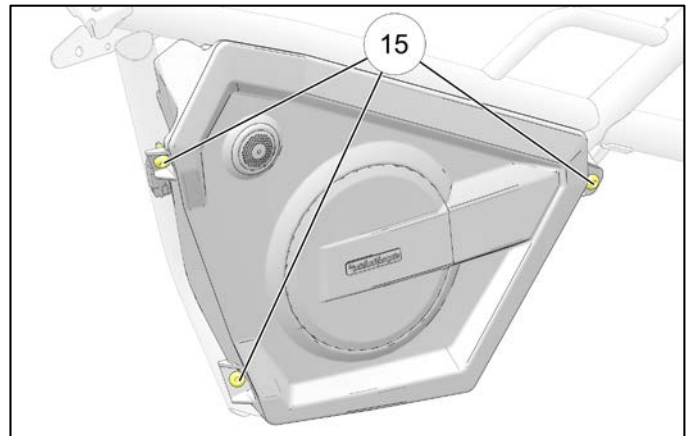
15. If applicable, install speaker enclosure. Torque fasteners ⑮ to specification.

Speaker Enclosure Fasteners:  
**48 in-lbs (5 Nm)**

Make sure wires are not pinched between the speaker enclosure and frame rail.

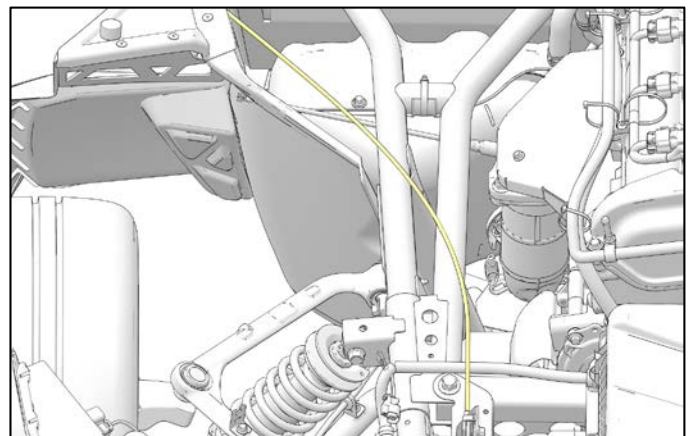
16. Verify proper routing of the hood latch cable.

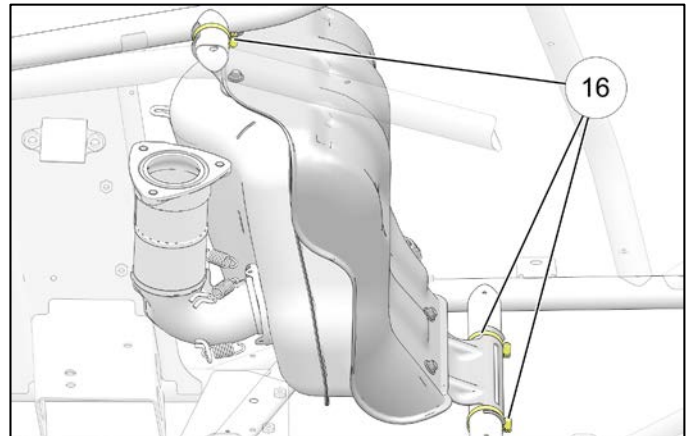
19. If equipped, verify the clearance between the top muffler seam and muffler heat shield after test drive. Adjust the heat shield as necessary.  
To adjust heat shield, loosen the three clamps ⑩ attaching the heat shield brackets to the chassis. Position heat shield in desired location and torque clamps to specification.

Heat Shield Clamps:  
**12 in-lbs (1 Nm)**
