FT4944 Radiator Canopy bottom assembly bolts loosening

Service Instruction

QJ 7621- 2124 – Rear Canopy Bottom Bolts Loosening

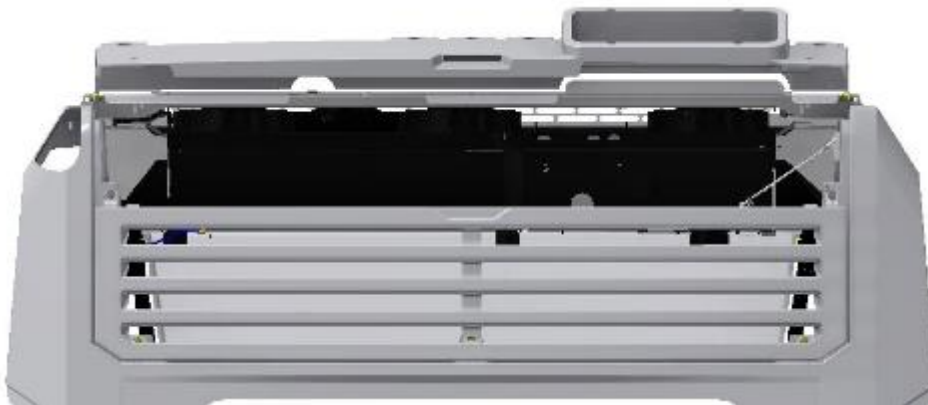
System Name	Rear radiator grill
Option	01-426.38
Drawing	401426NB35
Part	N81913

Grill removed to paint the bus and not installed back on per the assembly drawings

Loctite to be applied on bottom bolts

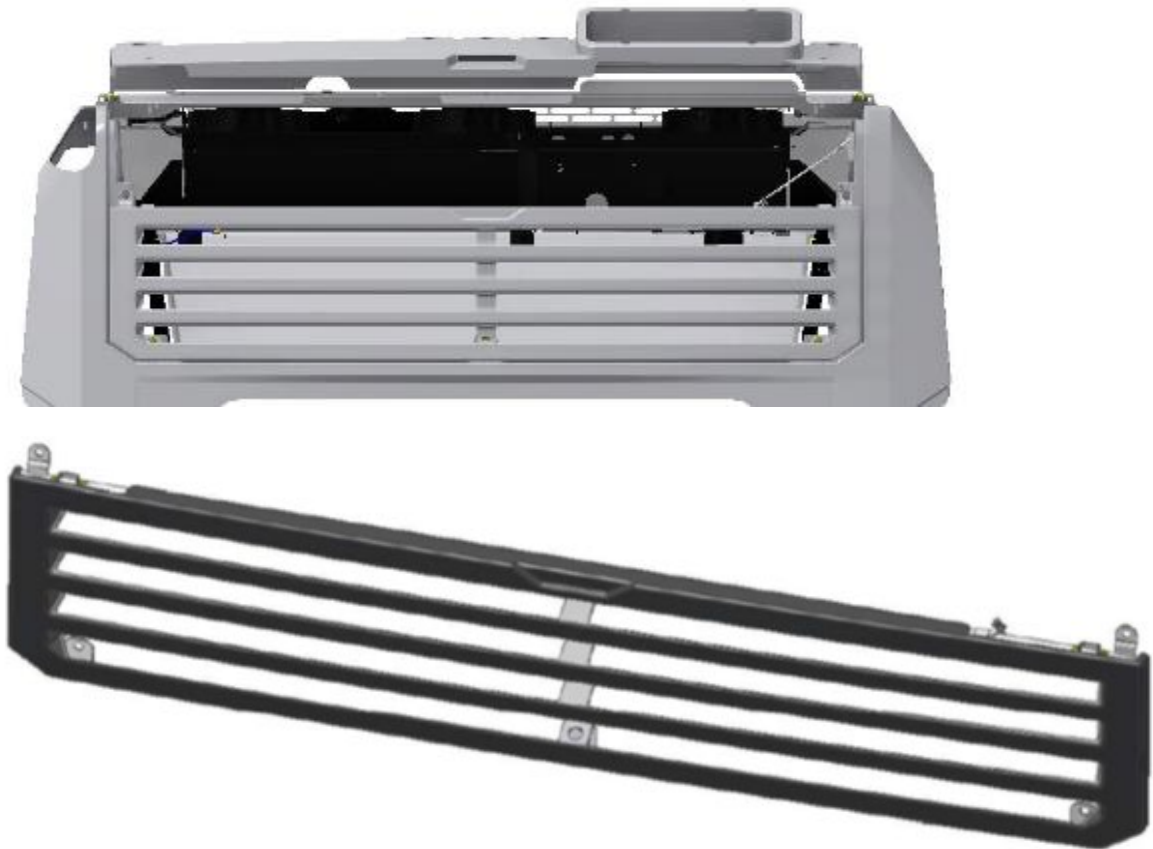
1. Locate the rear radiator canopy grill

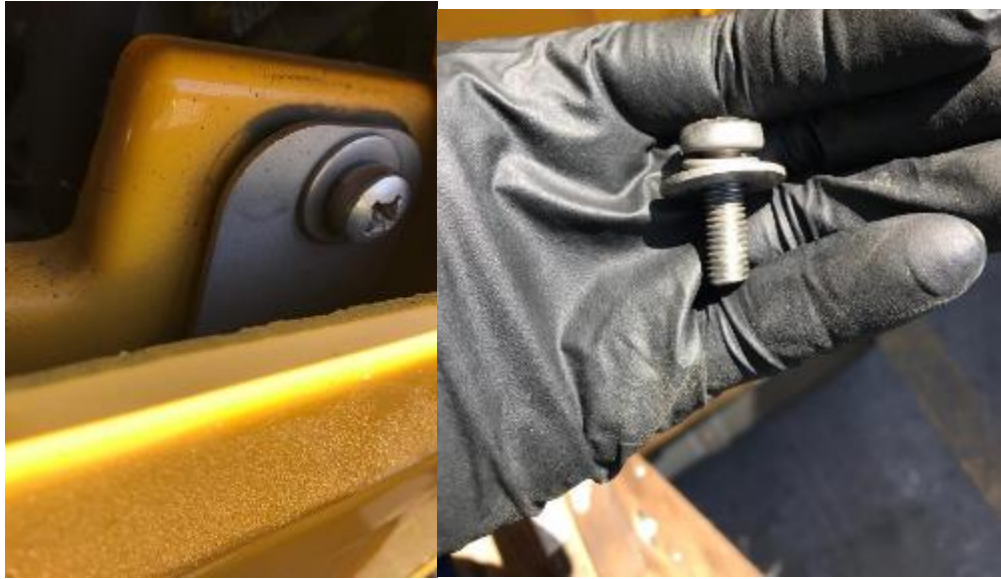
2. Place ladder behind bus
3. Starting with the bottom, left hardware assembly on the radiator grill, remove the N71421 Screw, N28220 Lockwasher, N28219 Washer Oversize using a #3 Phillips head screwdriver
 - a. Note: if the hardware is missing, reinstall new hardware (level 2 parts)
 - b. Be sure to clean any reused hardware and interior threads with degreaser to remove any debris

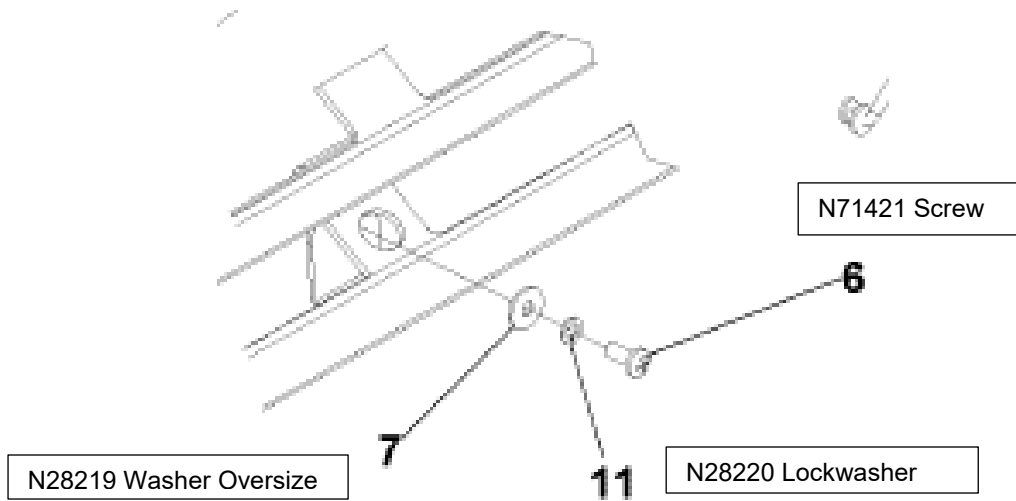
4. Add 9985283 Thread Locker Blue to the screw thread
5. Install the screw and washers into the rivnut and tighten using a Phillips # 3 head screwdriver.

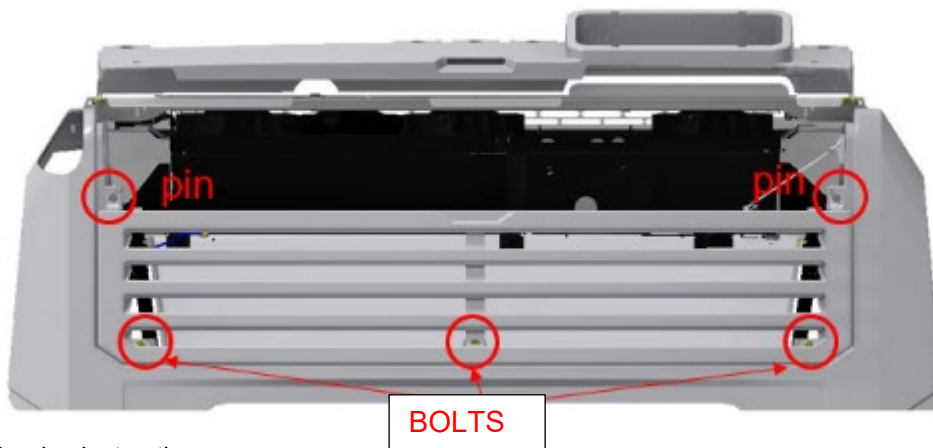
6. Torque to 19.1 Nm with a torque wrench. Apply torque seal.
7. Repeat for the other two bottom locations
