FT4929 Curb side front wheel air brake hose rubbing

Brake hose internal campaign C/S and S/S front brake hoses

NYCT LC32

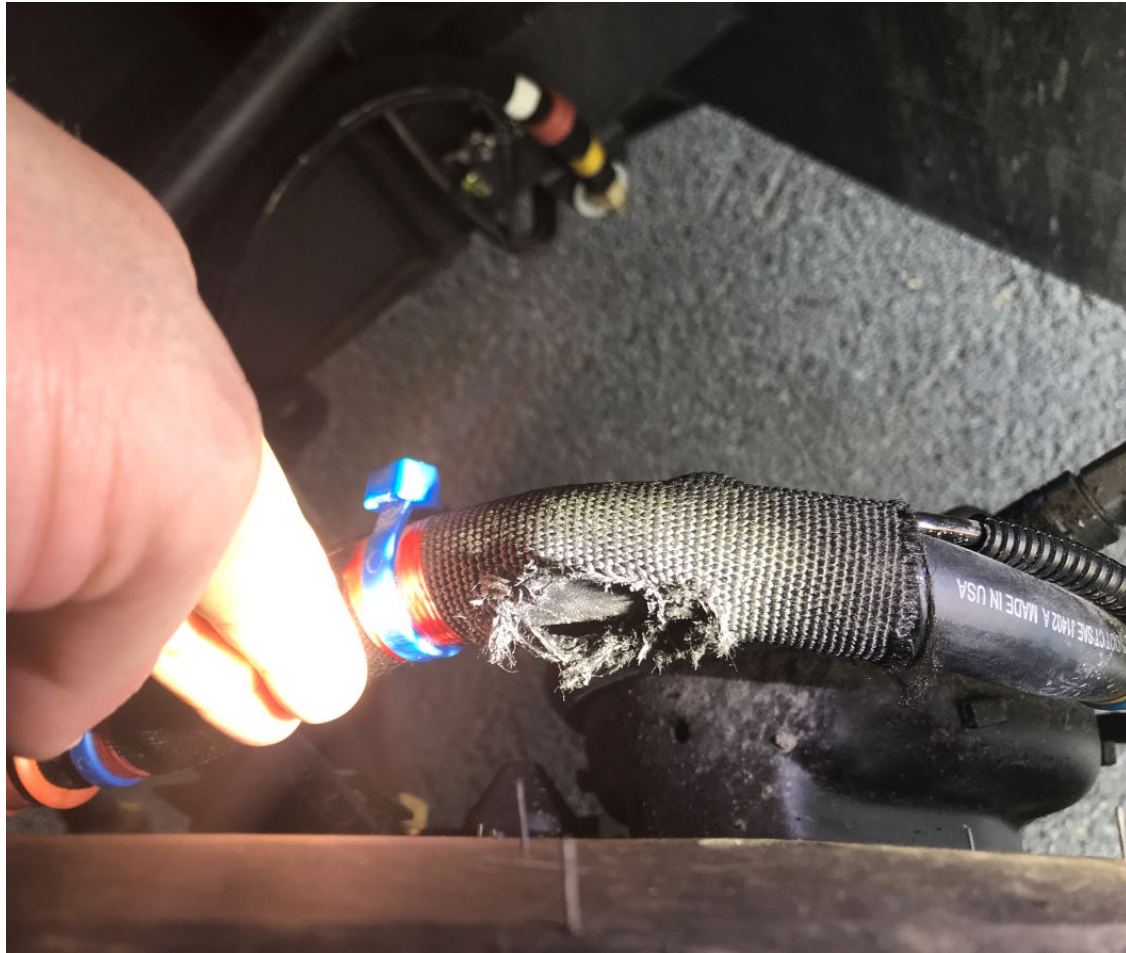
Brake hose rubbing tire

- While tightening the brake hose at the C/S front brake chamber some buses have had the brake line twist toward the front tire during the torqueing process, this is not present on the street side, this hose when torqued moves away from the tire due to it being the opposite direction as the curb side.

A 30mm minimum of clearance is required between brake hose and tire

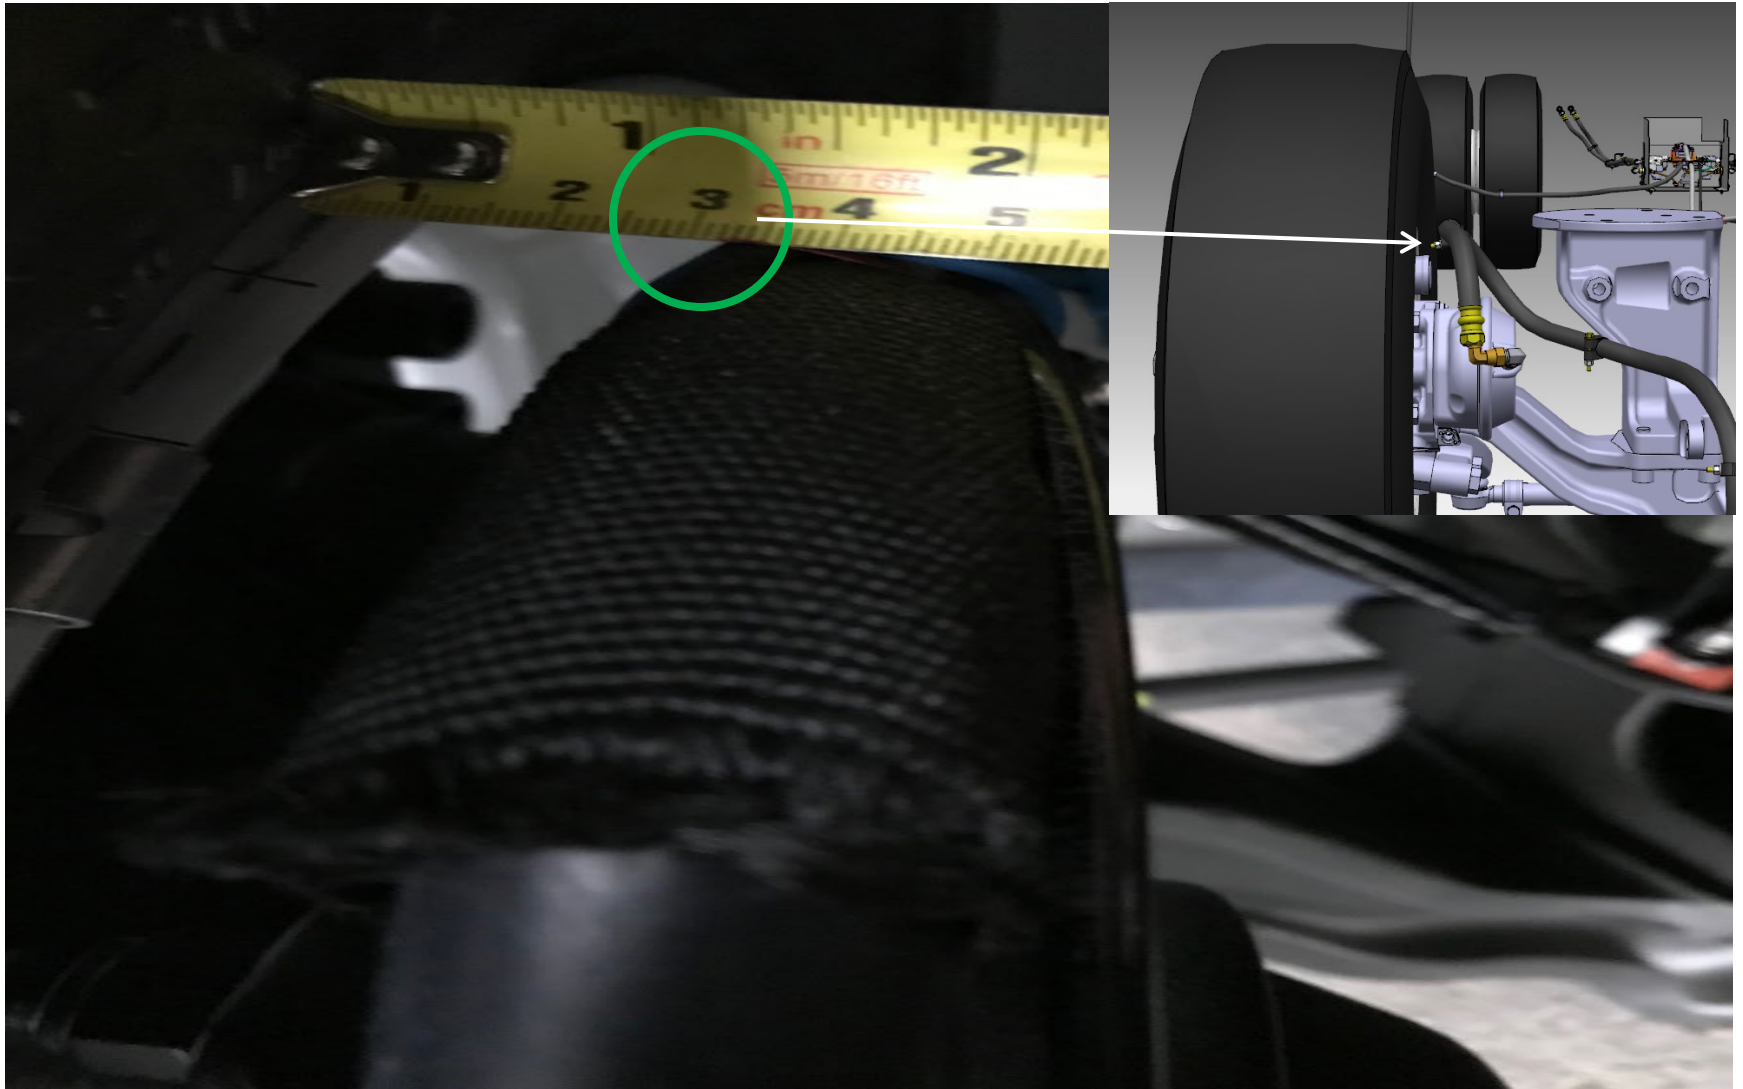
Measure distance between brake hose and tire at its closest point

If there is less than 30MM and no contact between the brake hose and tire has been made, conduct the following procedure, keep bus locked out/chocked/stands in place

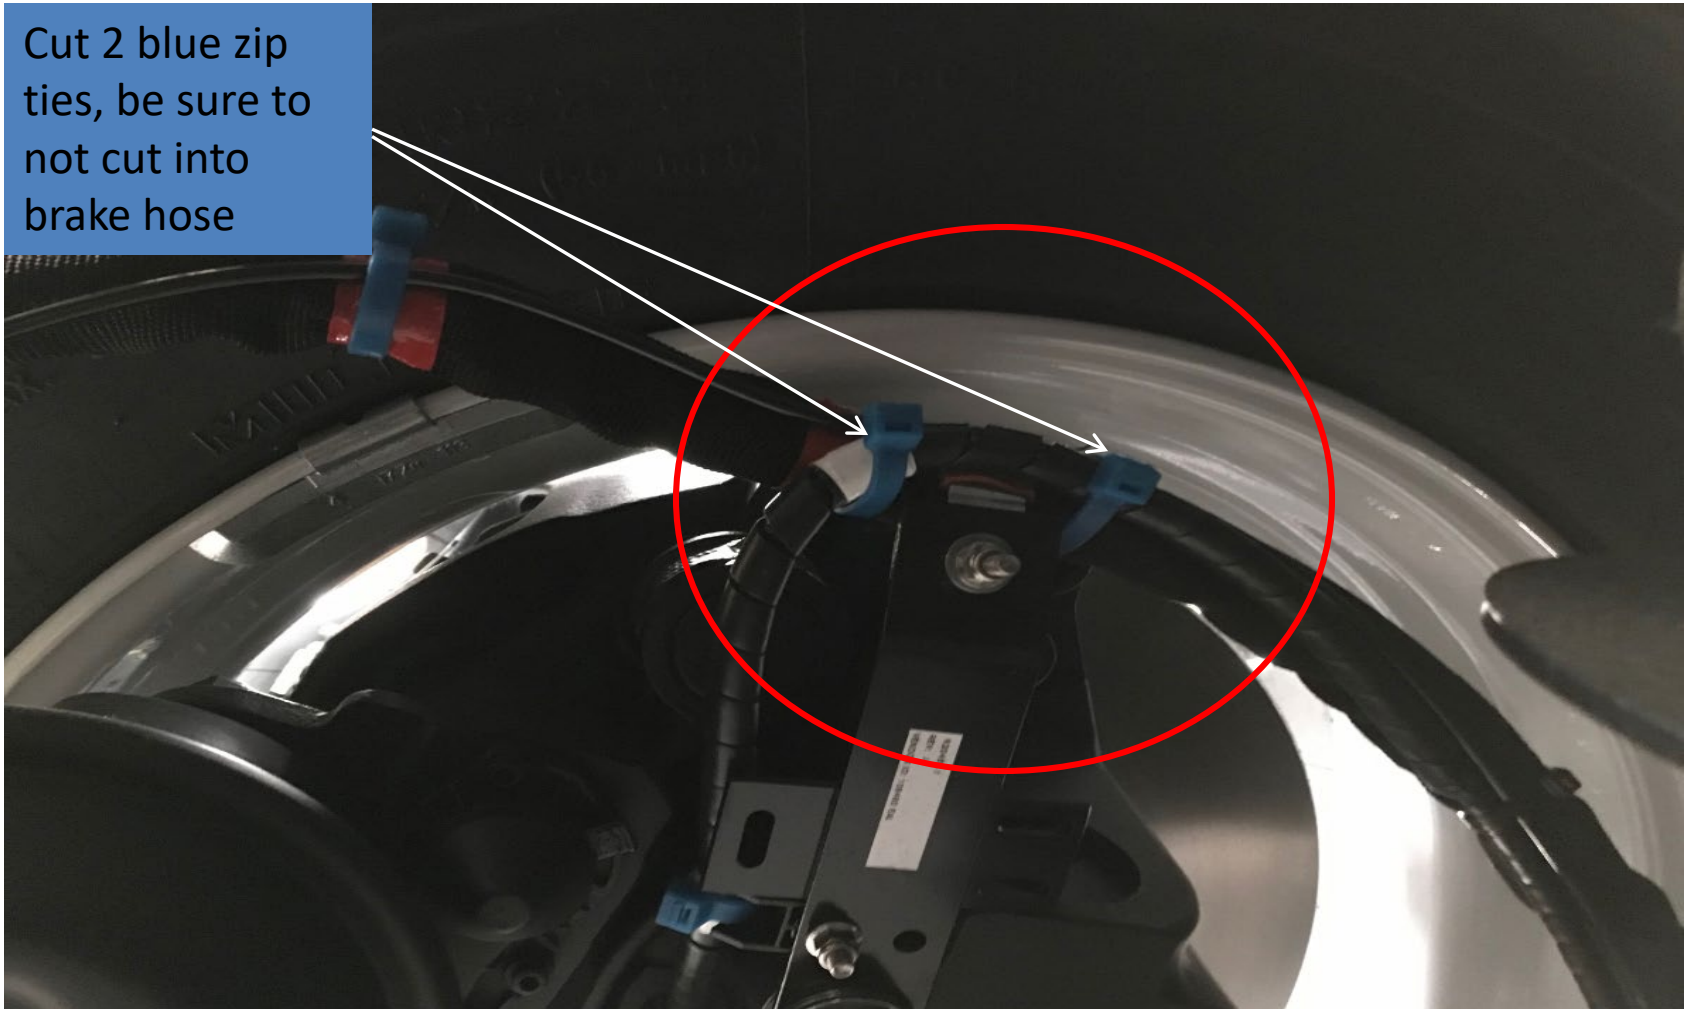
Cut 2 blue zip ties, be sure to not cut into brake hose

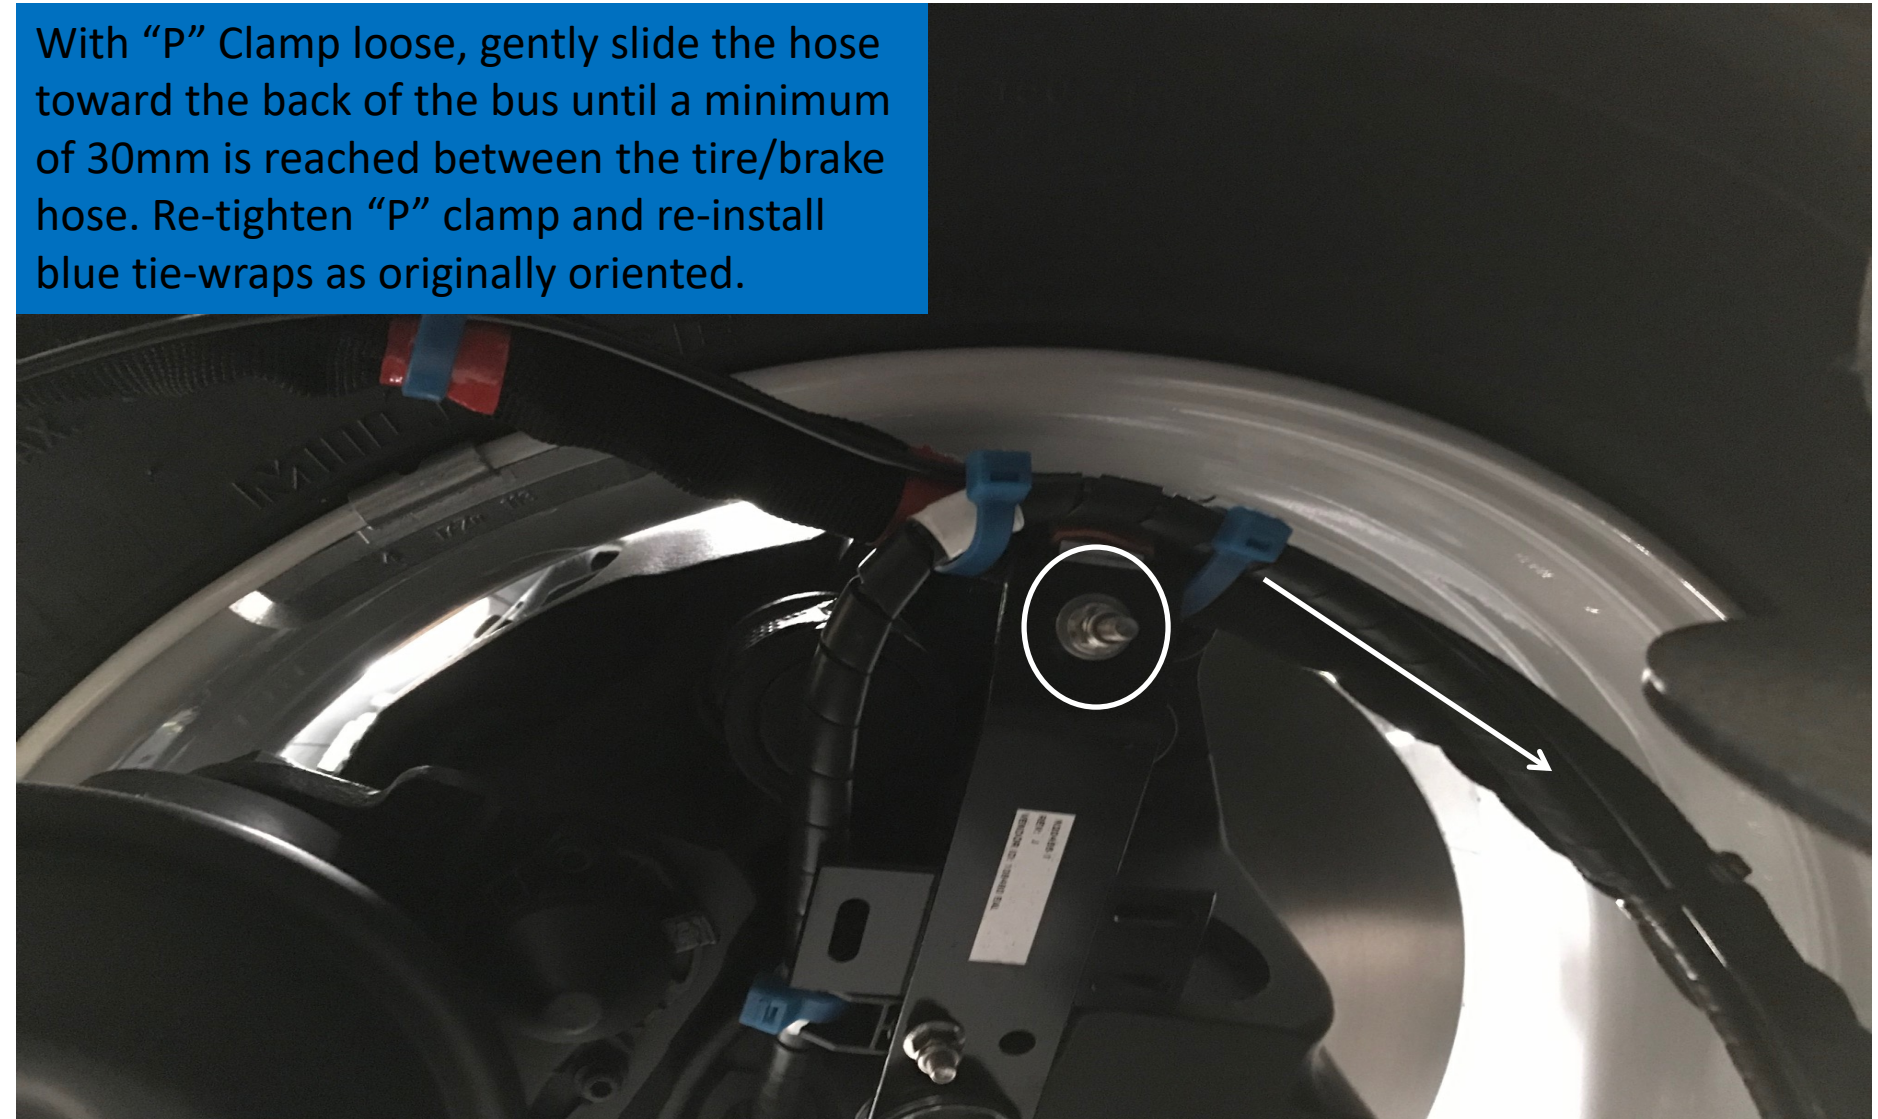
Loosen “P” Clamp

With “P” Clamp loose, gently slide the hose toward the back of the bus until a minimum of 30mm is reached between the tire/brake hose. Re-tighten “P” clamp and re-install blue tie-wraps as originally oriented.

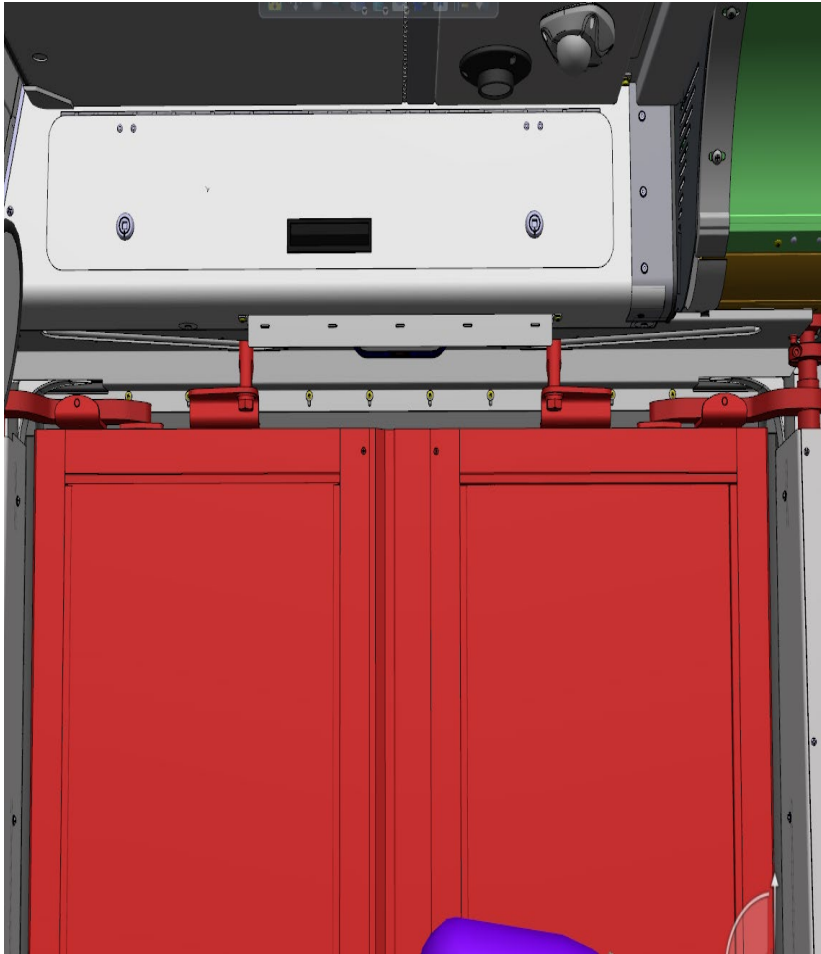
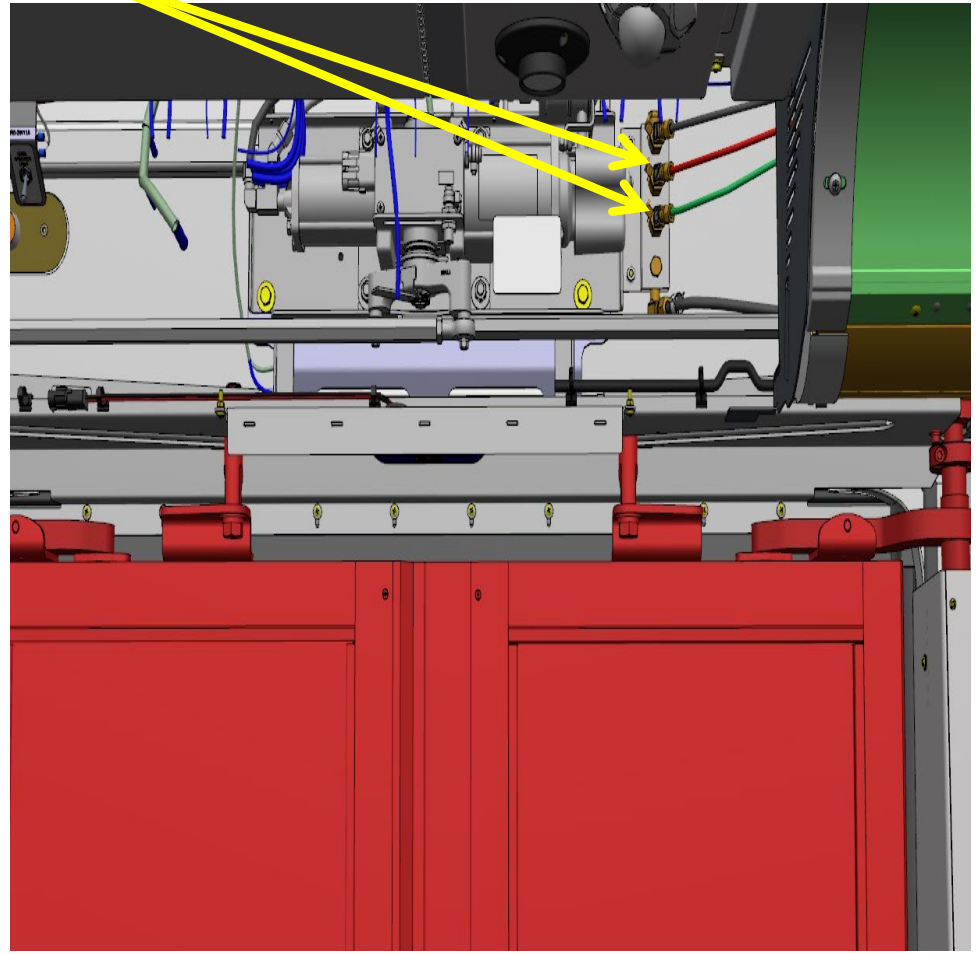
Empty primary and secondary air tanks, red and green shown below

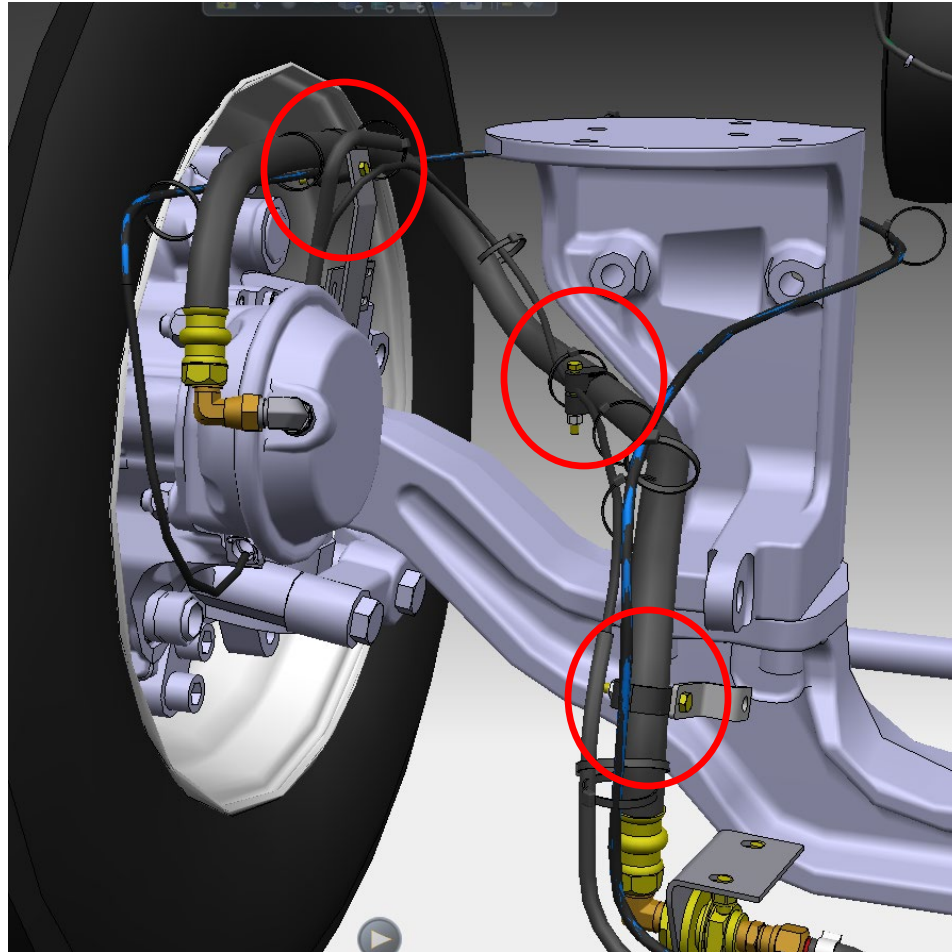
Remove “P” clamps from brake hose X3

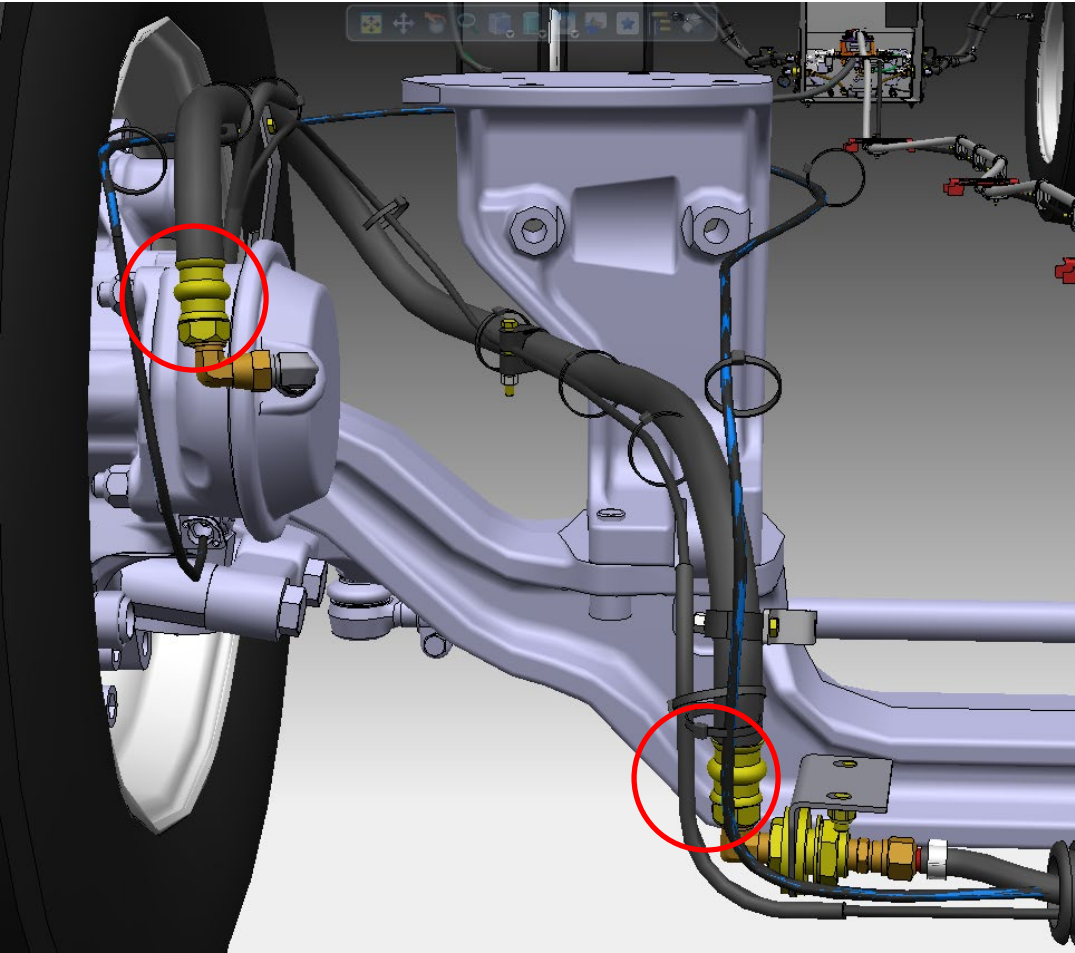
Disconnect air hose and discard

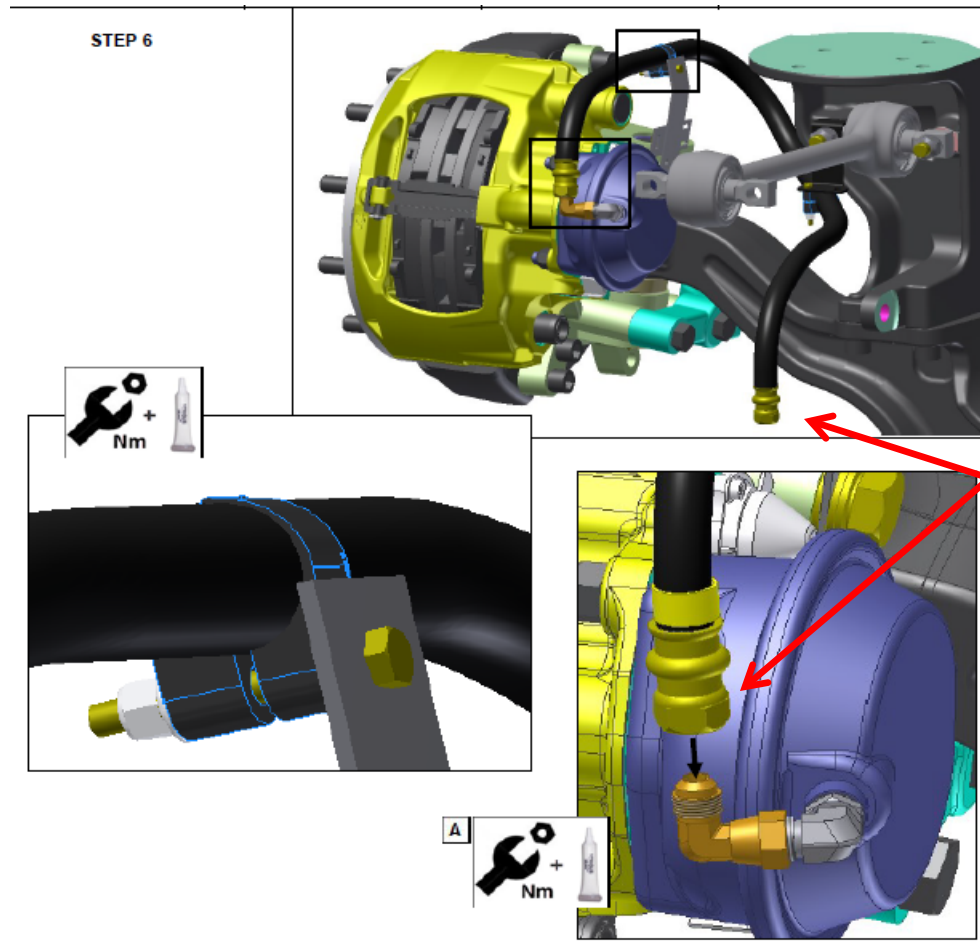
Install new air hose into “P” clamps, follow routing shown below

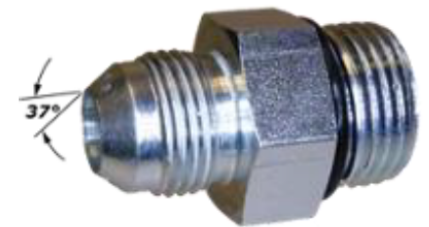
6.0 SAE 37° JIC TYPE FITTINGS AND adapter

The 37° JIC fitting seal is achieved through metal-to-metal contact between the flared nose of the fitting and the flared tube face in the female port.

- **SAE 37° JIC flare fitting assembly instructions**
- 6.1.1 Inspect the contact surface and threads for any damage or material flaw.
- **(Do not apply sealer on threads.)**

- Use thread size to determine torque to be applied (see **Table 5**).
- 6.1.4 Screw in the adapter or fitting by hand to ensure threads are correctly engaged
- and finger tighten as much as possible.
- 6.1.5 Using a wrench, complete tightening to the recommended torque (see **Table 5**).
- 6.1.6 Apply anti-tamper seal (“Torque Seal”) to indicate torque has been applied (**AVT-0203**).

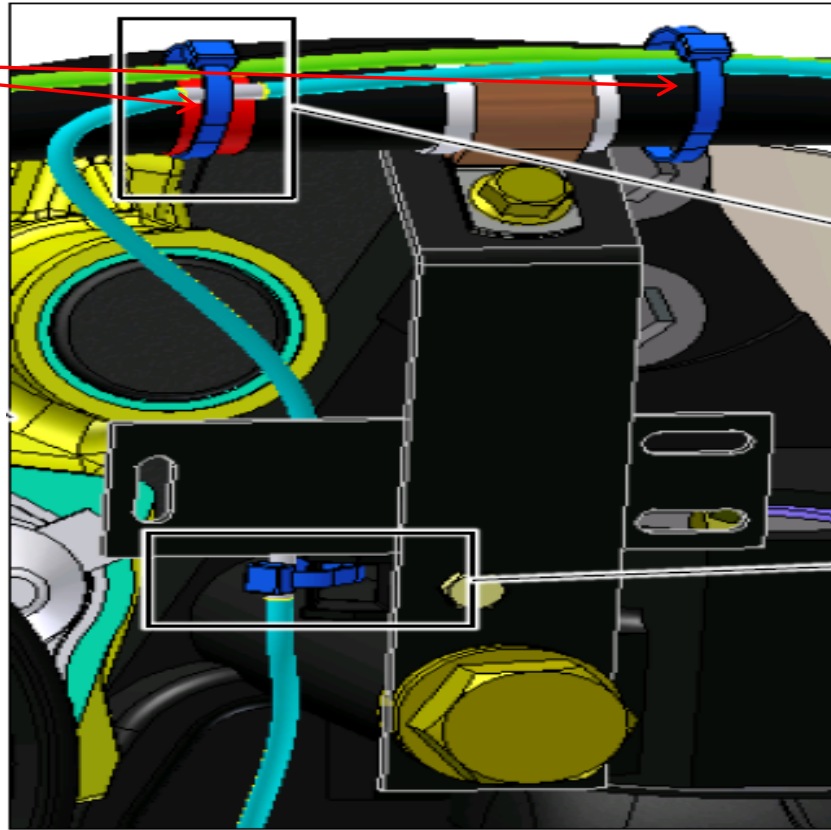
N56339

Re-secure cables on brake hose
