## Coolant warning in instrument cluster - Leak in coolant line below air filter

Topic number	LI20.20-P-071612
Version	1
Function group	20.20 Radiator, coolant hoses
Date	08-12-2020
Validity	All with M139
Reason for change	
Reason for block

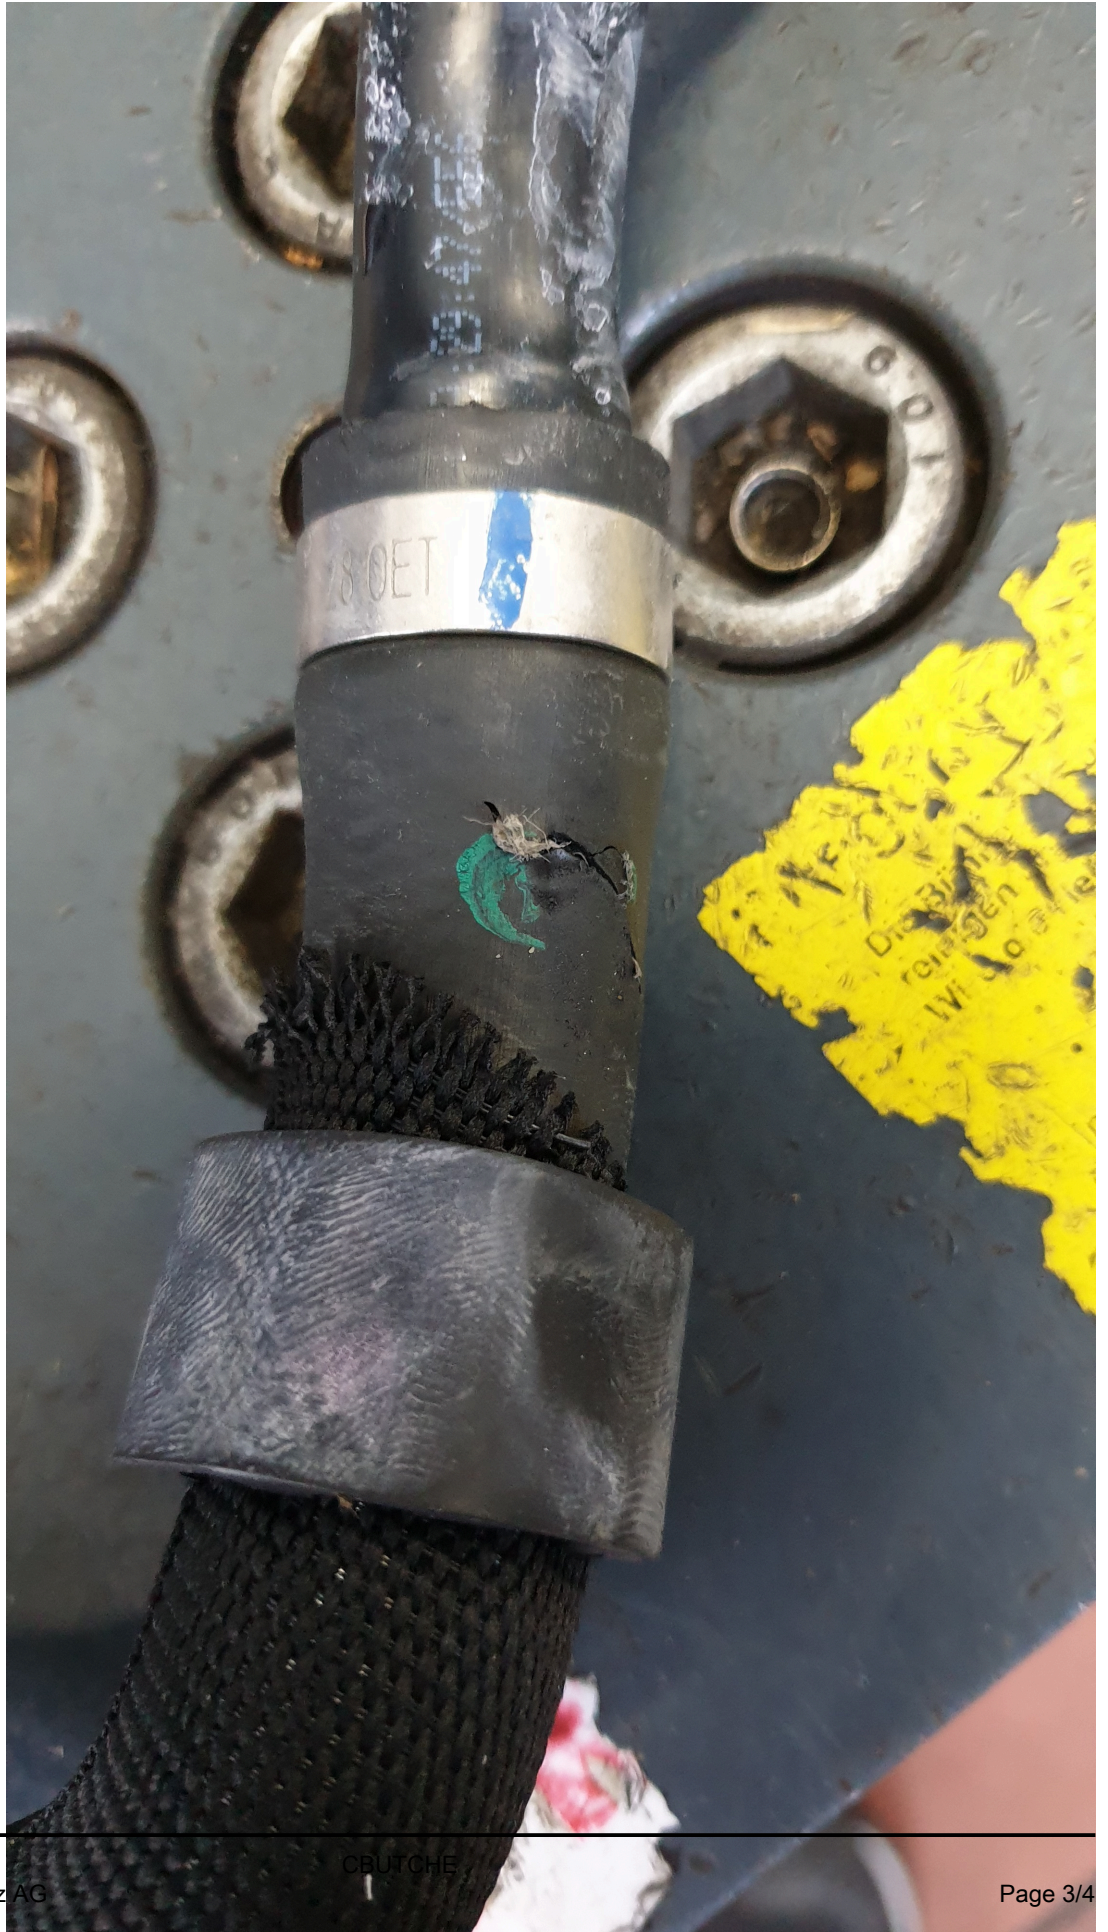
20200124\_095501.jpg:

Attachments	
File	Description
20200124_095501.jpg	Example of leak location

Coolant line below air filter (A1775012702) may leak, see example image

Before replacing the line, it is essential to create a PTSS case, with images showing location of leak
