MBUX multimedia system: The central display turns dark, various other system complaints

Topic number	LI82.85-P-071623
Version	1
Function group	82.85 Navigation and Communication systems
Date	08-25-2020
Validity	Model series 167 with code 548/549
Reason for change	
Reason for block

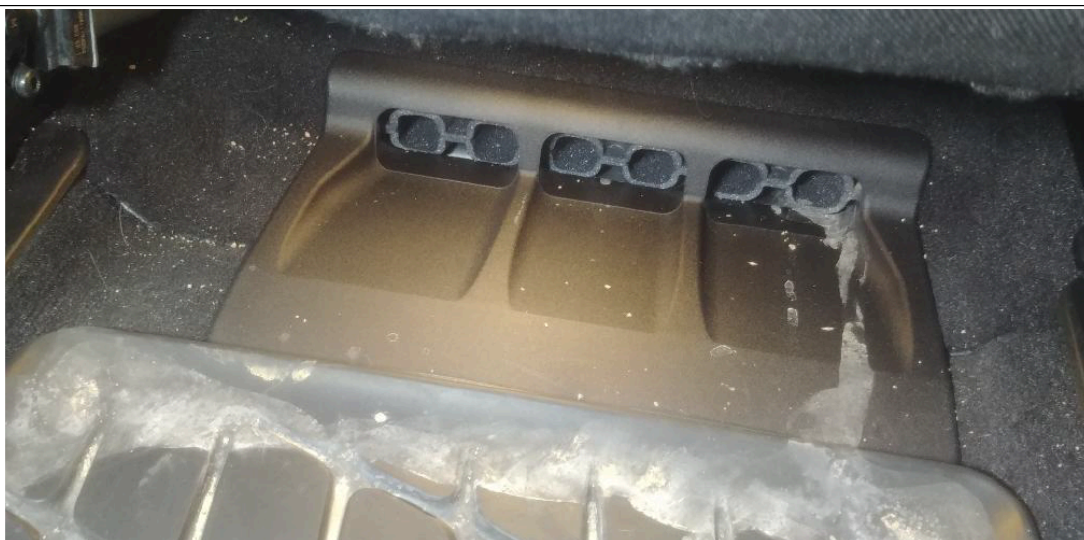
passenger air vent.jpg:

Water ingress through the air vent under the front passenger seat (see attached, note that the vents are facing the rear of the vehicle). As a result, the head unit (A26/17) may become damaged.

Attachments	
File	Description
passenger air vent.jpg	Traces of water ingress into passenger seat air vent Note: The vent is located under the front passenger seat and faces the rear of the vehicle

Avoid using rubber floor mats for the second row seats on which water can collect and subsequently enter the air vent under the front passenger seat.

An optimized cover is in development for the air vent under the front passenger seat. It is estimated to be available Q1 2021. This document will be updated once the part is available.
